Opuha Water Ltd

Opuha Dam
Annual Dam Safety Inspection 2013

Report prepared by:
Tonkin & Taylor Ltd

April 2013

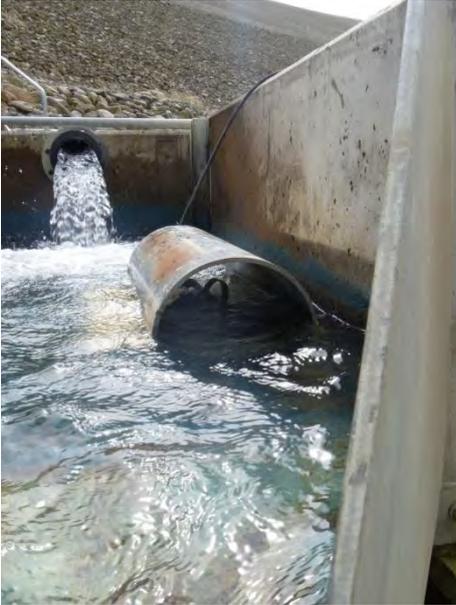
Figure 2 Turbidity meter in D7 H-flume

The turbidity meter installed in the D7 H-flume is to detect changes in sediment concentrations in the drainage discharge. However, we understand that the build up of algae on the instrument lens causes a false reading to be provided. ECS has indicated that OWL will be cleaning the lens on a regular basis in the hope that the data provided will be more accurate. Raw data has been recorded over the period and has yet to be processed. ECS have advised that this is due to the data collected not being an accurate representative of the actual turbidity, due to the build up of algae on the lens.

OWL continues to measure and report the turbidity of drainage flows by way of manual turbidity measurements taken at the time of the manual flow rate recordings. Reported turbidity readings appear to be relatively stable and are reviewed by T&T as part of the ongoing dam surveillance and monitoring requirements.

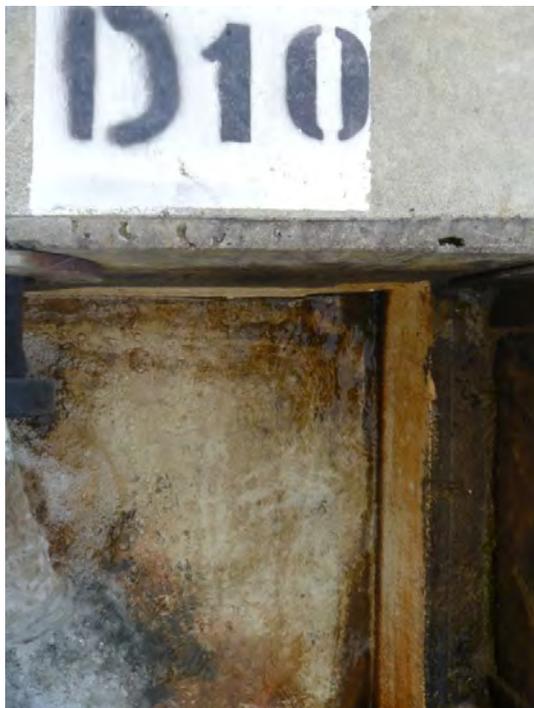
Figure 4 Sediment deposited in the D10 H-flume

The surveillance regime carried out by OWL over the period has allowed for observation of the levels of solids within the drains. OWL advise that the observed sediment in D10 drain flow had increased in terms of the volume of sediment that is settling in the H flume. Though recorded flow rates were within the acceptable bounds, sediment levels within the flow have apparently increased.

The source of the sediment is unknown, with potential for it to have originated from the chimney drain material. The location of the D10 flume also may allow for accumulation of windblown dust and grit. OWL advise that a sample of the drain flow will be collected for material analysis. Drain D10 should be included in the sediment flux measurement trial recommended in Section 3.2.2.

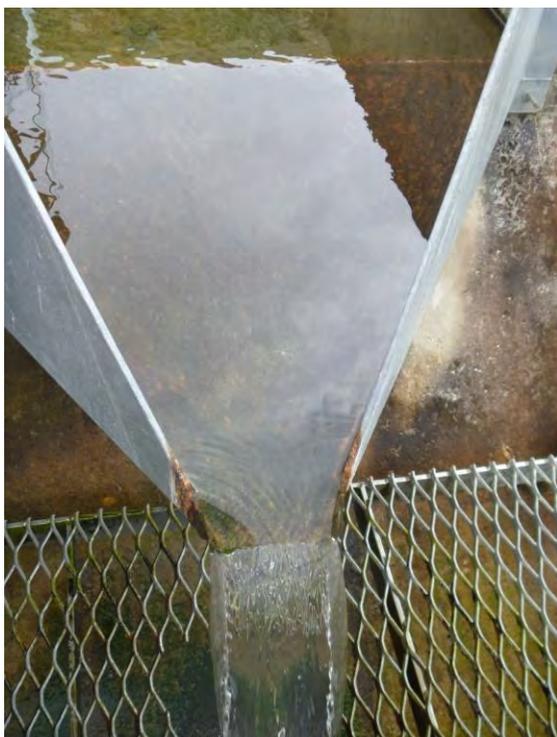
Figure 5 H-flume used to measure D21 flow

D21flow rates have exceeded the lower bound Alert Level on several occasions throughout the period. D21 is very responsive to lake level, and the exceedance has occurred when the lake is operating close to its top water level. The recorded flow from D21 continuously exceeded the Alert Level criteria from October 2012 to February 2013. The Alert Level criteria was also exceeded during the first half of August 2012. It should be noted that the Alert Level varies depending on reservoir level. Periods where the flow exceeded the Alert Level were appropriately investigated. At all times flows were well below the upper bound D21 Trigger Level criteria of 500 l/s for all reservoir levels. Figure A1-4 in Appendix A shows the data.

A drop in D21 flow of approximately 0.9l/s was noted between the hourly readings of 12pm and 1 pm on 15 February 2013. This brought the D21 flow to below the alert level. The change in flow did not reconcile with cleaning of the flumes or any other apparent event. This flow was attributed to an inconsistency in the instrument measuring water level in D21. However, ECS indicated that the instrument was functioning properly to the best of their knowledge. This unexplained drop in flow may mean that some earlier flow readings that exceeded the Trigger Level may not be accurate.

Based on flow rates derived from water level recorder information, surveillance data indicates that the D21 flows depart from the baseline trend when the reservoir level rises above approximately 390.8m RL. Over the period the reservoir level has been kept relatively high in comparison to previous periods. This has attributed to the large number of Alert Level readings that have been recorded throughout the period. There seems to have been no other occurrences that have had an influence on the D21 flow rate. The drain flows being observed at the higher lake levels are not considered to be of concern from a hydraulic flow capacity point of view, and there is no evidence of increased turbidity at the higher flows.

We note that electronic readings for D21 have been influenced to some extent by algae growth in the flume. During the summer months, when algae is an issue, cleaning of the H-flume occurred before manual readings were taken.

We recommend that the Alert Level is revised accordingly.

RCM2013-04: Revision of the Alert Level for D21

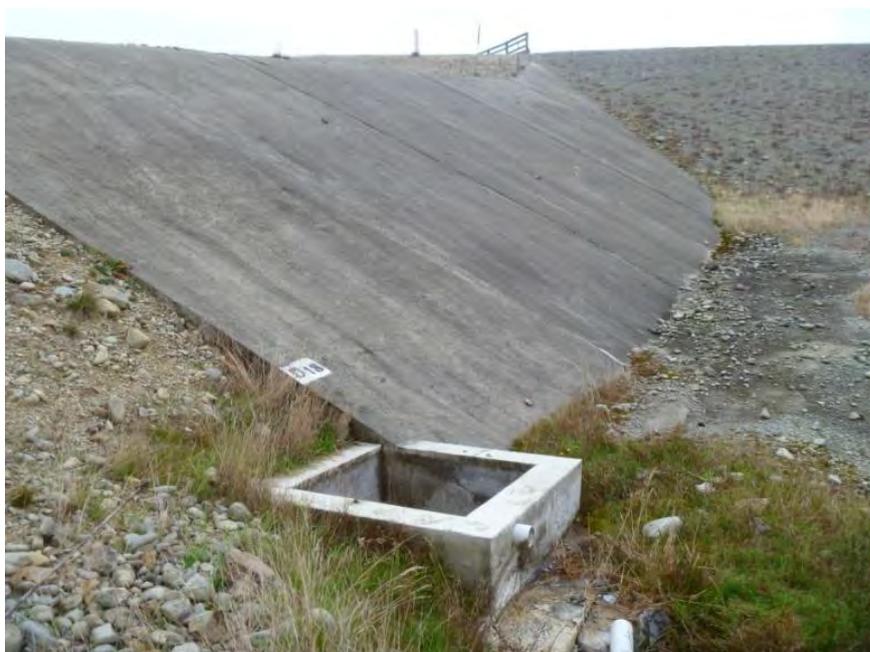
Figure 6 Location of D18

Drain D18 is located at the RHS base of the auxiliary spillway fuse plug and only flows when reservoir levels exceed 390 m RL. This level corresponds to the base of the right hand side auxiliary spillway channel.

Flows were observed and measured between 20 August 2012 and 26 February 2013. The Alert Level was not exceeded and all flows were reported to be clear.

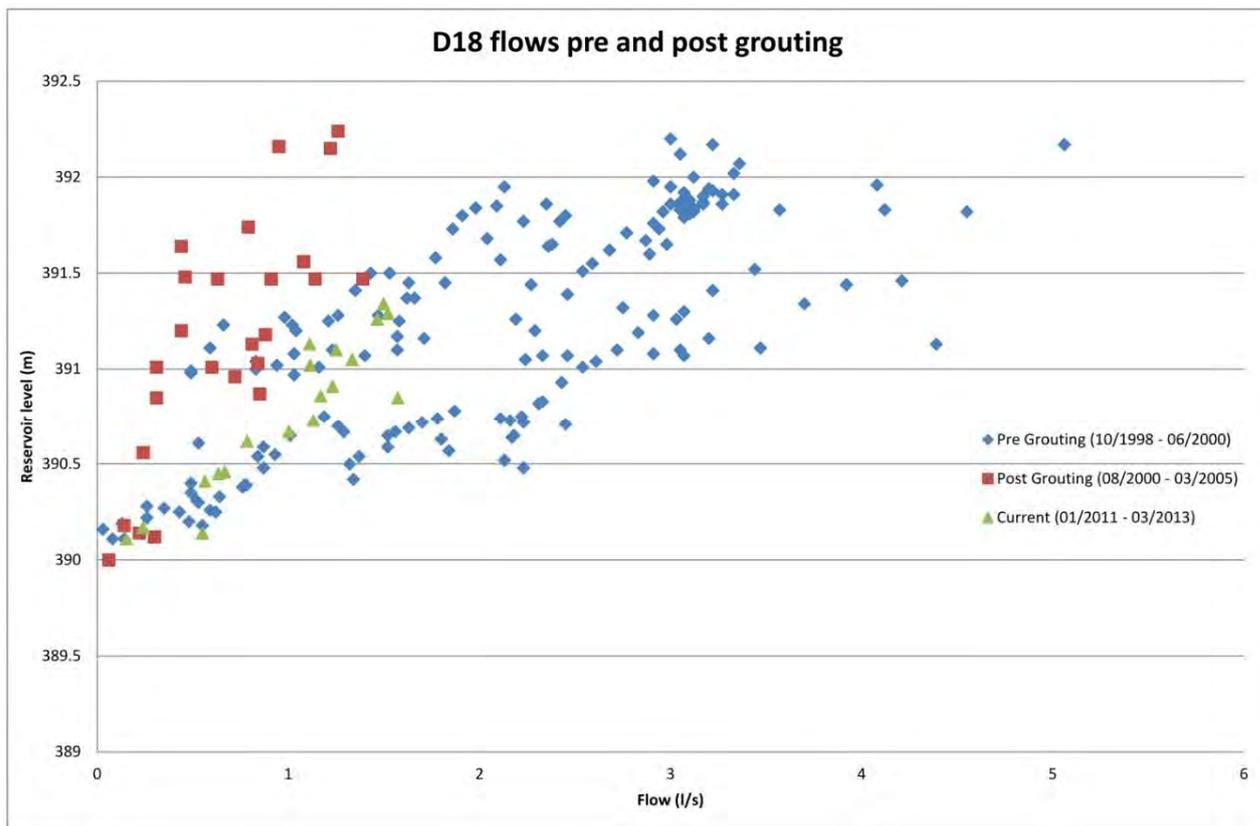
Figure 7 Drain D18 flows, pre and post grouting Piezometers

Grouting of the upstream three meters of D18 was carried out in July 2000 as a result of the April 2000 Six Monthly Inspection recommendation. Figure 7 below shows the flow produced pre-grouting, post-grouting and current flows from the drain. From the plot it can be seen that at equivalent reservoir levels, flow has increased from post-grouting to current flows produced.

Given the long term trend of increasing flow from this drain, we recommend that an investigation is completed to identify the source of the seepage, and a concept developed for works to reduce this seepage. This is outlined in Section 7.3.

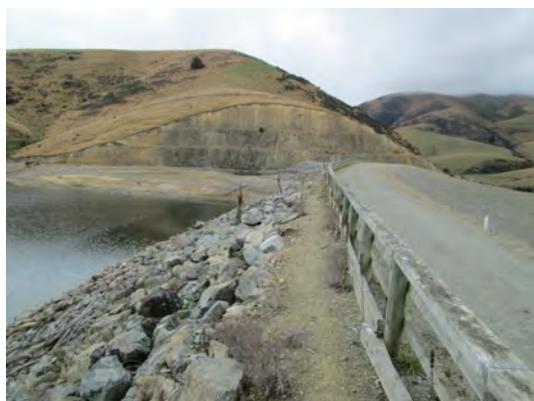
Figure 10 *Upstream face*

The upstream slope and riprap appeared to be in satisfactory condition to the extent visible above the 387.4m RL reservoir water level.

Accumulation of debris was visible on the face. Periodic debris removal is undertaken and this should continue. There were no visible deep rooted weeds and only a small amount of surface weeds. To the extent that it was visible, the riprap is robust and sound.

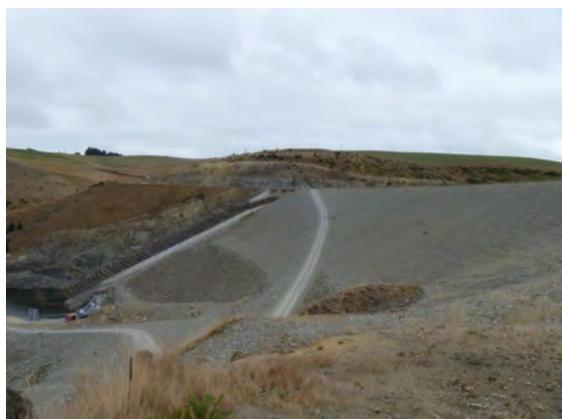
Figure 11 *Downstream face*

The downstream face appears to be in good condition. Periodic spraying continues to control local growth of scrub and bushes to prevent them from penetrating through the riprap into the embankment fill below.

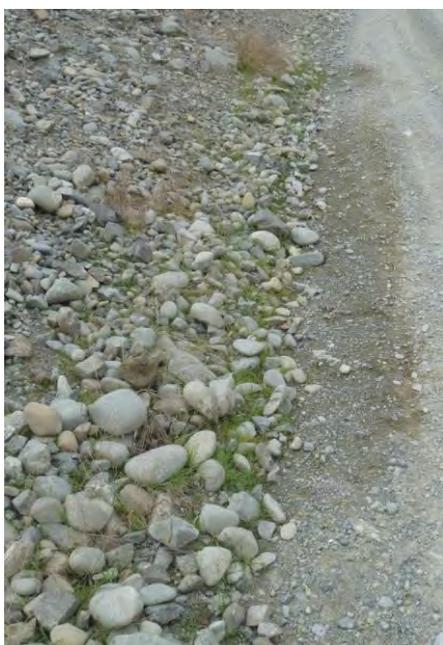
Figure 12 Wet patch located on dam road near D16

OWL report that the historical small wet patch on the upper part of the embankment dam face, on the access road and near the D16 drain outlet, has grown in size between January 2013 and March 2013.

The location of the wet patch is just above the drain outlet of D16 which is a high level connection to the true right base of the thickened chimney drain at 383 m RL.

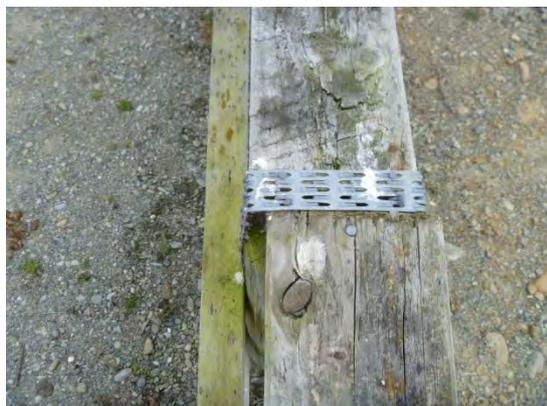
Figure 12 Damage to crest fence handrail

The crest roadway and fence were generally in good condition. However, there were some instances of slight damage to the fence handrail.

We recommend that this minor damage is repaired.

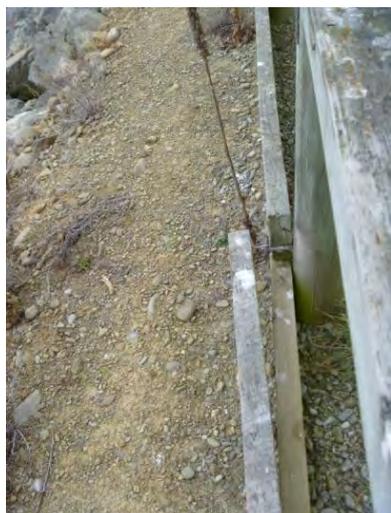
Figure 13 Damage to wave barrier

Some areas of the wave barrier had slight damage and there was a gap between the bottom board and the ground.

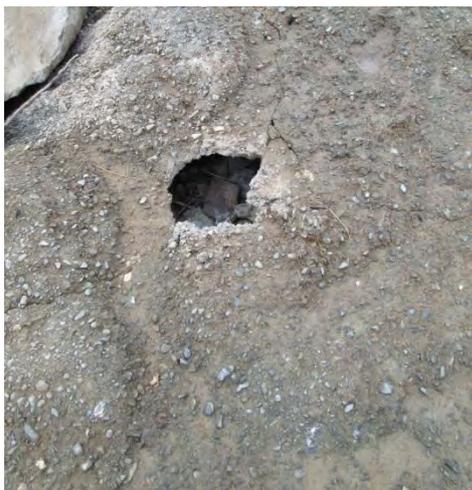
Figure 14 Undermining of boat ramp

The public boat ramp located near the service spillway approach channel has developed a hole in the concrete protecting the edge of the ramp. The hollow tapers off towards the ramp and opens up away from the ramp. It is recommended that maintenance work is carried out to infill the void; however, this is not a dam safety matter.

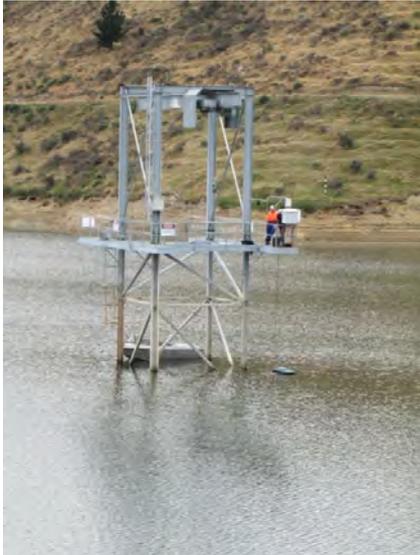
Figure 15 Intake tower

A dive inspection of the intake tower has not been undertaken since March 2008. We understand that an inspection was not undertaken in 2010-2011 due to difficulties in scheduling the inspections coincident with low reservoir water level to enable adequate dive time and safe access by divers in accordance with current safety regulations.

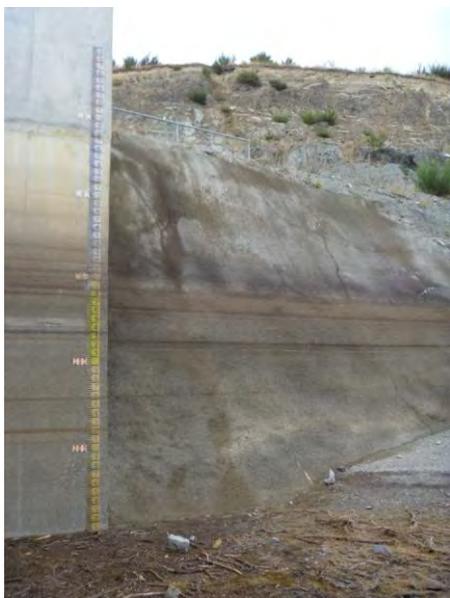
Figure 16 Shotcrete repair

The approach to the service spillway was visible at the time of the inspection due to the low reservoir level. The approach was reasonably clear of significant debris with a few light sticks scattered around. The approach was in good condition. The repair to the shotcrete coating on the rock on the right hand side of the spillway remains in good order.

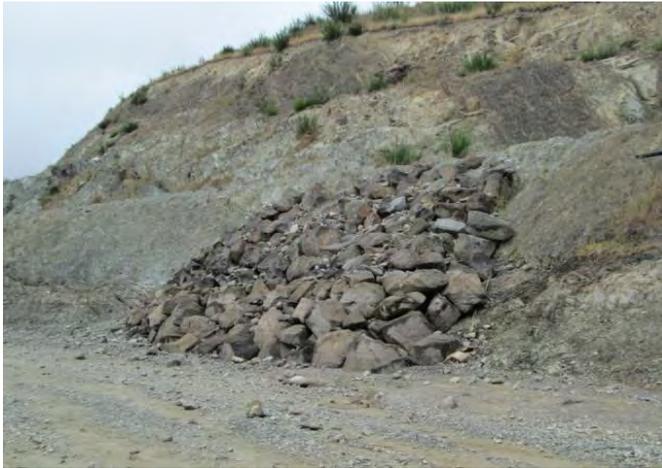
Figure 17 Slip repair

The repair to the slip failure that occurred to the right hand side of the approach channel/road cutting northwest of the service spillway (between the bridge and the boat ramp) is still effective and in good condition.

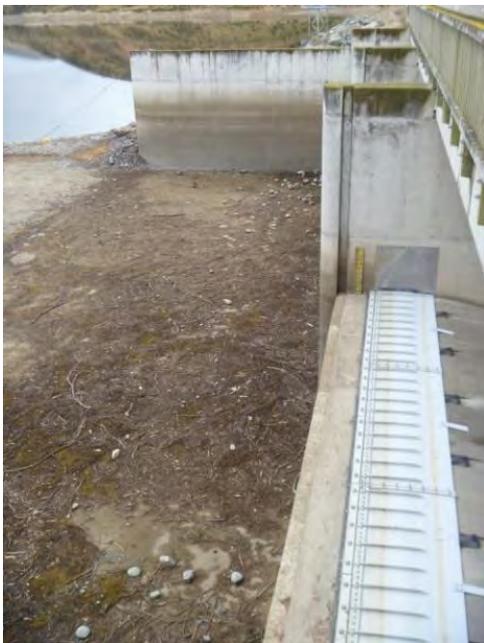
Figure 18 Obermeyer gates

The Obermeyer gates weren't able to be manually operated on the day of the inspection. The issue was subsequently identified as a consequence of the gate control logic that keeps the gates lowered when the lake level is below a specific level. OWL has requested TrustPower modify this aspect of the control logic to provide manual operability at all lake levels.

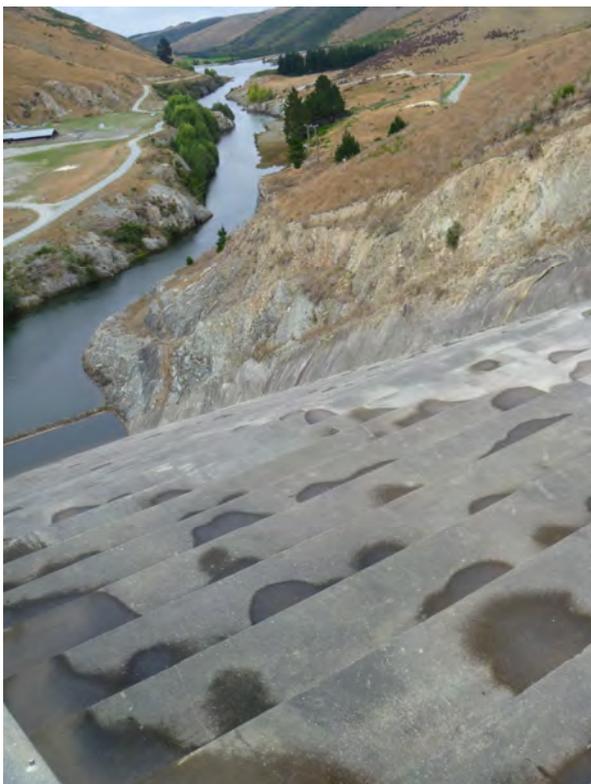
Figure 19 Service spillway

The spillway steps appeared to be in satisfactory condition. A few large rocks were noted on the spillway; however, there was no visible damage to the step edges due to the rocks being thrown onto the spillway.

These rocks will be washed into the spilling basin at the toe of the spillway. On the day of the inspection there was no substantial accumulation of rocks in the stilling basin.

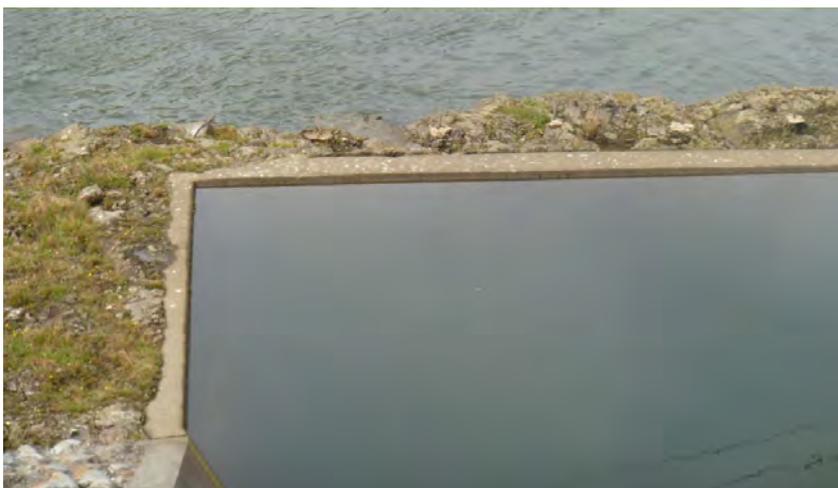
Figure 20 Stilling basin

Inspection indicates that the periods that the spillway flowed during the period did not erode a significant additional quantity of rock from the sill area beyond the stilling basin. Close monitoring of the sill by OWL has been recommended and is part of routine monitoring.

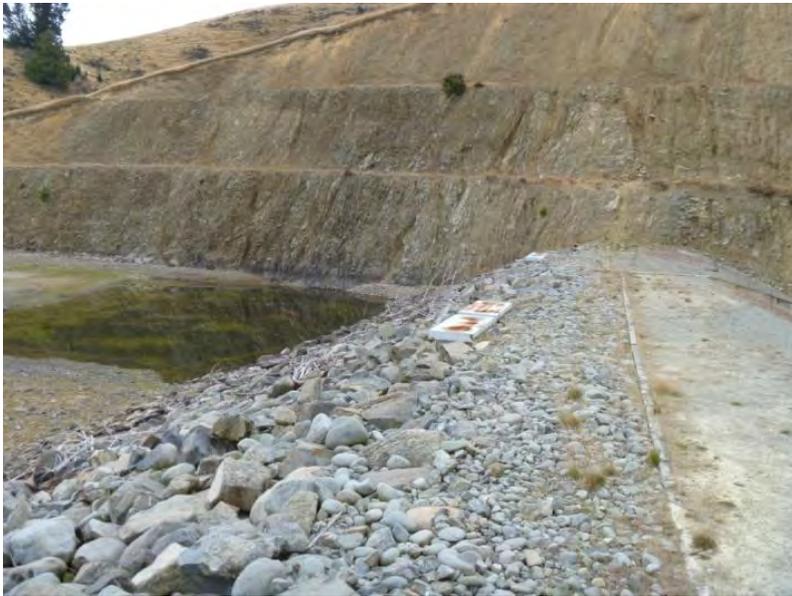
Figure 21 Auxiliary spillway upstream face and crest

The auxiliary spillway appeared to be in satisfactory condition. The riprap on the upstream face and approach channel were in good condition.

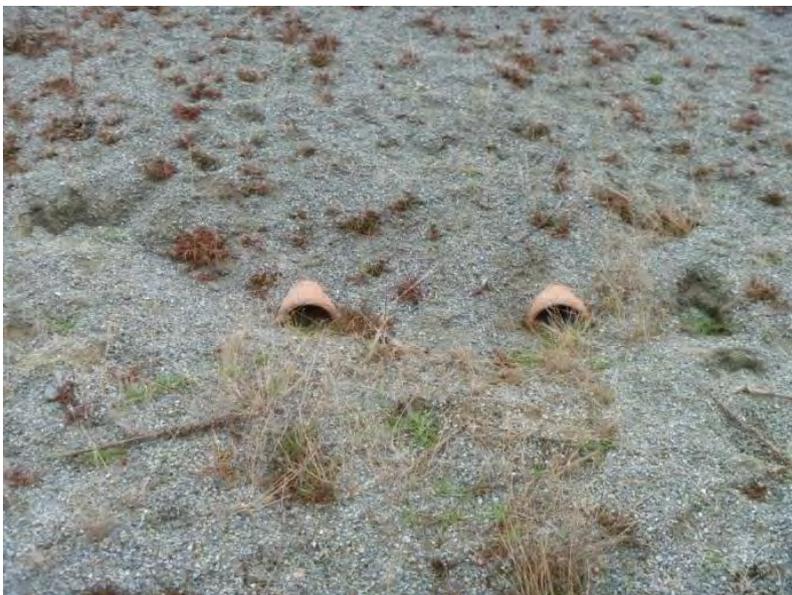
Figure 22 Right hand side fuse plug triggering device clay tile pipes

The pipe outlet of the right hand side fuse plug triggering device clay tile pipes was partially block by surrounding sand and vegetation.

It is recommended that this is cleared and any future blockages removed as they arise. The pipe outlets on the left hand side fuse plug triggering device clay tiles were clear. One of the pipe outlets on the LHS was broken but this is of no concern.

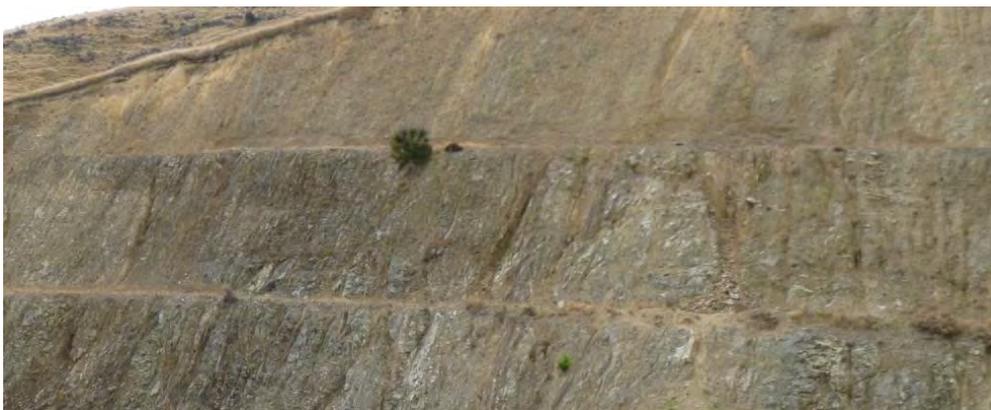
Figure 24 Left abutment cut slope

The left abutment cut benches, above the auxiliary spillway, are in good condition. The historical wedge failure downstream of the fuse plug shows no sign of recent movement. There were no further signs of significant movement on the slope.

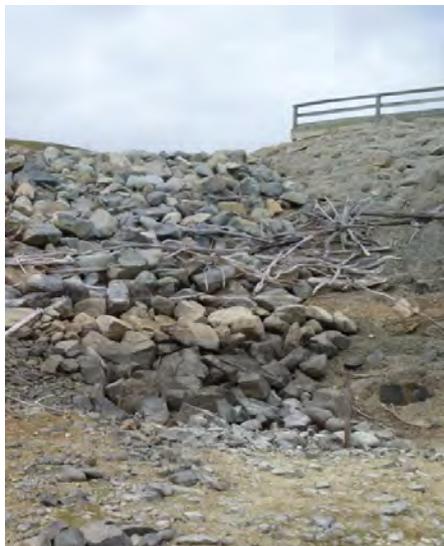
Figure 25 Area of interest on the upstream face of the auxiliary spillway

D18 collects seepage from under the auxiliary spillway true right wingwall concrete slab. At present, the origin of this flow is not known. However, there is an area of interest on the right hand side of the upstream face of the auxiliary spillway.

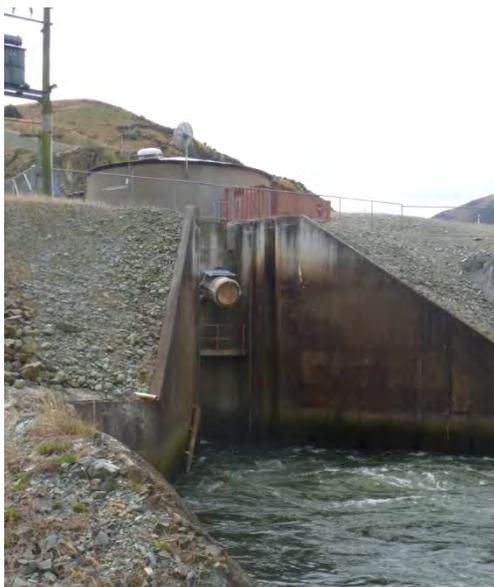
Figure 26 Release valve

The external and internal structure appeared to be in satisfactory and tidy condition. The powerhouse was viewed from the access platform and from around the base of the generator and turbine. No seepage was observed around the penstock pipe penetration through the station wall. Also no other internal leakage into the structure was observed. The power station and release valve were not operating at the time of the inspection.

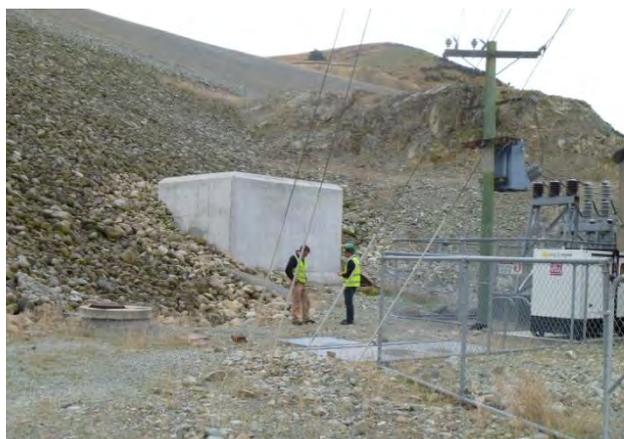
Figure 27 Anchor block, AB2

Previous proof load testing undertaken on the conduit Anchor Block 2 (AB2) caused a failure to occur on one of the anchors at a load considerably lower than the rated bar capacity. During the period, the concrete anchor block was modified (additional concrete mass added) in order to provide an adequate gravitational force to resist unbalanced hydraulic forces on the bend of the conduit below.

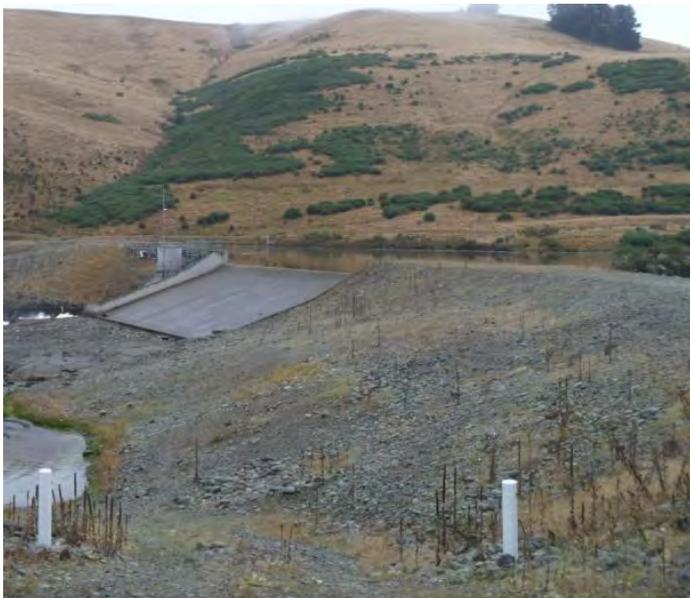
Figure 29 Downstream face of overflow embankment and spillway

The Downstream Weir Overflow Embankment (DWOE) is designed to fuse during a five year or greater Average Recurrence Interval (ARI) flood. The estimated five year ARI routed dam outflow is 100 m³/s. The present DWOE was constructed in 2009 after it operated during high flows in May 2009.

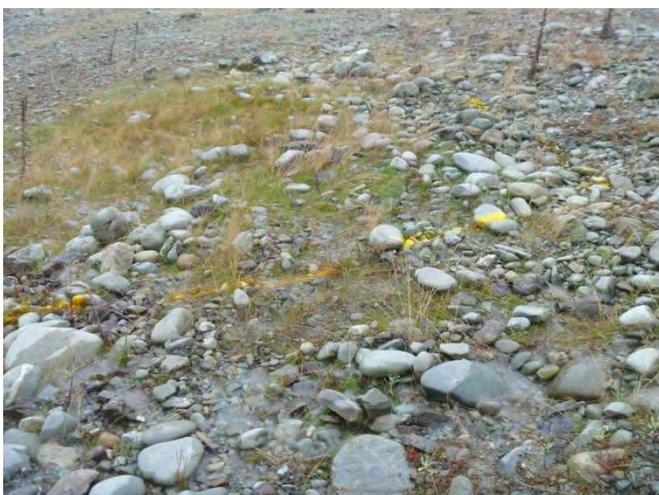
Figure 30 Seepage area on DWOE face.

Areas of leakage on the downstream face of the overflow embankment were observed when the regulation pond was raised in order to achieve the desired flow during the flushing trial, performed February 2013. Reinstatement of this area was carried out during March 2013 by excavation and backfilling of sinkhole features on the upstream face. However, some areas of leakage still remain and alternative repair options are currently being investigated.

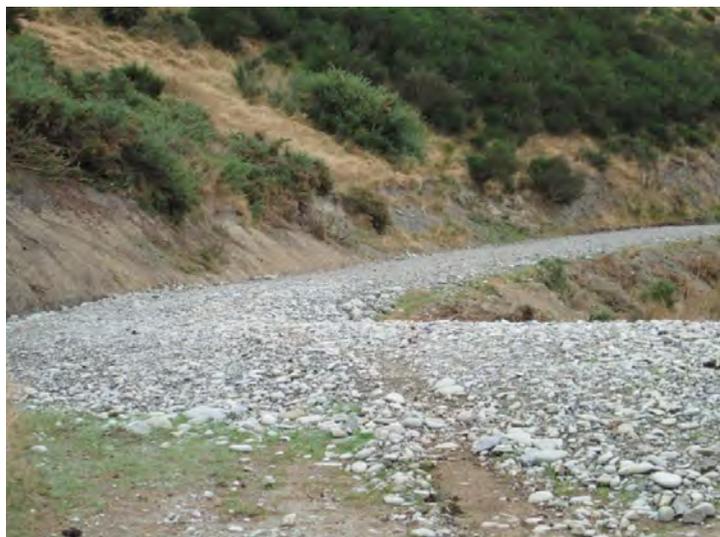
Figure 31 Downstream weir regulation embankment raise

A survey of the embankment carried out during the period indicated that the crest level was not at the original design level, 340.2 m RL. Maintenance of roading in the area was required which allowed for the crest level to be restored to its original design level during these works.

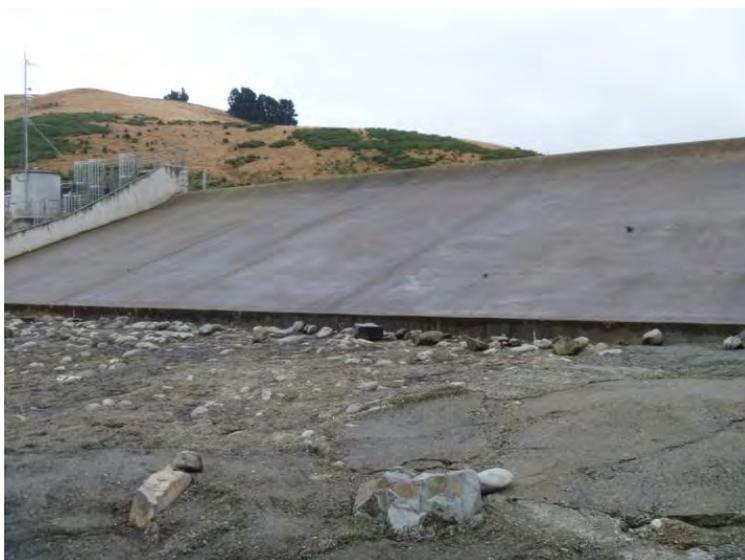
Figure 32 Service spillway

The concrete weir spillway is in a satisfactory condition, with a few logs having accumulated at the base of the spillway. Inspections of previous years identified a number of small continuous horizontal cracks in the spillway face, as well as occasional small surficial spalls. These features do not appear to have significantly changed in the last year.

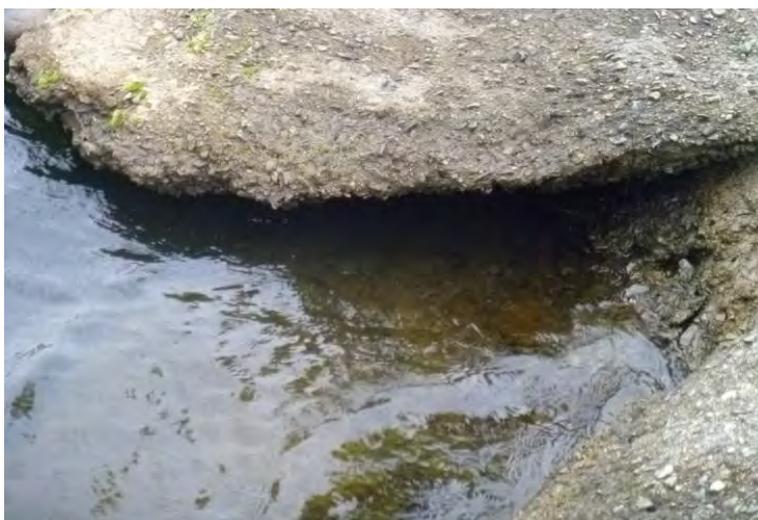
Figure 33 Undermining of chute

The concrete and stone armouring on both banks is generally in satisfactory condition. It was previously noted that the mass concrete beyond the end of the chute right hand training wall (beyond the toe of the ogee weir) is at least partially undermined. This remains unchanged since the previous period but ongoing monitoring of this area by OWL is warranted.

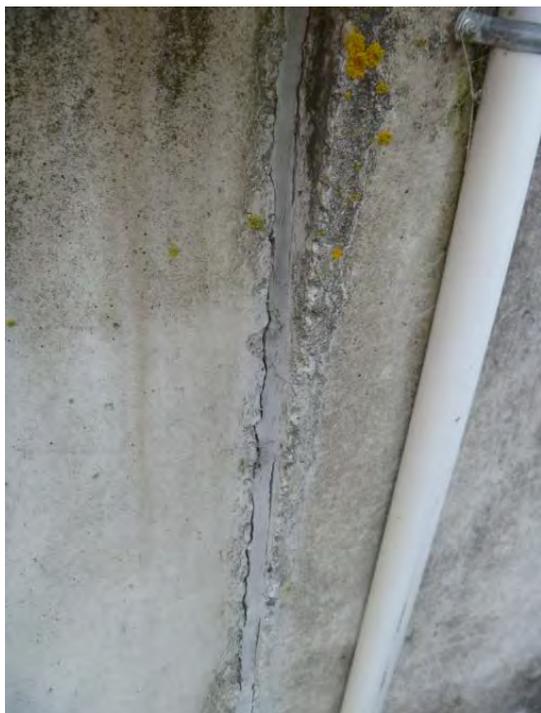
Figure 34 *Cracking of concrete wall*

Cracking of the concrete wall next to the control shed previously reported has not appeared to have moved during the period.

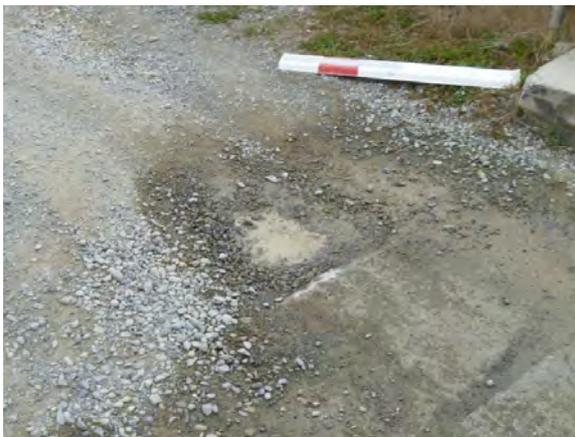
Figure 35 Dam road pothole

The dam road was generally in good condition, with a few potholes on the road above the service spillway. OWL is responsible for maintenance of the road down the dam face and has advised that these will be filled in and maintained.

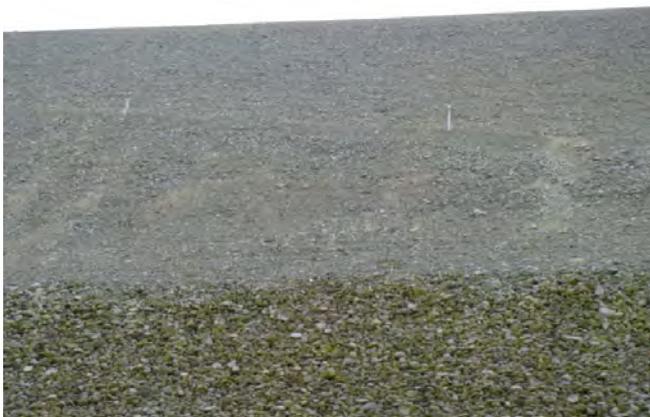
Figure 36 Scouring of downstream face

Some scour has occurred on the downstream face below the road due to surface water runoff. This is an issue that relates to the grading of the road by the contractor (slope of the road, extent of swale and extent of longitudinal bund along the outside edge). OWL advise that they will continue to monitor the grading of the road.
