Opuha Water Ltd

Opuha Dam
Annual Safety Inspection 2014

Tonkin & Taylor Ltd

April 2014

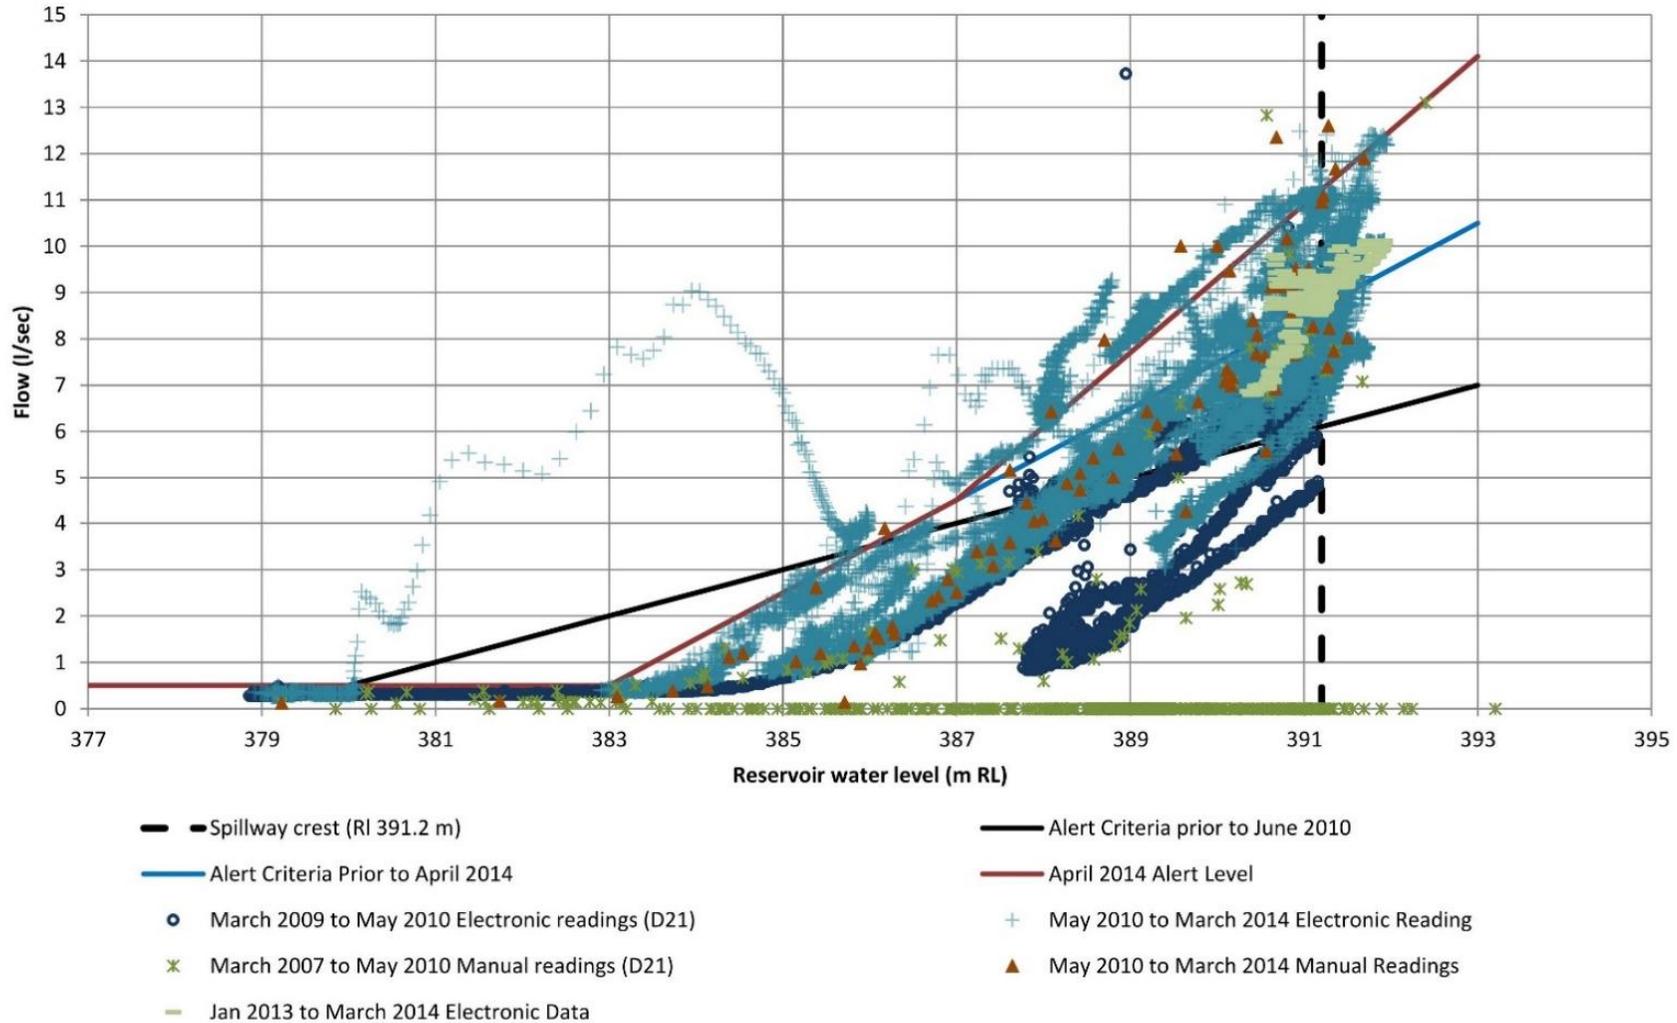
Figure 3 Drain D21 Alert Levels

D21 flow rates have exceeded the lower bound Alert Level on several occasions since the Alert criteria was last revised in July 2010, and revision of the Alert Level is a recommendation of the 2013 Annual Safety Inspection (RCM2013-04). The July 2010 Alert Level was based on a limited amount of data, during a time in which the reservoir level was typically kept well below the spillway crest level of 391.2 m RL. Since July 2010, there is now approximately twice the number of data points for flows produced at D21. Operation of the reservoir over the last two to three years has kept the reservoir level high relative to previous years. There is also significantly more flow data available at higher reservoir levels than was available previous to July 2010.

With the currently revised Alert Level, the majority of the flows produced since July 2010 are deemed acceptable given the circumstances in which these flows were produced. Flows produced since July 2010 have outlined how D21 responds to higher reservoir levels and high rainfall. Algae build up also influences water level from time to time and this in turn influences inferred flow rates. Instances in which these have had an effect on D21 flow are now considered to be 'normal' and are not considered to be of any concern. Flows produced during the period of September 2010 to March 2012 have remained above the revised Alert Level. This is due to the effect that the earthquakes had on flow during the period, and it not being considered a normal circumstance.

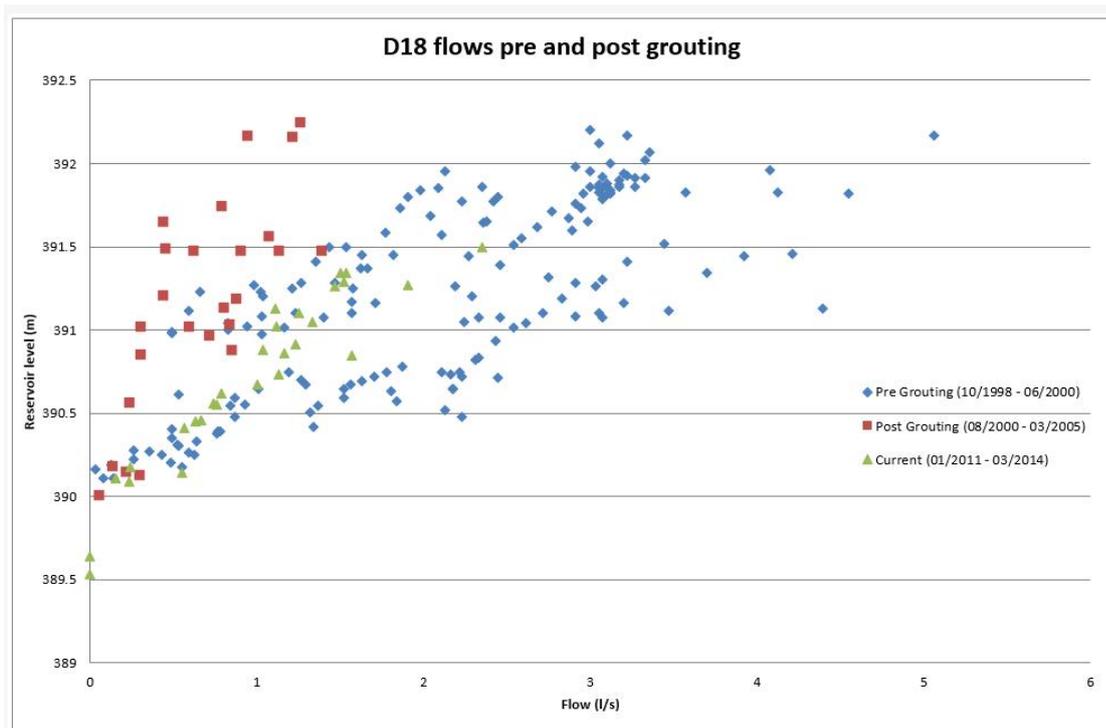
Figure 4 Drain D18 flows, pre and post grouting

Flows were observed and measured on a monthly basis between 27 June 2013 and 30 January 2014 except for 29 August 2013. The Alert Level was exceeded on 26 September 2013 and 24 October 2013.

It has been speculated that the flow may originate from seepage through a small concave area on the upstream face of the embankment and connect through to the upstream end of the D18 drain that runs along the right hand side training wall of the auxiliary spillway. On 13 June 2013, water was pumped into this area until it was full. No response was noted in D18 (refer Section 7.3 following).

It is important that close attention is given this area in order to better understand long term trend associated with seepage in the vicinity of D18.

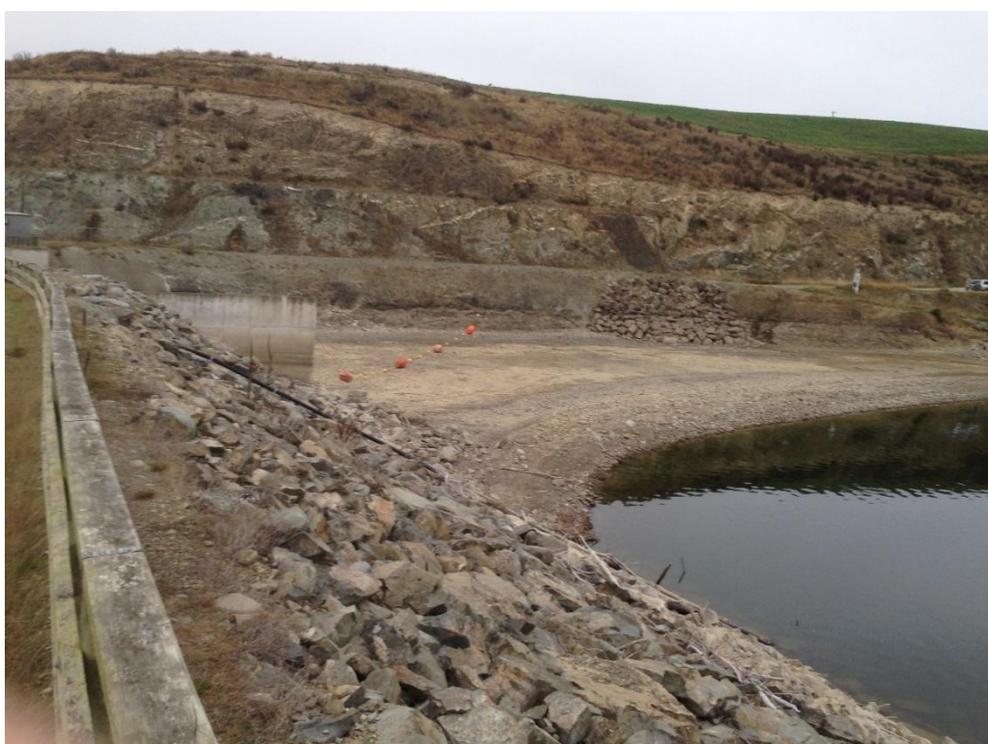
Figure 6 Upstream face

The upstream slope and riprap appeared to be in satisfactory condition to the extent visible above the 387.0 m RL reservoir water level.

Accumulation of debris was visible on the face. Periodic debris removal is undertaken and this should continue. A deep rooted weed was removed during the visit. No other deep rooted weeds were noted. To the extent that it was visible, the riprap is mostly robust and sound.

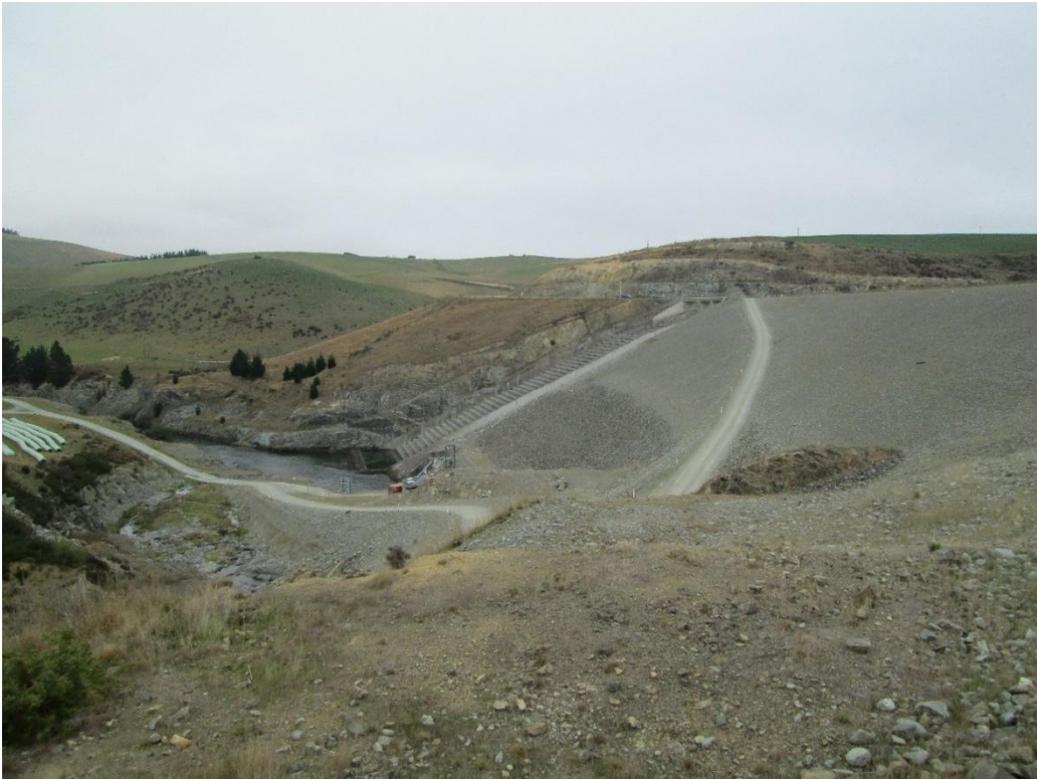
Figure 7 Downstream face

The downstream face appears to be in good condition. Periodic spraying needs to continue to control weeds to prevent them from penetrating into the embankment fill.

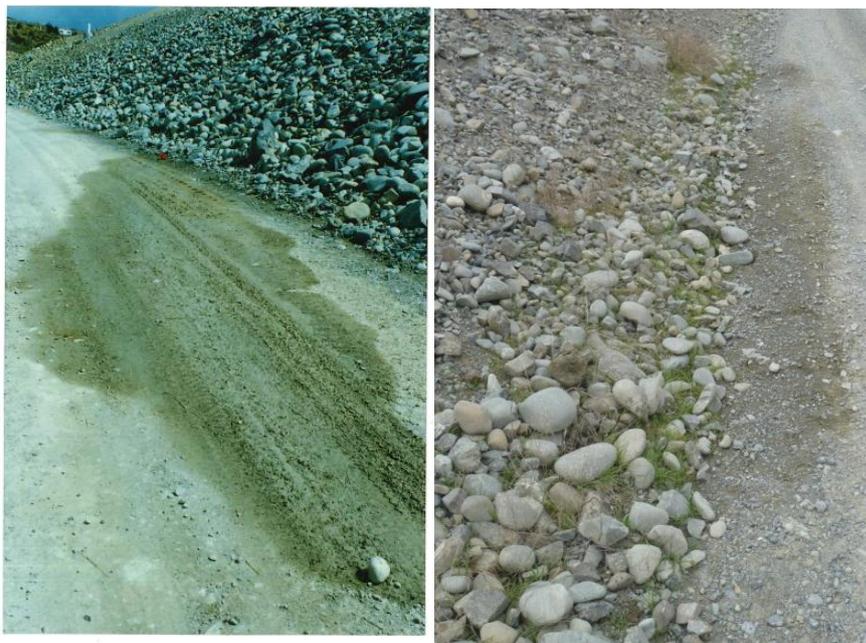
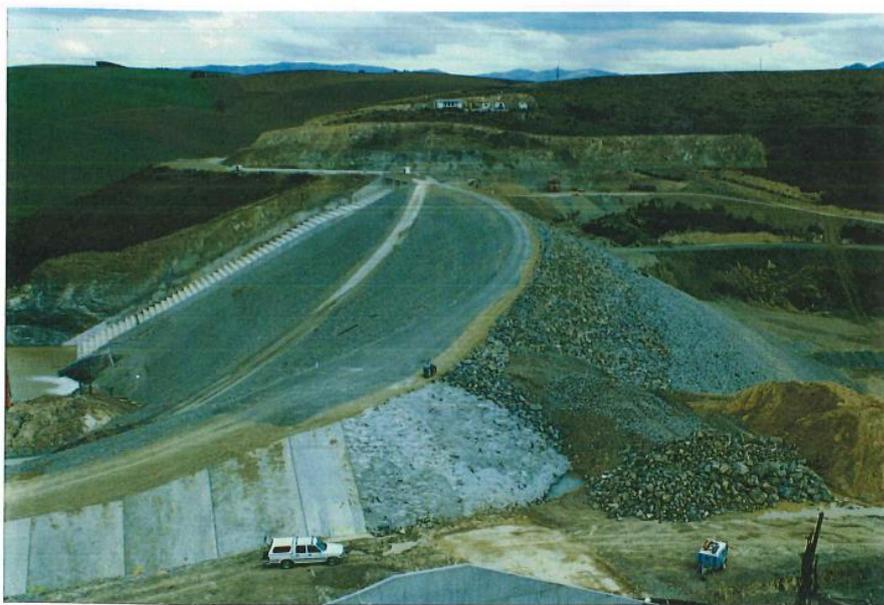
Figure 8 Wet patch located on dam road near D16 during and after construction

Investigation into the historical wet patch on the upper part of the embankment dam face, on the access road and near the D16 drain outlet, found evidence that it was present before the filling of the dam and thus is unlikely to be hydraulically connected to the reservoir.

It is believed that surface water is infiltrating the embankment and exiting at this location. The level of the wet patch coincides with a change in dam fill type in the downstream shoulder from Type A (NSCZ) fill to Type B (NSCZ) fill. It is inferred that there is a horizon of lower permeability material that traps rainfall infiltration in this area. It is speculated that rainwater infiltration into the shoulder is tracking sideways when reaching this lower permeability zone and exiting on the downstream face.

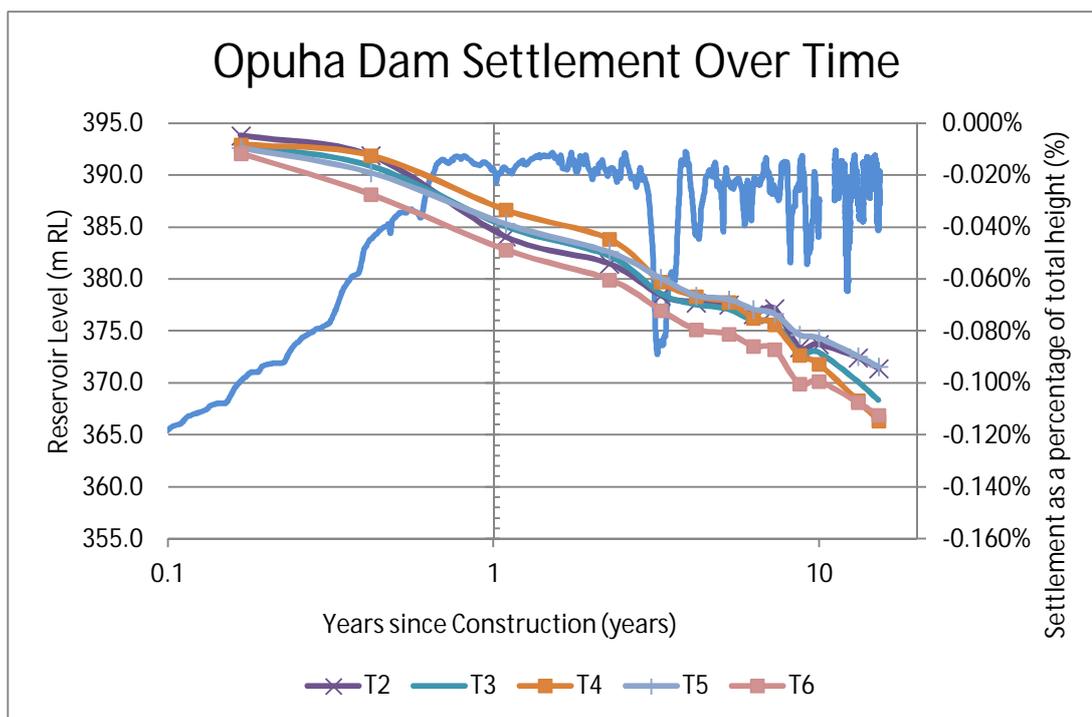
Figure 10 Settlement of Opuha Dam crest (log scale)

The magnitude of the overall settlements are relatively modest. Nonetheless, the trend of ongoing settlement illustrated in Opus Figure 1 (Appendix B page 14) some sixteen years after the base survey is of interest and warrants some comment.

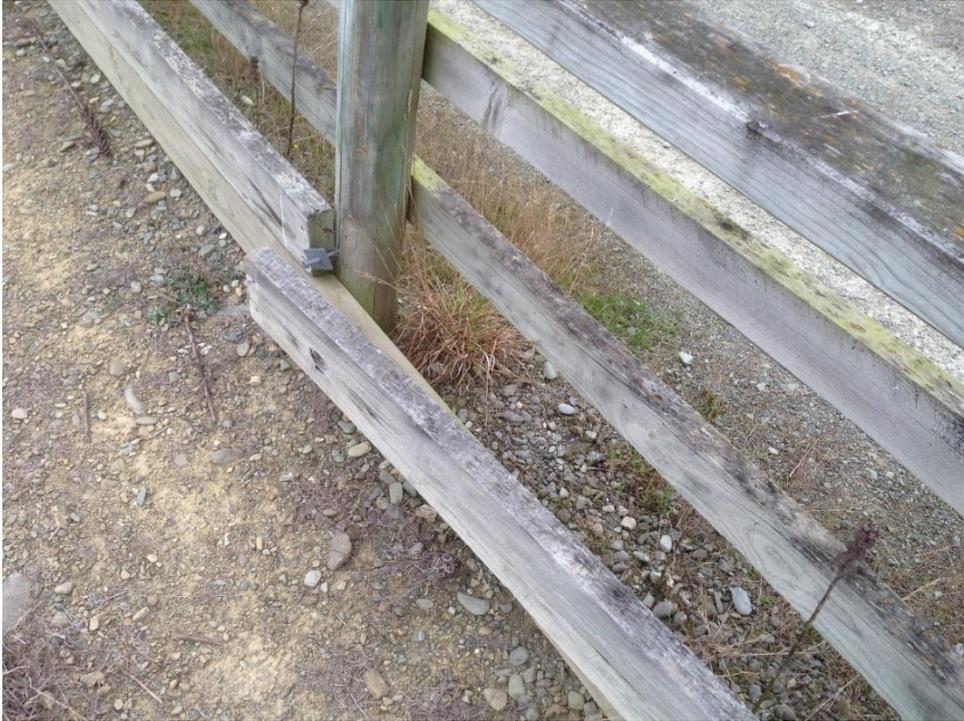
Figure 11 *Damage to wave barrier*

The crest roadway and fence were generally in good condition. However, there were some instances of slight deterioration to the wave barrier and there was a small gap between the bottom board and the ground in some places. We recommend that the damage to the wave barrier is repaired and any gaps between the timber and embankment surface filled.

RCM2014-03: Carry out crest maintenance on the main embankment including repair of the timber wave barrier.

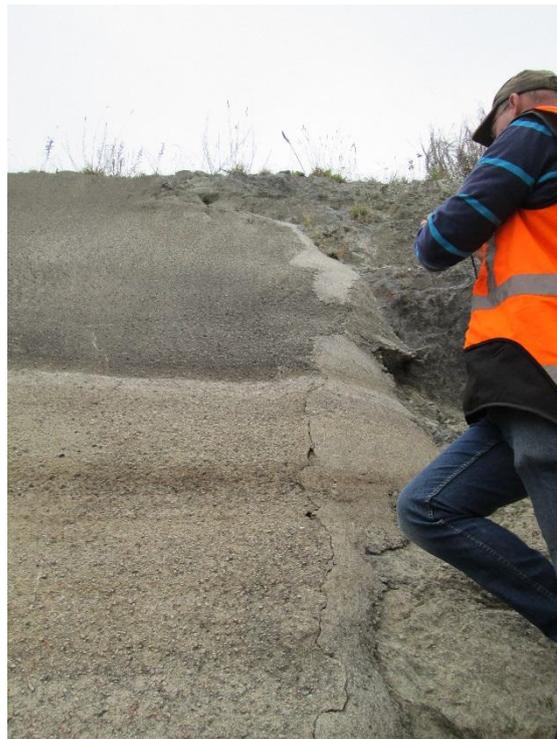
Figure 13

The approach to the service spillway was visible at the time of the inspection due to the low reservoir level. The approach had some debris present, primarily drift wood. The approach was in good condition. The shotcrete coating on the rock on the right hand side of the spillway sounds hollow along the height of the northern side of the repair. This suggests a void is present behind the repair. The repair should be monitored closely to ensure that the shotcrete remains stable.

Shotcrete repair

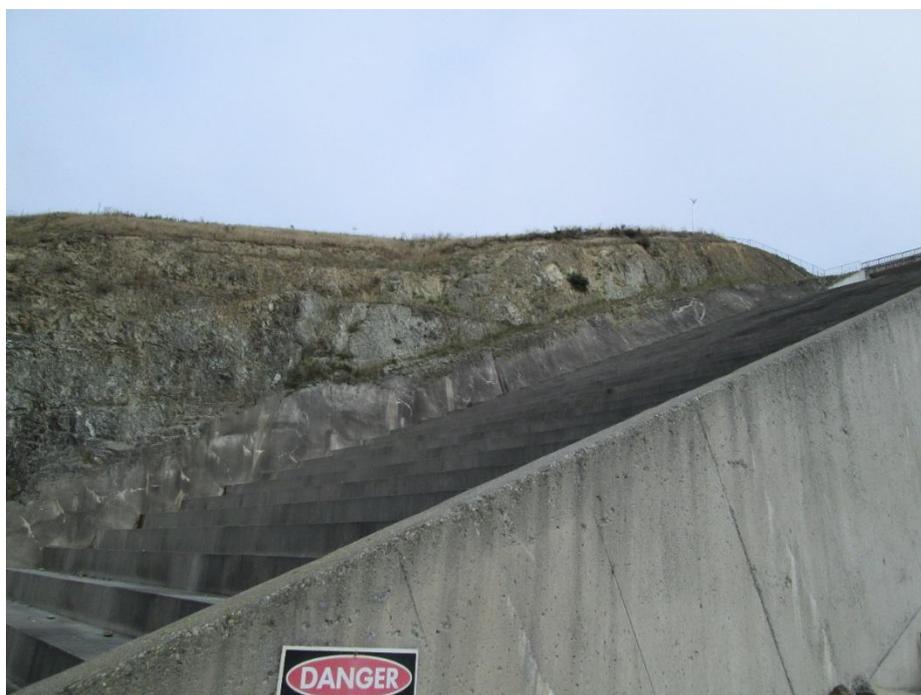
Figure 14

The spillway steps appeared to be in satisfactory condition. A few medium sized rocks were noted on the spillway as well as a large branch; however, there was no visible damage of major significance at this time to the step edges due to the rocks being thrown onto the spillway.

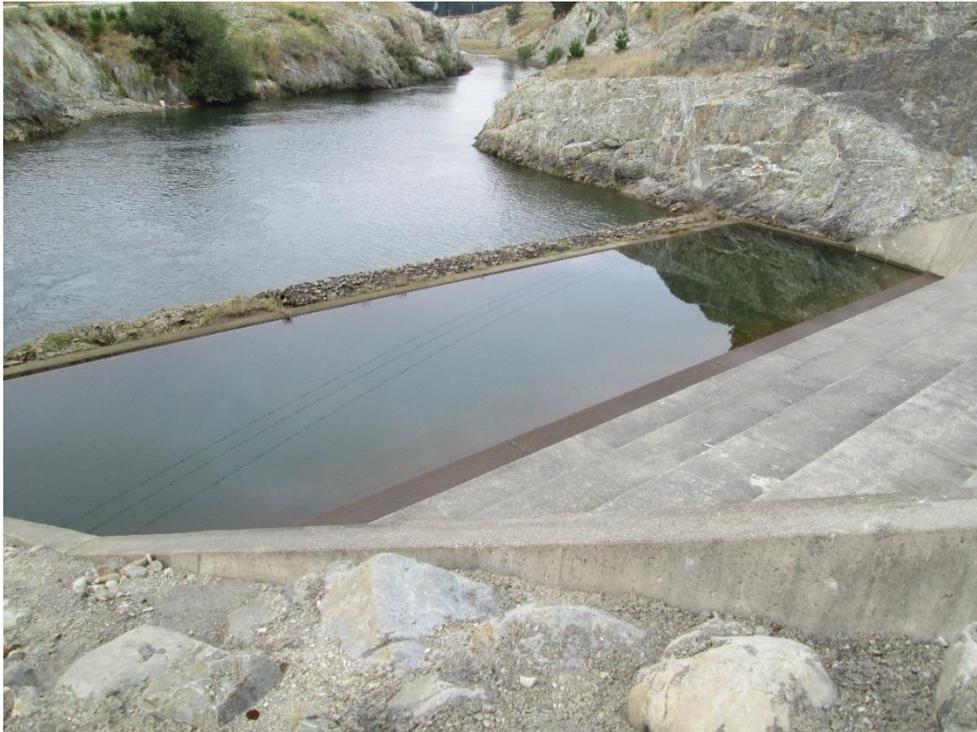
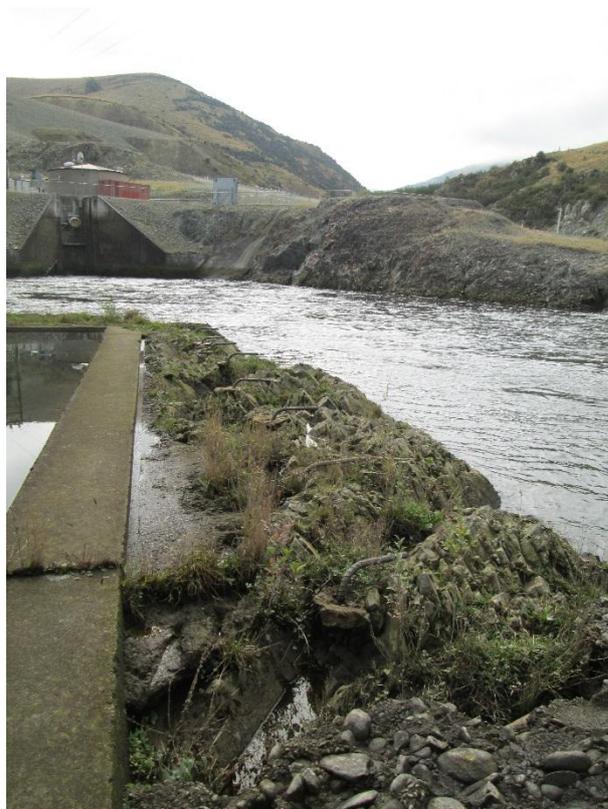
Inspection of the tailrace and stilling basin found that they were in a satisfactory condition as could be viewed from the ground surface. However, the sill along the end of the stilling basin is damaged. Inspection indicated that operation of the spillway during the period does not appear to have caused noticeable additional quantities of rock to erode from the platform directly beyond the stilling basin. Previous Annual Reports have recommended monitoring of this area and it is important that this continue.

Figure 16 Damaged Sill of Stilling Basin

At some point, it will be necessary to drain the stilling basin to inspect the structure and remove accumulated rock.

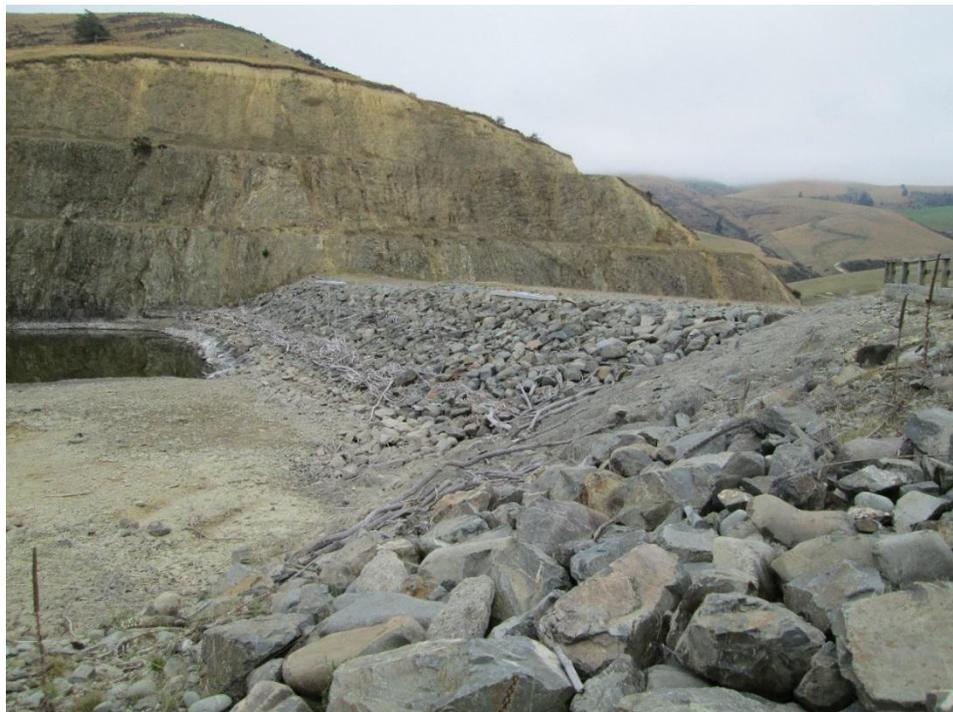
Figure 17

The auxiliary spillway appeared to be in good condition. The riprap on the upstream face and approach channel were in good condition. Routine spraying should continue in order to prevent establishment of vegetation on the fuse plug fill, particularly in the vicinity of the drain outlets.

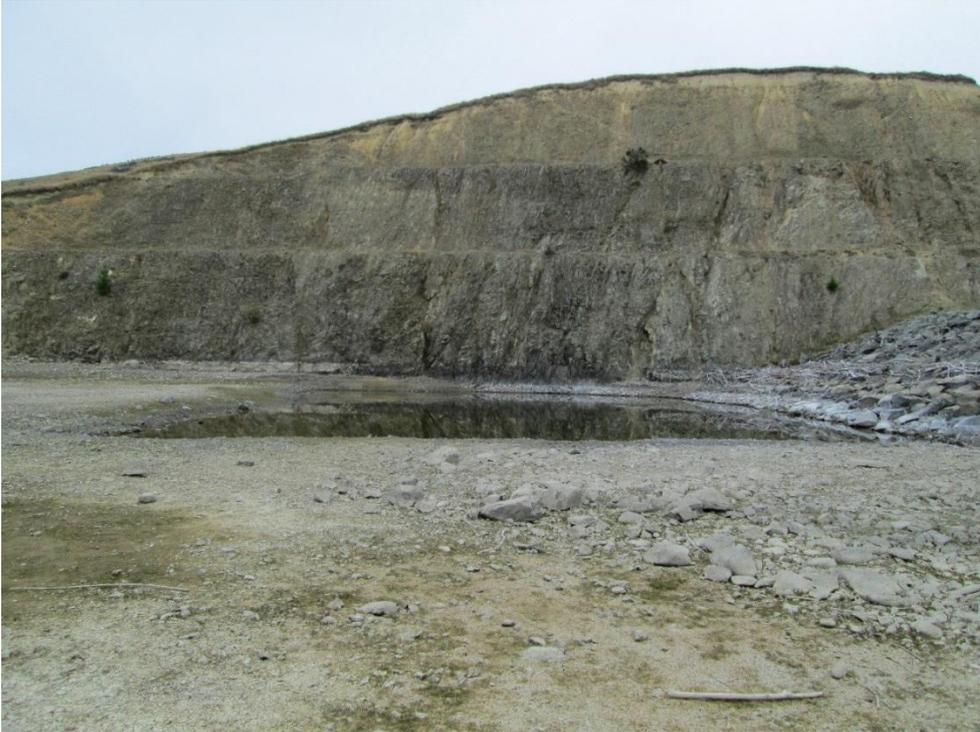
Figure 19

The left abutment cut benches, above the auxiliary spillway, are in satisfactory condition. The historical wedge failure downstream of the fuse plug shows no sign of recent movement. There were no further signs of significant movement on the slope or of fuse plug erosion from concentrated stormwater runoff down the cutting.

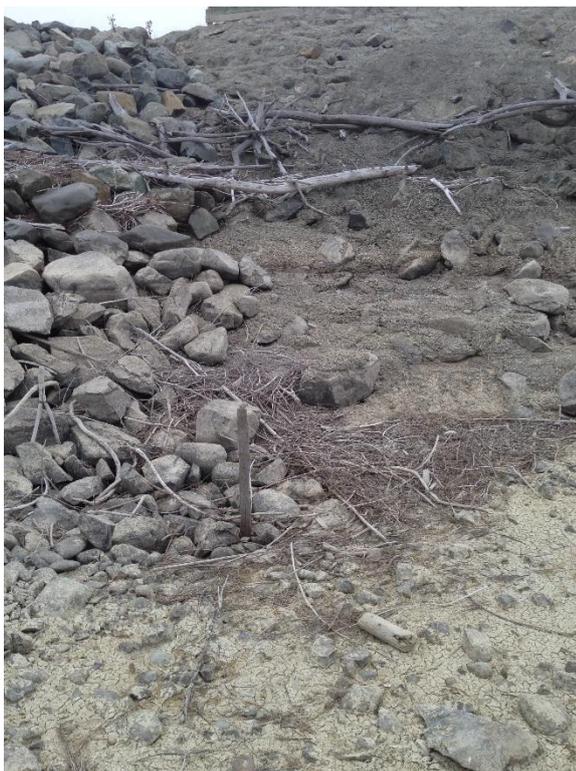
Figure 20

Water was pumped into the area of interest until it was full. The pump was left running for 3 hours and then the area was allowed to drain. The capacity of the pump was 10 l/sec and ponding took about an hour to fill and drained rapidly. This led OWL to note that the rate of drainage of the area was likely only slightly below the capacity of the pump. No visible response was noted in D18 or anywhere on the downstream face.

As noted in Section 3.2.5.2, based on this work current indications are that the concave area of interest is not directly linked to seepage flow exiting D18. Further ongoing monitoring of D18 drain flows is warranted.

Area of interest on the upstream face of the auxiliary spillway

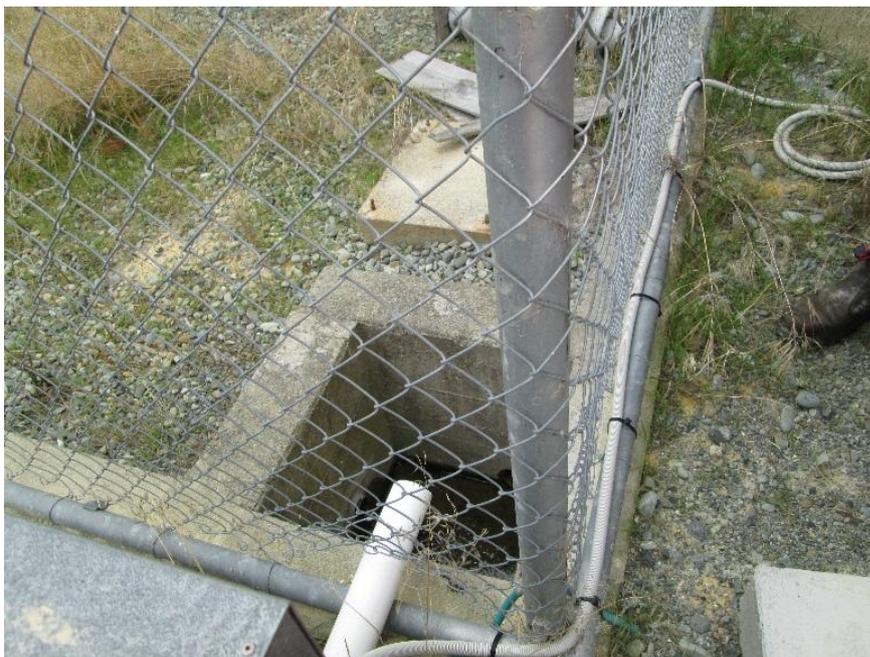
Figure 21 Conduit outlet drain discharge

The conduit outlet drain pipe is now feeding into a sump that also serves the subsoil drainage system in the switchyard. This additional water is creating a surcharge on the subsoil drainage system which should be monitored to ensure it does not affect the performance of the subsoil drainage system and stability of loess fill in this vicinity.

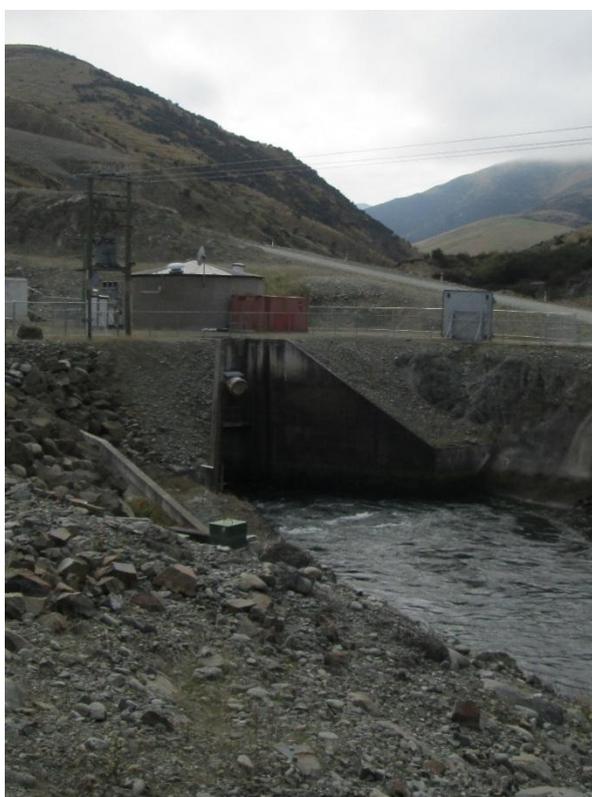
Figure 22 Draft tube outlet

The recommendation from the dive inspection carried out in 2008 (RCM2008-32) has yet to be resolved. RCM0213-32 states that the damage to the tailbay concrete should be investigated in greater detail to assess the effects and consequences and determine whether immediate repairs are required. The dive inspection of June 2013 did not note erosion at the draft tube outlet.

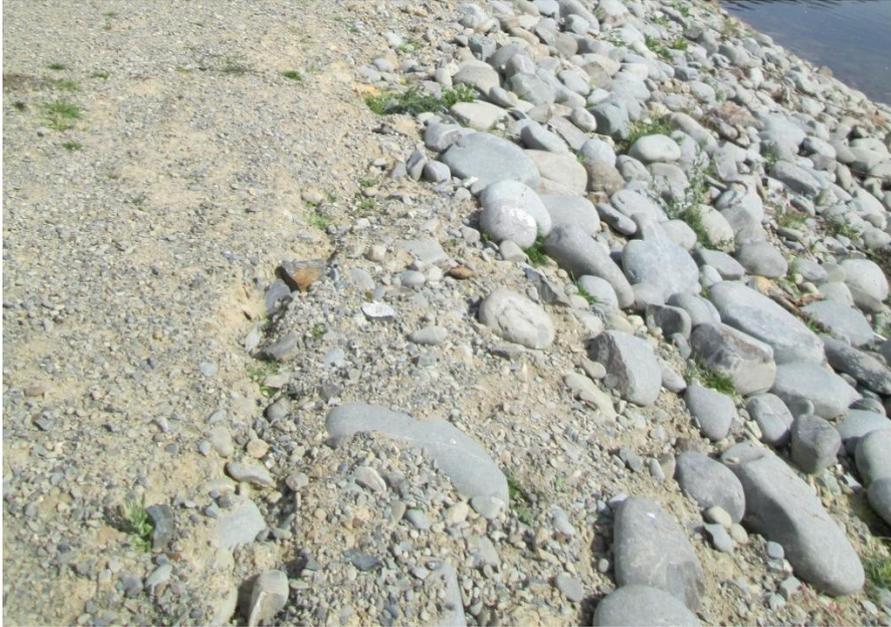
Figure 25

Remedial works were undertaken on 12 and 13 December 2013 to excavate and backfill a sinkhole located on the DWOE. The identified sinkhole was the only collapse or erosion feature seen on the upstream face in the monitoring period. Some additional movement was noted in January and March 2014 during visual inspection of the area. During the annual inspection an 8 m long crack was noted on the OE crest. We recommend that this area be monitored into the new period for further movement.

Movement of the upstream face of the overflow embankment occurs as a consequence of the upstream fine liner washing into voids within the main embankment fill. Because the structure was considered to have a short design life T&T were previously advised that the cost of a filter was not justified. It was also not a dam safety matter insofar as the stability of the bulk/gravel fill is concerned and that that seepage was of nuisance value. It is anticipated that the life of the overflow embankment will now increase and thus it is suggested that OWL review the strategy to manage the overflow embankment. Options range from visual surveillance and regular monitoring and review whilst accepting some minor leakage to a major rebuild featuring filters between the upstream liner and gravel bulk fill.

Crack in crest close to recent embankment repair

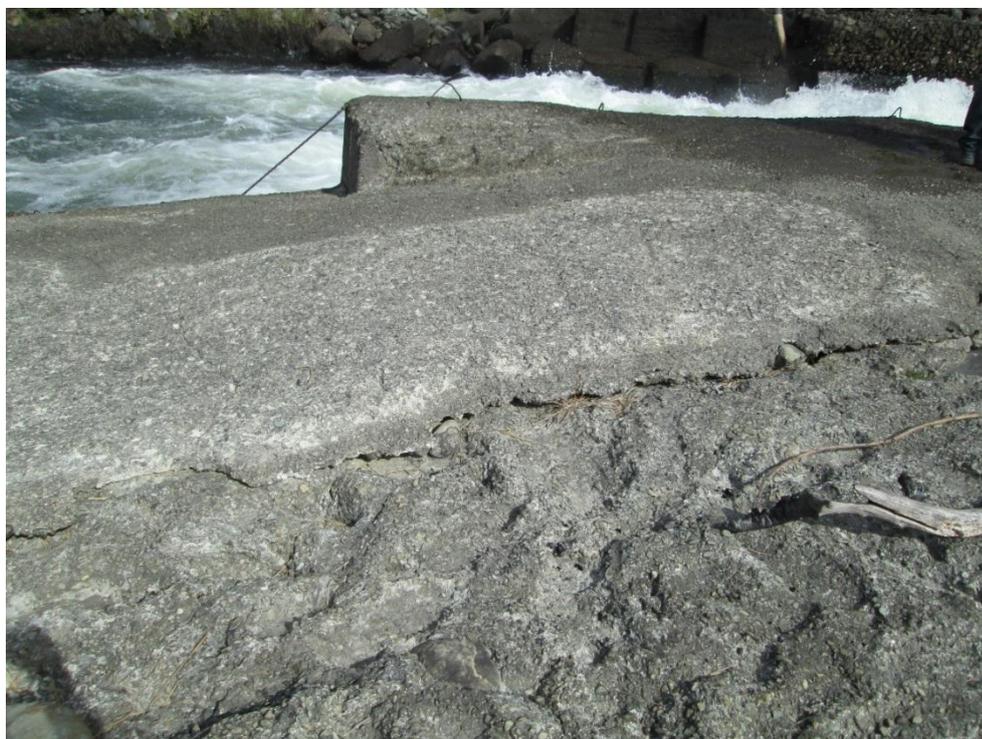
The concrete and stone armouring on both banks is generally in satisfactory condition. It has been previously noted that the mass concrete beyond the end of the chute right hand training wall (beyond the toe of the ogee weir) is at least partially undermined. This has not changed significantly since 2010 but ongoing monitoring of this area by OWL is warranted.

*Figure 27**Undermining of chute*

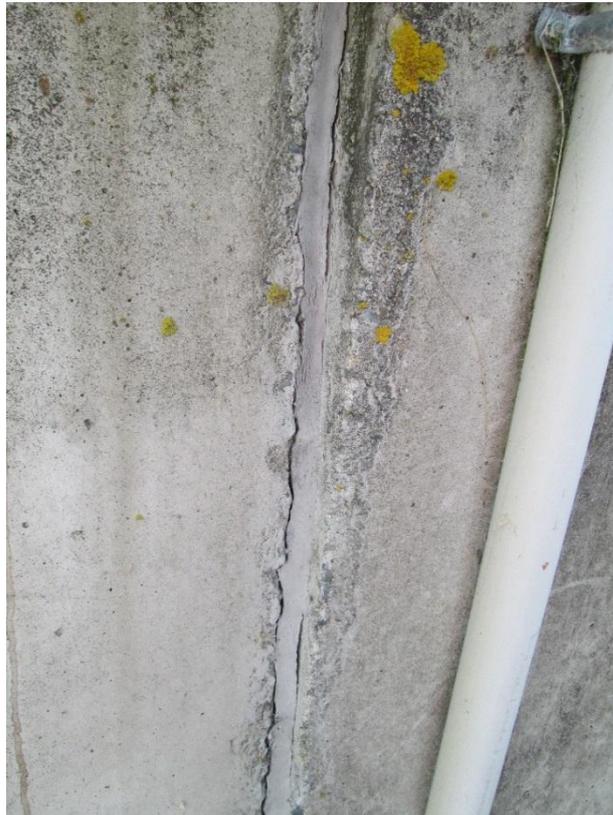
Figure 28

Cracking of the concrete wall next to the control shed previously reported has not appeared to have moved during the period when compared with photographs from last year's inspection.

Cracking of concrete wall

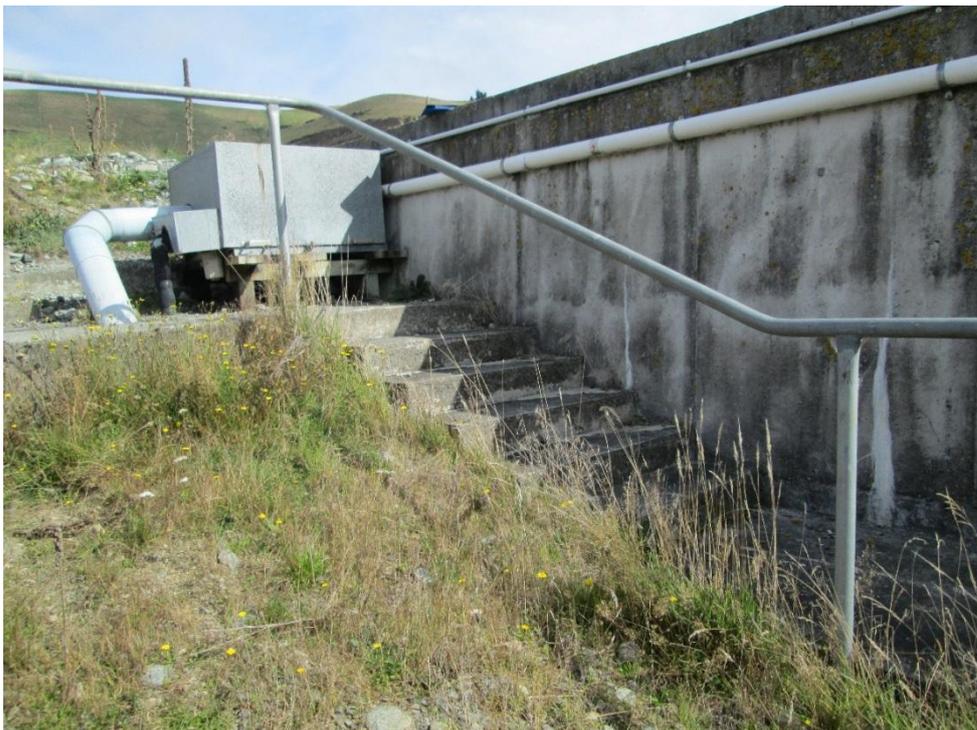
*Figure 29**Current handrail configuration*

Some of the handrails around the control structure may not comply with current requirements according to Building Code Clause F/4 which requires that, in areas used exclusively for maintenance where someone can fall more than 1 m, vertical gaps between longitudinal bars must not exceed 460mm. We suggest investigating whether these handrails require upgrading.
