OPUHA WATER LTD

**Opuha Dam
Annual Dam Safety Inspection 2010**

Tonkin & Taylor Ltd

May 2010

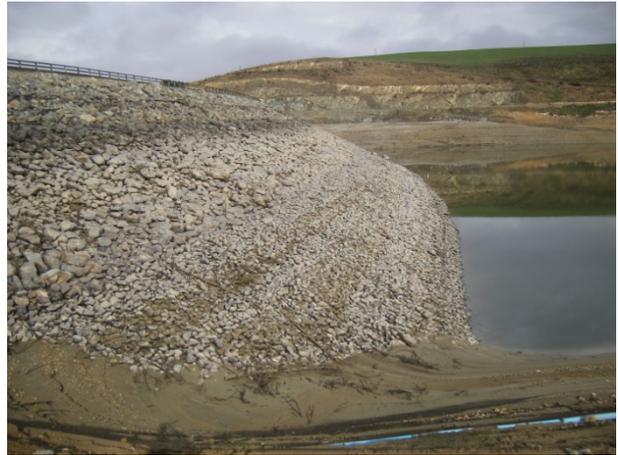
Figure 2.1 – Upstream face from auxiliary spillway approach

The upstream slope and riprap appeared in good condition to the extent visible above the 379.3 mRL lake level (Figure 2.1).

Minimal accumulation of debris was noted with no immediate need for debris removal. We understand that periodic debris removal is undertaken and this should continue.

The riprap is robust and sound. No signs of riprap bulging were observed near the base of the Type 4A riprap.

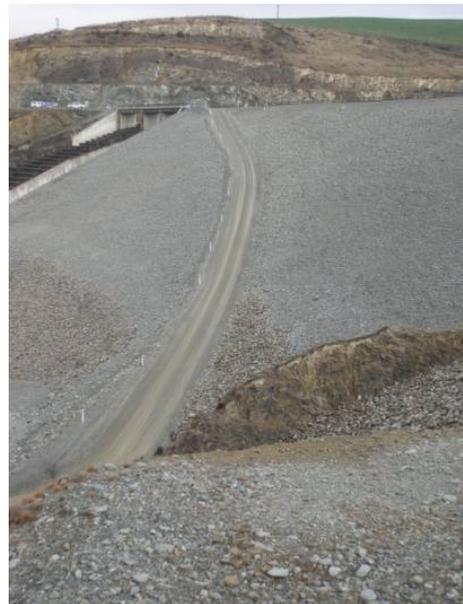
Figure 2.2 Downstream face from right abutment

The downstream face appears to be in a good condition (Figure 2.2, Figure 2.3 and Figure 2.4). Spraying continues to control local growth of scrub and bushes to prevent them from penetrating through the riprap into the embankment fill below.

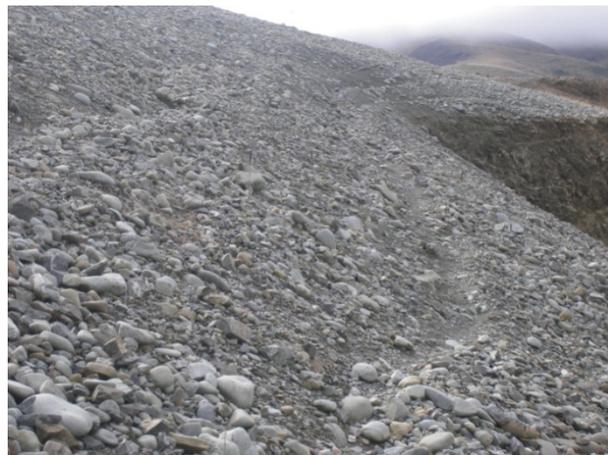
OWL reports that in several locations sheep have formed tracks across the face of the dam, particularly in the vicinity of promontories towards the left abutment of the dam (Figure 2.4). OWL has expressed concerns that stock tracks could lead to concentration of storm water run-off flows and OWL advises that it is in the process of investigating options to fence the downstream face to exclude stock from this area.

Figure 2.4 Downstream face – area where stock tracks have formed.

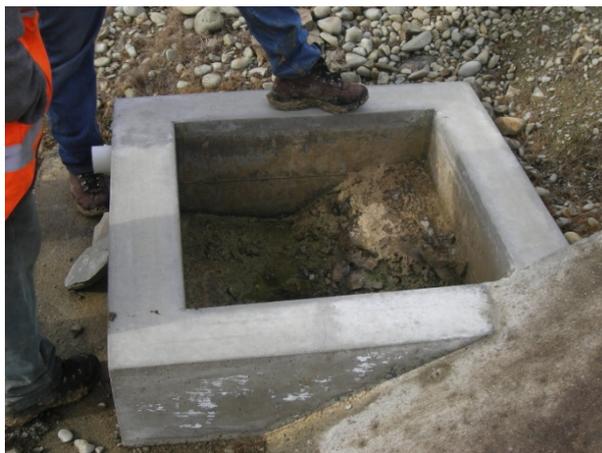
Figure 3.3 D18 outlet.

D18 is located at the base of the auxiliary spillway fuse plugs and only flows when reservoir levels exceed 390 mRL. Flows measured during the past year were reported to be clear and within historic ranges. This level corresponds to the base of the right hand side auxiliary spillway channel. The Operator advises that an investigation may be undertaken in the near future to better understand the source of D18 drain flows. We understand that this will not involve any excavation. It is noted that this matter has been investigated in the past and based on historical drain flow records and recent inspection observations this is not considered a dam safety matter at this time.

The outlet from Drain D18 has recently been upgraded to improve measurement of flow rates. Once measured flows are now diverted into a pipe line below the invert of the auxiliary spillway (Figure 3.3). OWL confirms that the height of the new concrete work is consistent with the earlier structure to avoid any drain surcharge effect.

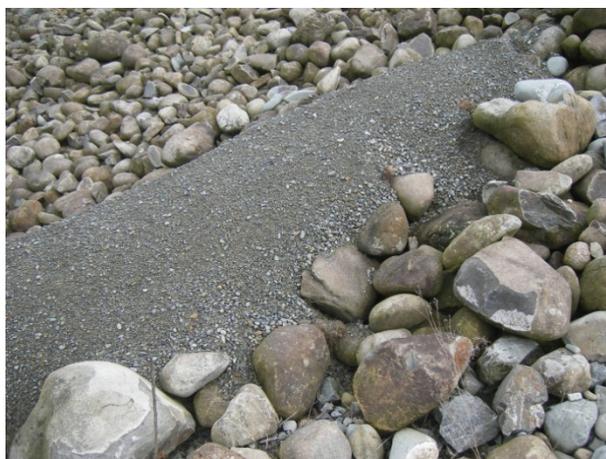
The poorly protected piezometer leads referred to in the 2008 report behind the power house were encased in a length of HDPE pipe prior to the 2009 winter. Following the post earthquake inspection on Thursday 16th July, OWL reported irregular and variable hydraulic piezometer readings. Five additional sets of readings were taken between 16th July and 22nd July 2009 from piezometers P1-1, P1-2, P1-4, P2-1, P2-2, P2-3, & P2-4. The piezometers readings were erratic with high differential pressures. This period coincided with a period of freezing overnight temperatures. The piezometer readings stabilised at the end of the period as the ambient temperature increased. At the time it was considered that the cause of these erratic readings was unlikely to be the earthquake and is more likely to be freezing of the piezometer fluid. OWL has subsequently placed frost protection cover material over the exposed hydraulic piezometer leads (Figure 3.5).

Figure 3.5 Frost protection placed over hydraulic piezometer leads behind the Power Station.

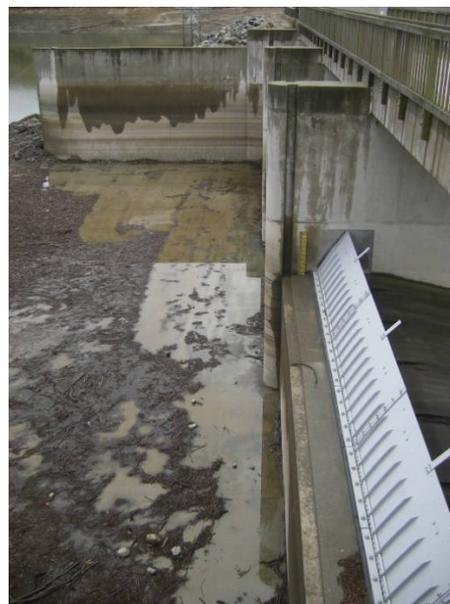
Figure 5.2 shows that the approach is relatively clear of significant debris. The approach to the service spillway was inspected and was in good condition. No erosion damage was evident adjacent to the true left approach training wall where dirty water was evident during the May 2009 high spillway flows (Figure 5.3).

Figure 5.2 Obermeyer gates from RHS of spillway approach

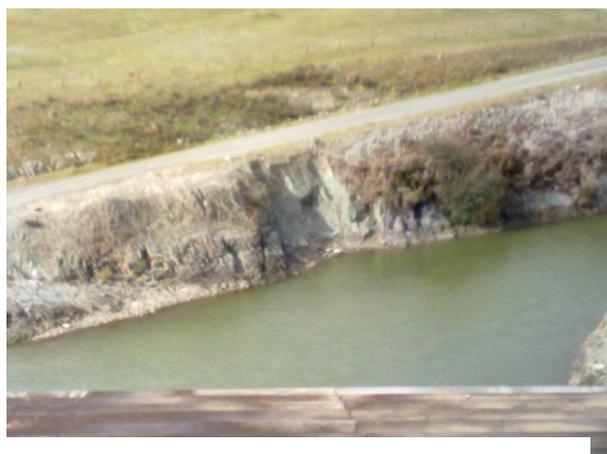
A small slip of minor significance was noted on the left bank of the tail race, opposite the spillway (Figure 5.5)

Figure 5.5 Small slip opposite Service Spillway

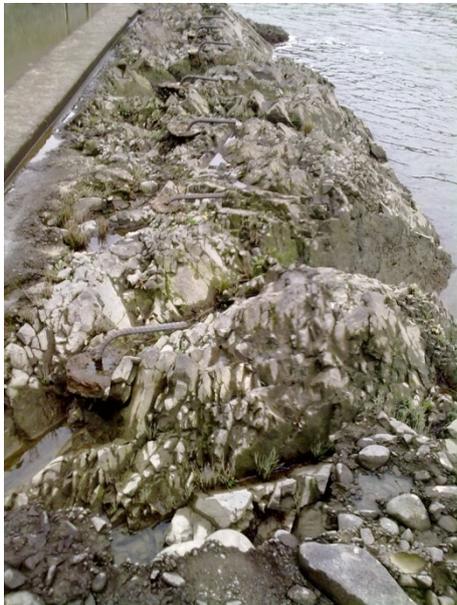
The tailrace water level was low enough this year to see the spillway basin rock sill during the inspection. There is minor erosion of the rock sill at the downstream edge of the basin (Figures 5.6 and 5.7). Indications are that a negligible amount of additional rock was eroded during the May 2009 event.

The upper rock cover to the dowel bars had been lost prior to the May 2009 flood. This damage is concentrated at both ends of the sill over a length of approximately 2m on the right and 10m on the left side. In some areas the concrete cover is undermined (Figure 5.7). The sill performed well during the May 2009 event, and as a result damage was limited to the loss of a minor amount of rock. Close monitoring of the sill will continue. Consequently, the Operator has indicated that works associated with 2008 report recommendation RCM2008-28 will be postponed for the time

Figure 5.6 Minor erosion – spillway stilling basin sill

being. The Operator advises that repair works will be implemented as deemed necessary by the ongoing inspection regime. Based on recent performance this approach is considered to be appropriate.

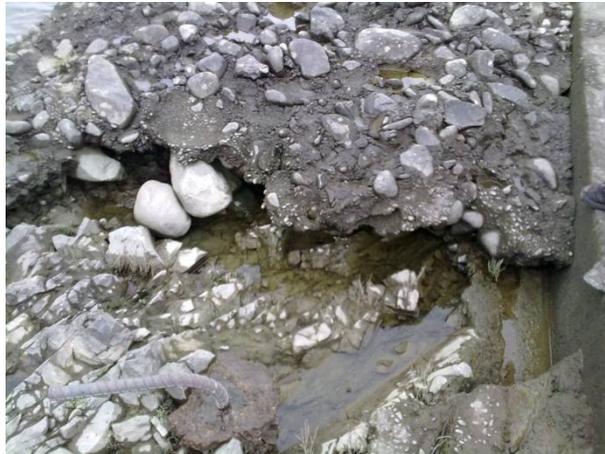
Figure 5.7 Minor erosion – spillway stilling basin sill

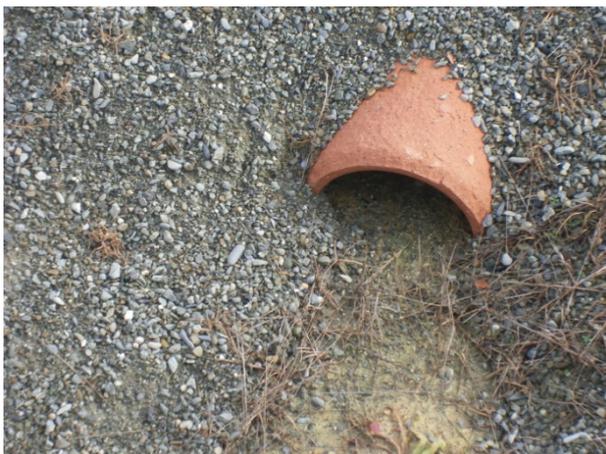
One of the right hand side fuse plug triggering device clay tile pipes is partially blocked. It is recommended that this is cleared and any future blockages removed as they may arise (Figure 6.2).

Figure 6.2 Partially blocked fuseplug triggering device clay tile outlet pipe

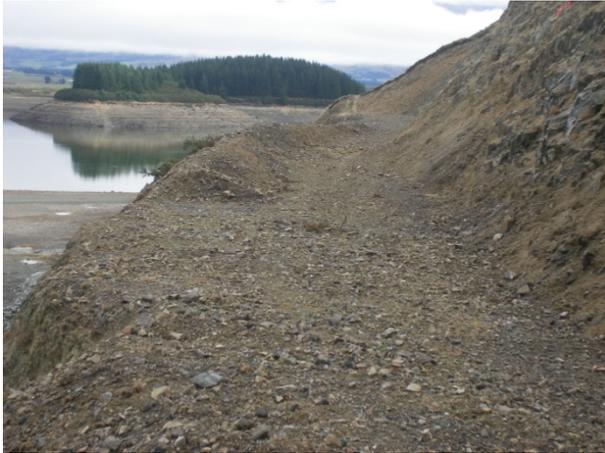
Figure 6.4 Concentrated cut erosion and debris fan viewed from bench above

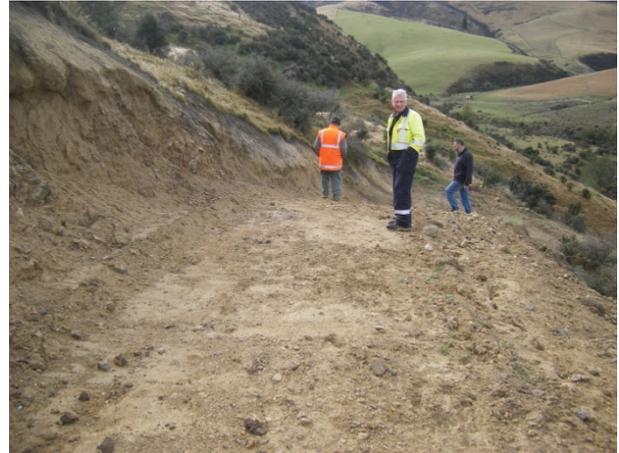
Figure 6.5 Left abutment cut slope drainage

In addition, OWL has undertaken considerable works to form tacks to access the cut slope benches from the downstream end of auxiliary spillway (Figure 6.5). These works are of a good standard and will facilitate future maintenance works in this area.

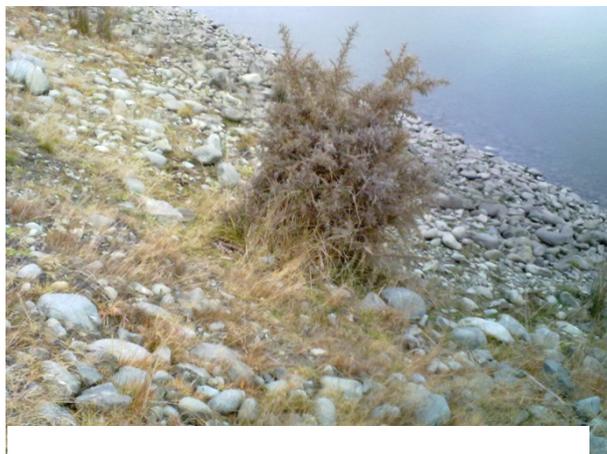
The small and isolated areas of gorse that had previously been reported as becoming established on the upstream face of the closure embankment above normal water levels have been sprayed. OWL maintains an ongoing spraying regime to ensure that gorse does not become established on, or in the vicinity or water retaining structures. The downstream face appears to be even and is in a satisfactory condition.

Figure 8.1 Downstream Weir Enclosure Embankment – sprayed gorse

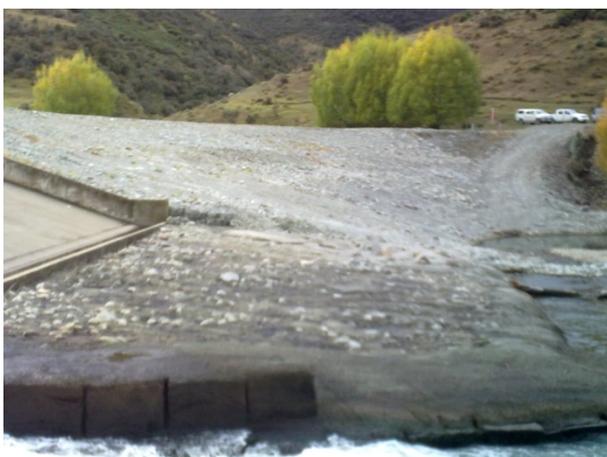
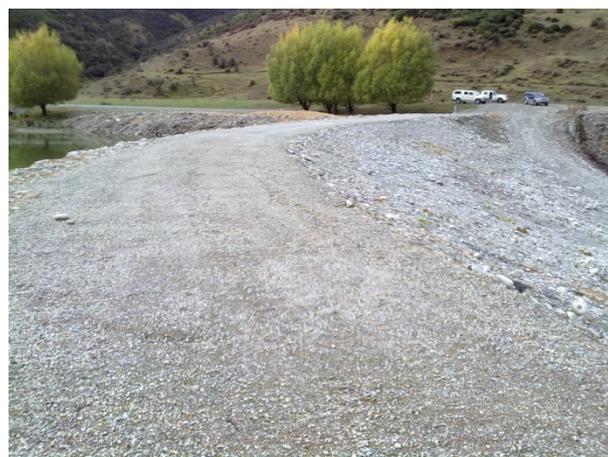
leakage through the DWOE was anticipated following initial filling as similar performance was also recorded following initial filling of the previous two DWOE structures. Some minor leakage near the toe of the DWOE was observed following first filling and was well within pre construction expectations. The leakage ceased in early October 2009. Ongoing monitoring has not identified any subsequent DWOE leakage. The Operator has prepared a comprehensive report⁴ describing the 2009 reinstatement works. This report covers matters relating to resource consent compliance, investigations and material sources, as well as design, construction, construction verification and commissioning. Commissioning of the reinstated DWOE was considered complete on 13th October 2009. No signs of seepage in the vicinity of the DWOE downstream face were visible and the reinstated fusible section of the left embankment was in good condition at the time of the inspection (Figures 8.2 and 8.3).

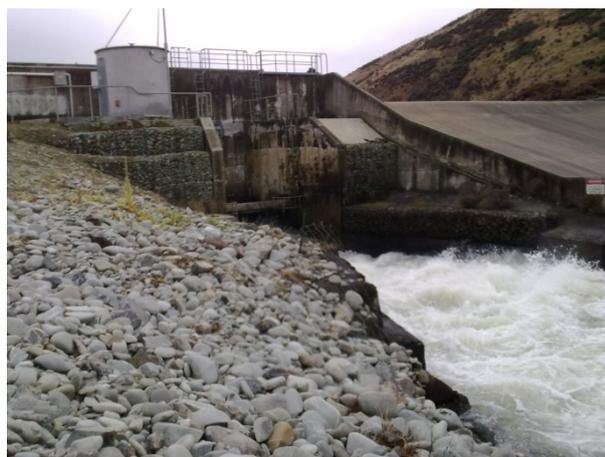
Figure 8.4 Downstream gate structure and ogee weir

The structure was generally in good condition. Figure 8.4 illustrates the area in the vicinity of the weir and gate structure.

OWL advises that the damaged fence downstream of the radial gate structure on the true right hand side will be reinstated soon. The ground level was reinstated in this area and additional rock armour protection placed at the time of the 2009 DWOE reconstruction works (Figure 8.4).

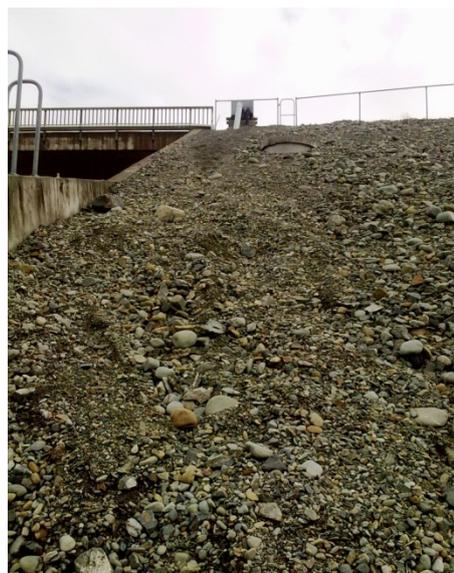
OWL reported localised storm water damage in the vicinity of the elver pass adjacent to the service spillway true left abutment during high intensity rainfall on 22nd January 2010. The damage was caused by storm water originating south west of the Service Spillway Bridge crossing the bridge and over topping the left hand side (western) bridge abutment. Figure 9.1 illustrates the repaired area.

Figure 9.1 Storm water erosion repairs

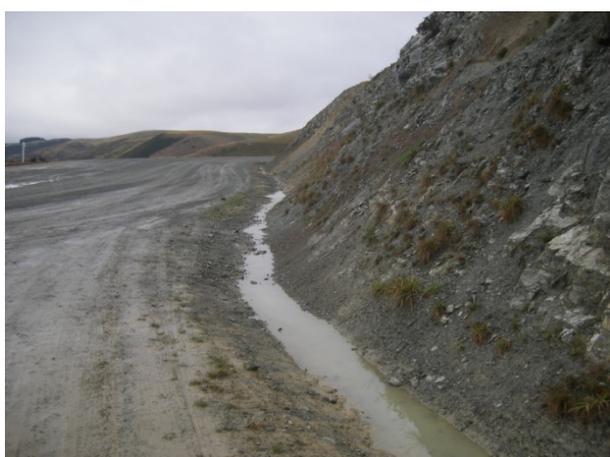
OWL has subsequently undertaken works to divert storm water away from the bridge right hand side abutment. The measures include an open drain at the toe of the access road cut slope (Figure 9.2) and an open drain channelling storm water south east from the Service Spillway (Figure 9.3). The reformed channel at the cut slope toe diverts storm water towards the boat ram area and prevents flow across the dam access road towards the bridge and the spillway gate control building (Figure 9.2).

Figure 9.2 Cut slope drain works

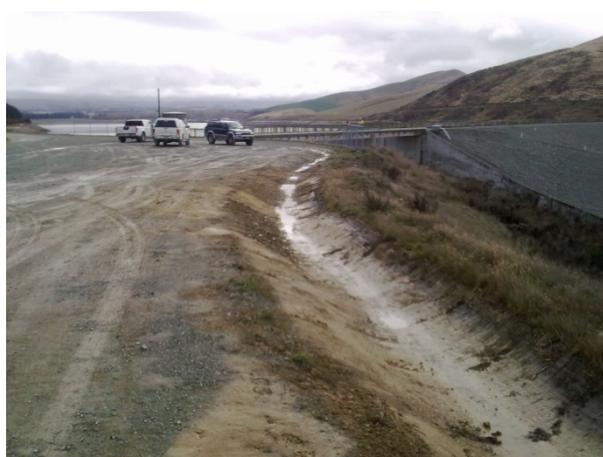
Figure 9.3 New drain diverting storm water away from the Service Spillway
