7. Mechanical and Electrical Works

7.2 Mechanical and Electrical Inspection

Appendix B: Photographs

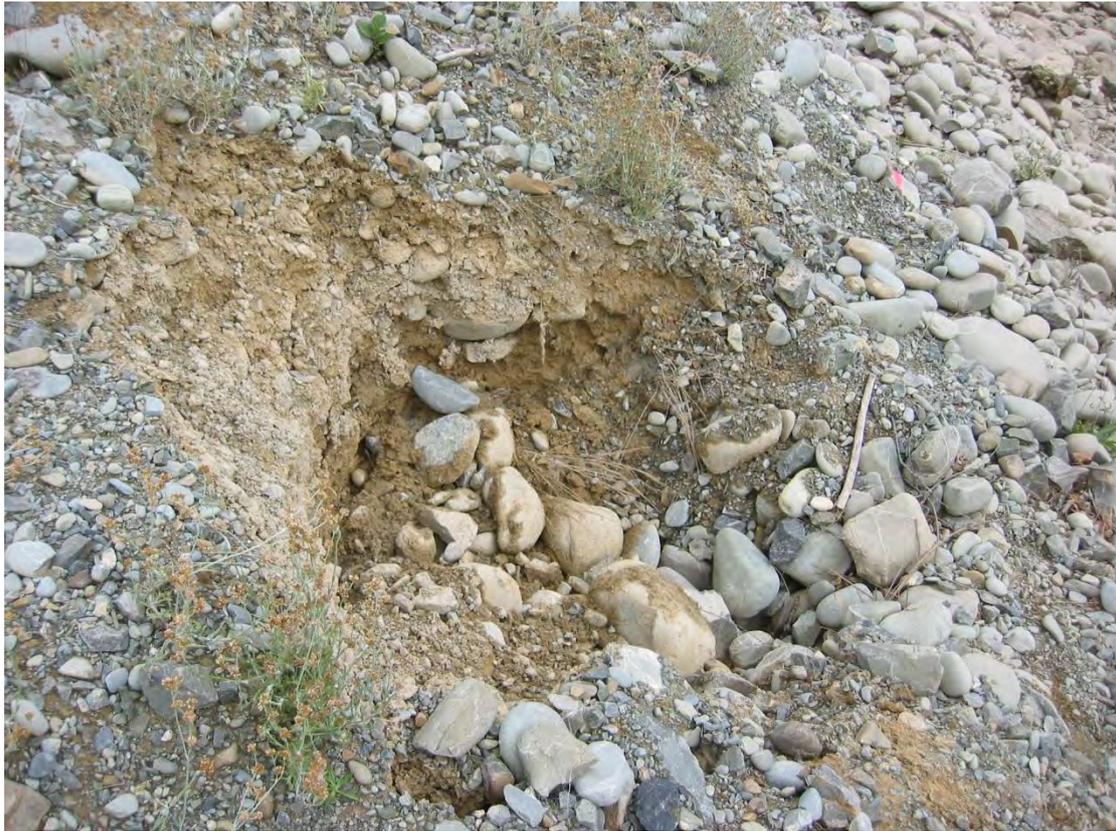
Photo 19: Re-Regulation Pond – Overflow Embankment, Sinkhole on Upstream Face

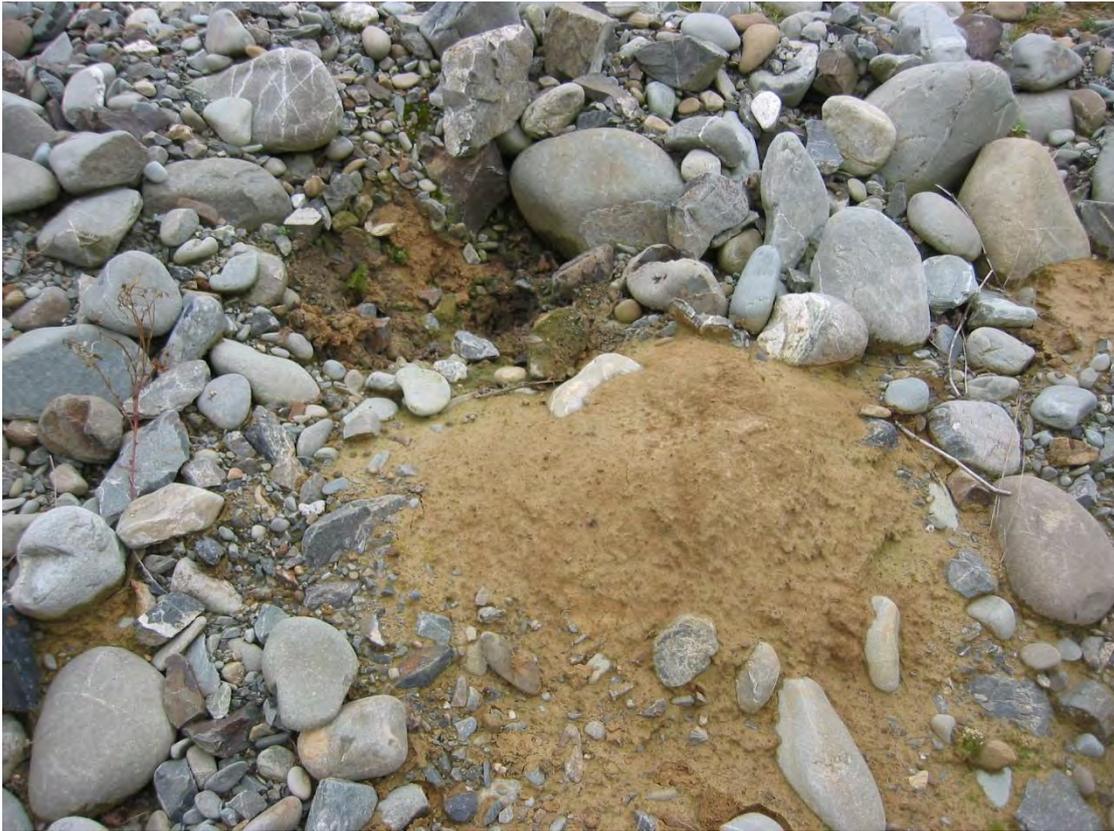
Photo 21: Re-Regulation Pond – Overflow Embankment, Fines on Downstream Face
