OPUHA WATER LTD
Enabling | Sustainable | Growth

Consent Self-Monitoring Annual Report

April 2013 to March 2014

Environment Canterbury
June 2014

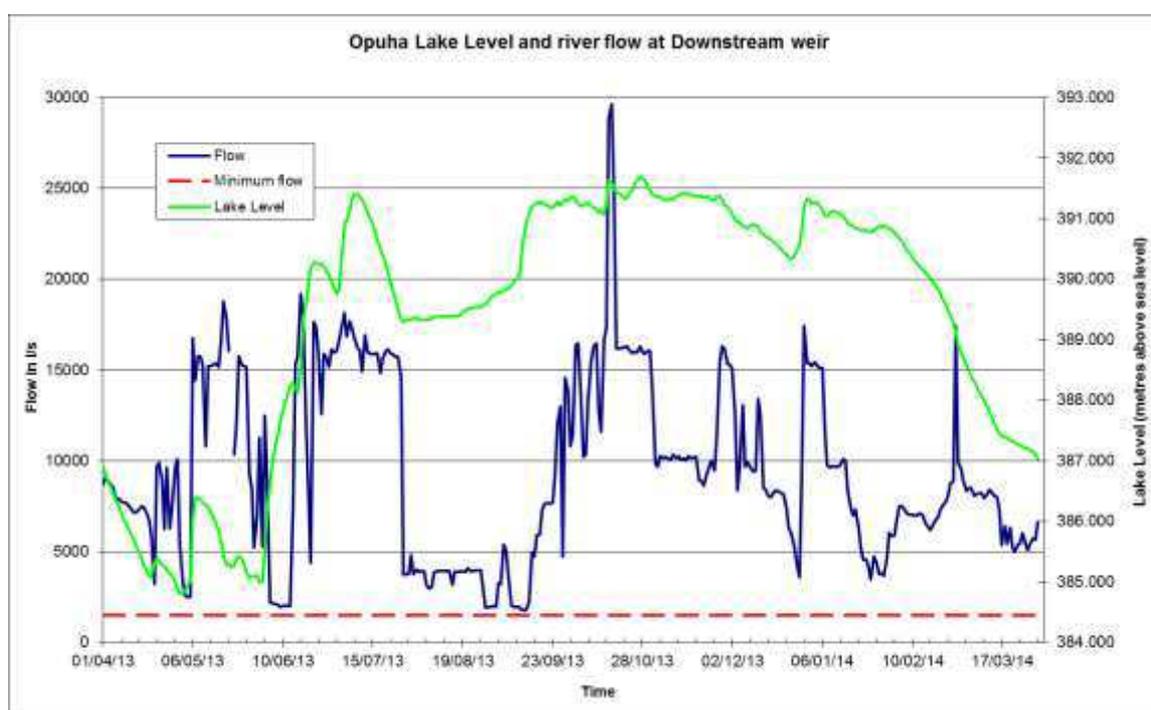
- The following graph indicates the downstream weir flow record and lake levels for the self-monitoring period. Recorder sites were maintained with data supplied to Environment Canterbury on an on-going basis during the period. The minimum permitted flow from the DSW was maintained throughout the monitoring period.

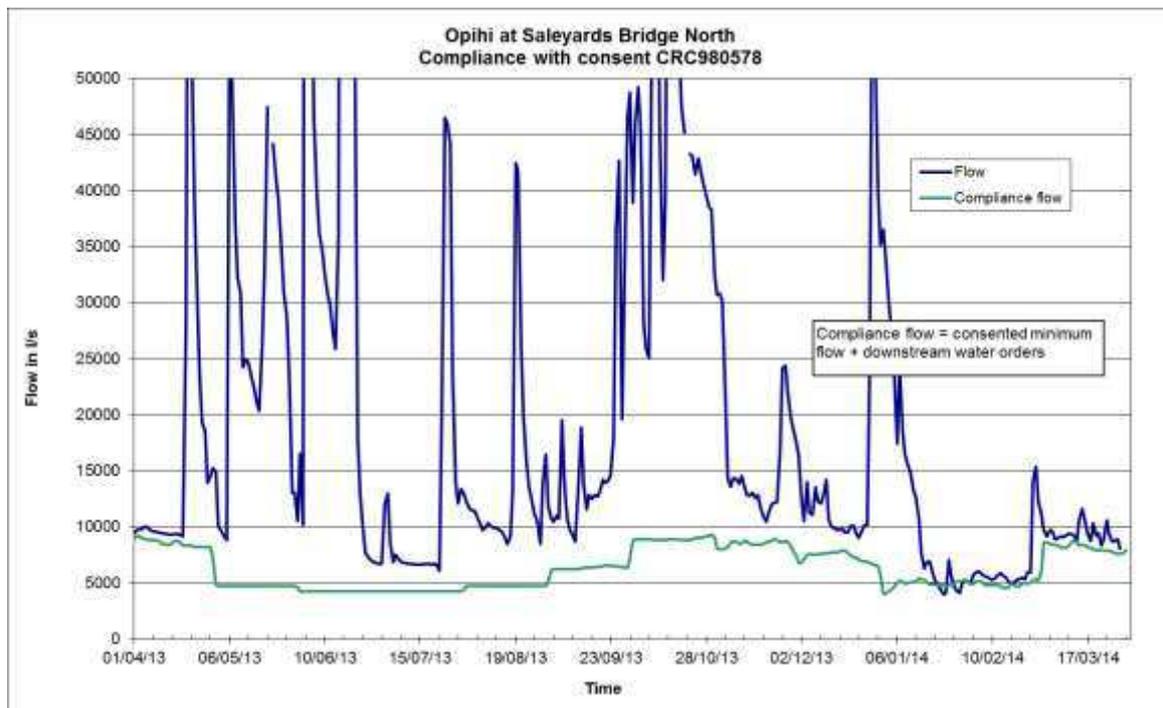
- The following graph indicates the Saleyards Bridge flow record and minimum consent levels (including downstream water abstractions) for the self-monitoring period. Recorder sites were maintained with data supplied to Environment Canterbury on an on-going basis during the period.
- Minimum flow requirements (including downstream water abstractions) were not achieved on two occasions during the 24th and 27th of January, and the 29th of January and the 4th of February due to inaccurate rating curves retrospectively illustrating failure to achieve minimum flow requirements. ECan were advised accordingly.

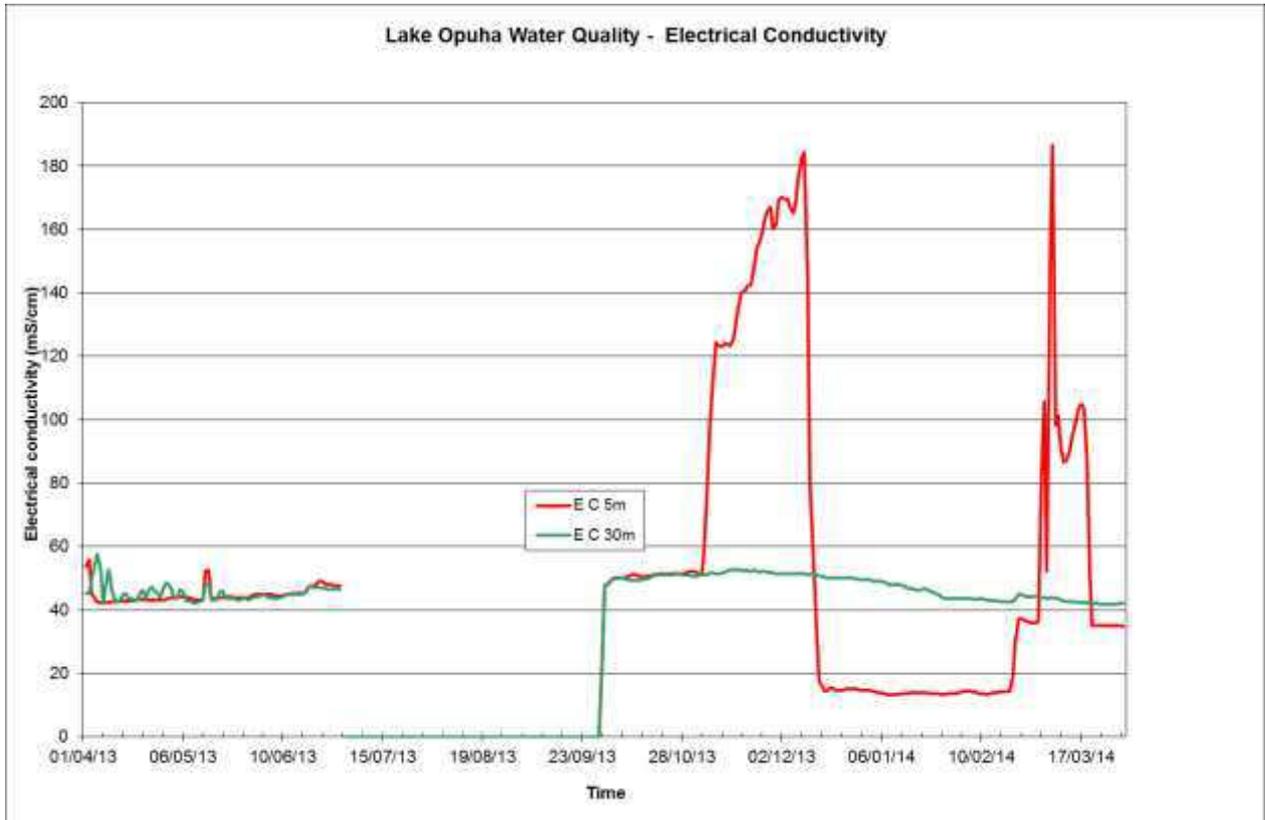
- The following graph indicates the Electrical Conductivity measurements recorded within the Lake at RL 360 and 5m below the lake free surface.

- The missing record between 1st July 2013 and 30th September 2013 due to a failure of the interface caused by an excessive number of sensors connected to a single datalogger. A new interface installed and sensors re-wired on the 30th of September 2013.

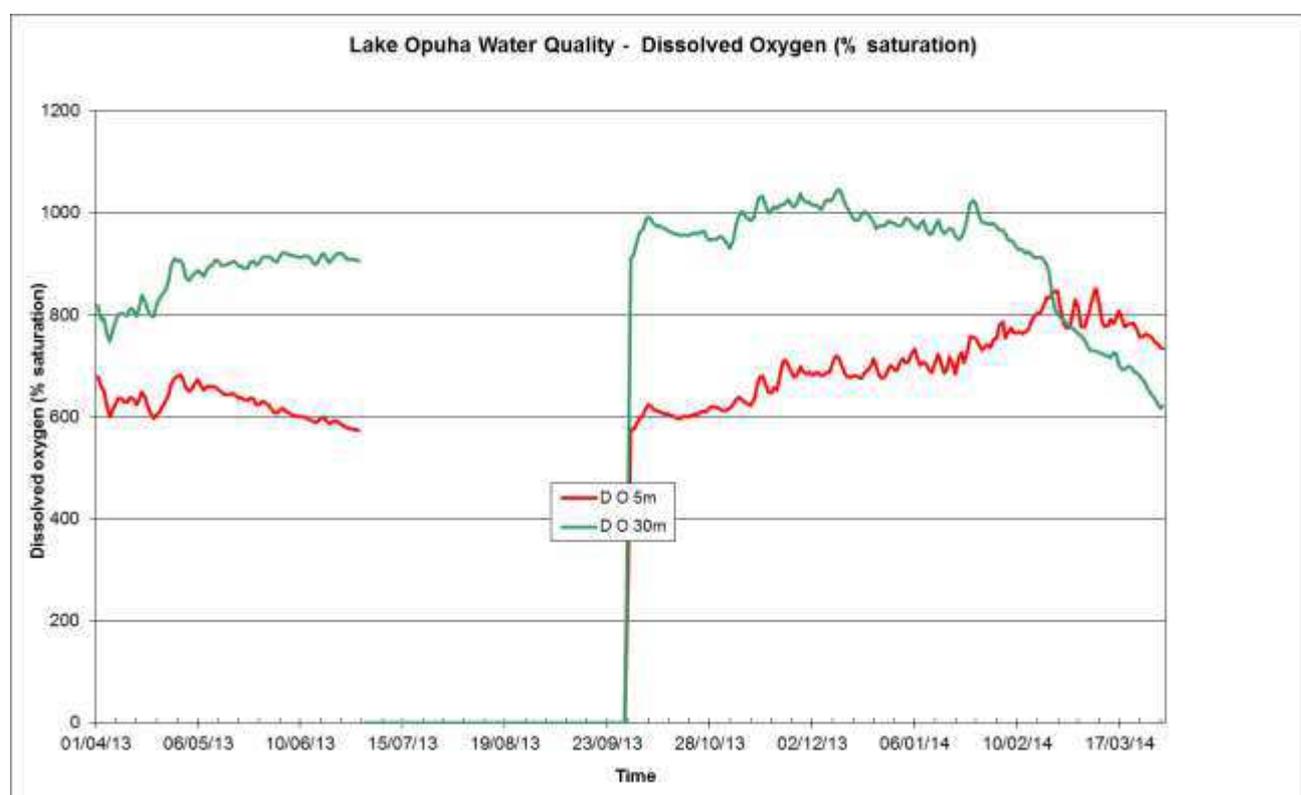
- Dissolved Oxygen Levels within the Lake at RL 360 and 5m below the lake's free surface are recorded in the following graph.
- The missing record between 1st July 2013 and 30th September 2013 due to a failure of the interface caused by an excessive number of sensors connected to a single datalogger. A new interface installed and sensors re-wired on the 30th of September 2013.
- Aeration of the lake was not undertaken during the reporting period.

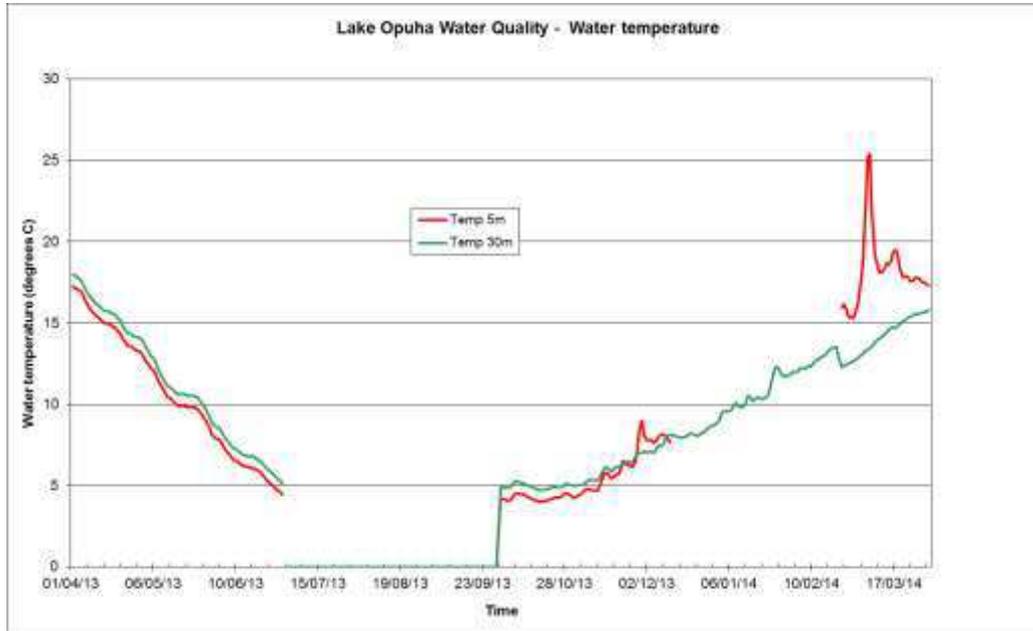
- The following graph shows Lake Temperature at RL 360 and 5m below the Lake surface.
- The missing record between 1st July 2013 and 30th September 2013 due to a failure of the interface caused by an excessive number of sensors connected to a single datalogger. A new interface installed and sensors re-wired on the 30th of September 2013.

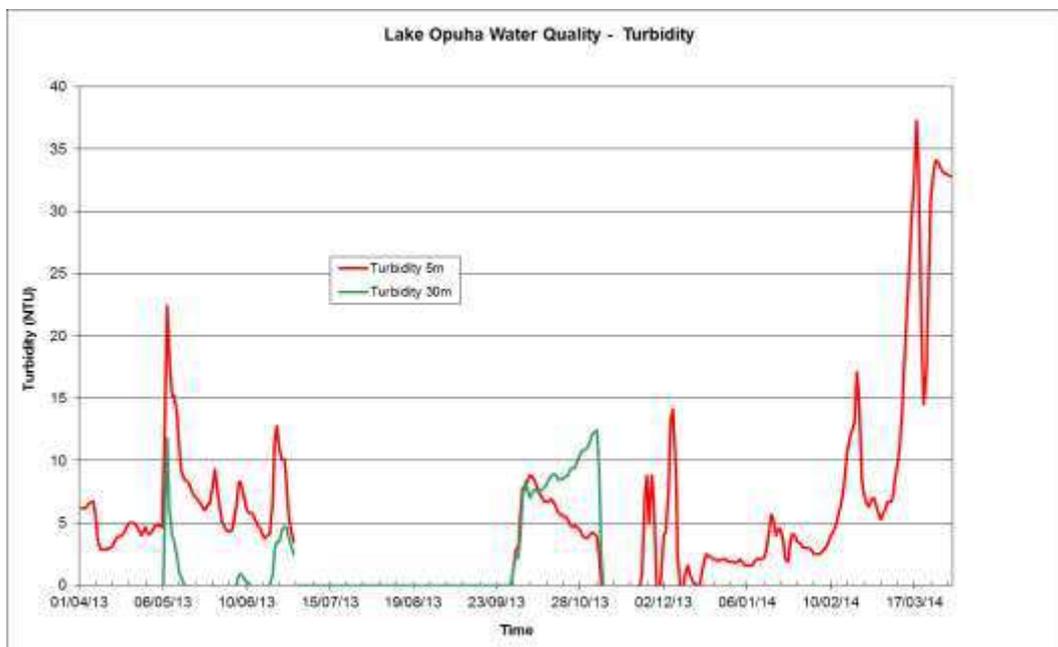
- The following graph shows recorded turbidity at RL 360 and 5m below the Lake surface.
- The missing record between 1st July 2013 and 30th September 2013 due to a failure of the interface caused by an excessive number of sensors connected to a single datalogger. A new interface installed and sensors re-wired on the 30th of September 2013.

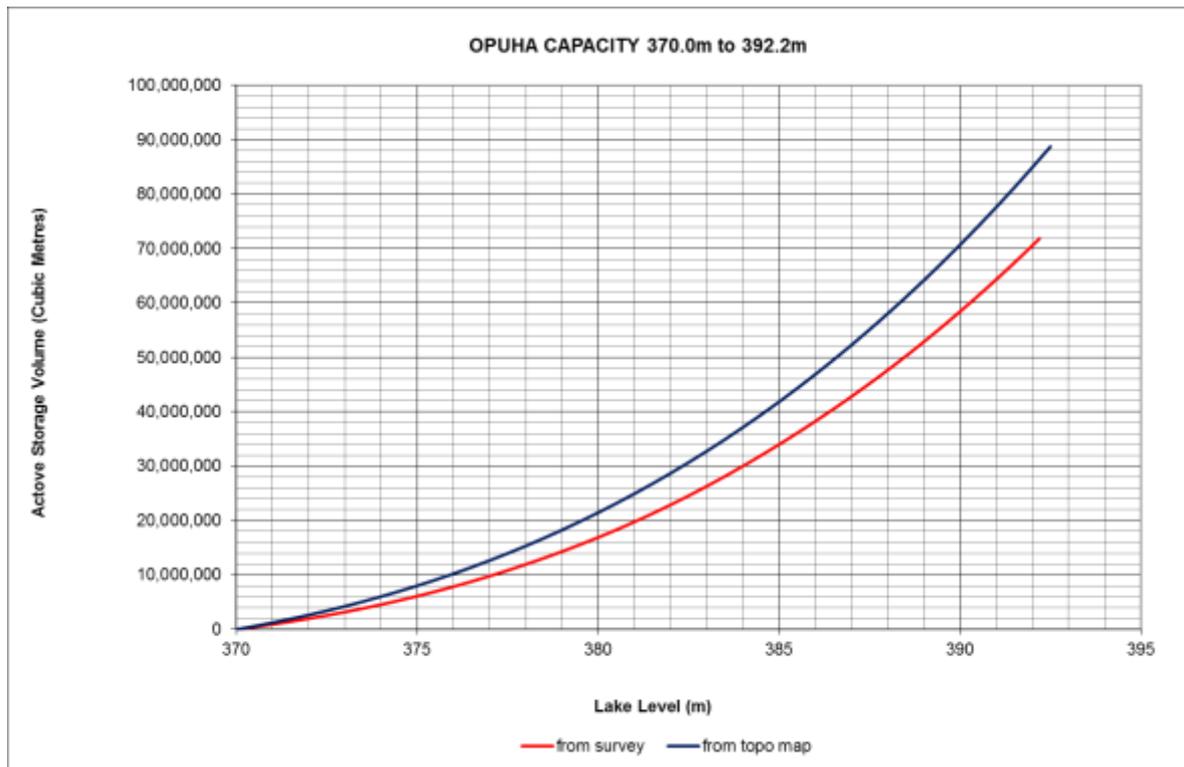
A detailed bathymetric survey has indicated that generally the stage-storage data for the lake was over estimating stored water volumes and the graph overleaf (also included as Appendix 2) shows the previous and revised lake height to storage volume curves. The new information suggests a total working volume of approximately 72 million m³ compared with the previous assumption of 90 million m³. The very detailed bathymetric information obtained has provided a much more accurate model for operational use, including estimation of total lake inflows based on short term level readings. This is particularly valuable in high inflow, high lake level scenarios.
