Opuha Water Ltd

Opuha Dam
Annual Dam Safety Inspection 2011

Report prepared by:
Tonkin & Taylor Ltd

April 2011

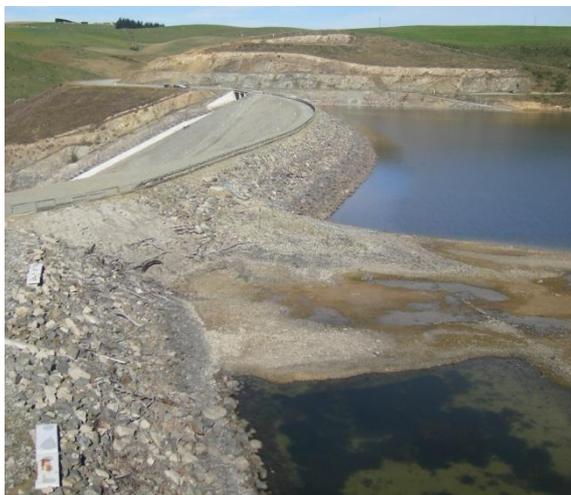
Photo 3.1 Upstream face from true left abutment

The upstream slope and riprap appeared in good condition to the extent visible above the 388.8 m RL reservoir water level (Photo 3.1 below).

Minimal accumulation of debris was noted. OWL advise that removal of the current debris is programmed for the near future. Periodic debris removal is undertaken and this should continue.

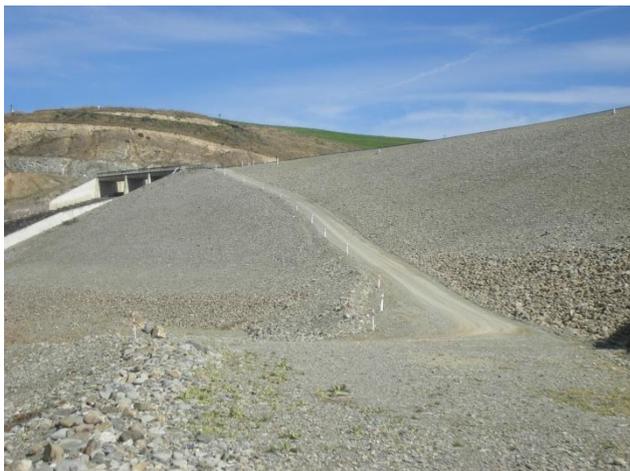
Photo 3.2 Downstream face from left abutment

The downstream face appears to be in a good condition (Photo 3.2 below). Generally spraying continues to control local growth of scrub and bushes to prevent them from penetrating through the riprap into the embankment fill below. A small area of lupins or similar have been overlooked on the right hand side of the embankment. It would be prudent to spray these soon.

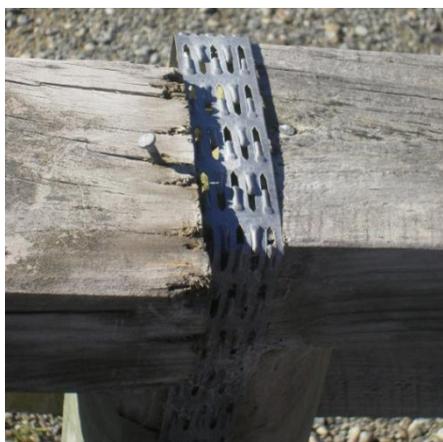
Photo 3.3 Minor damage to crest fence

The crest roadway and fence were generally in good condition. However, some slight damage to the fence handrail was observed as per Photo 3.3 below. We suggest that this very minor damage is repaired at a convenient future time.

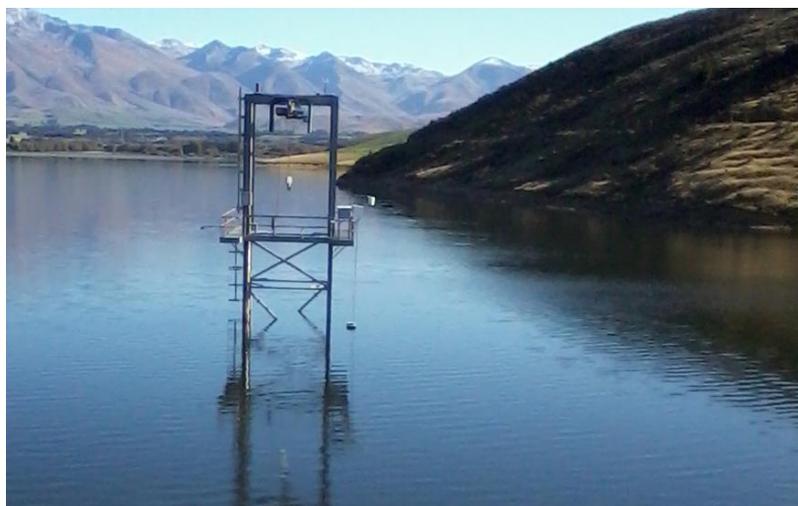
Photo 4.1 Intake tower from upstream face of dam

Photo 4.1 below shows the Intake Tower to the extent that the structure was visible from the dam upstream face of the dam as the time of this inspection.

A dive inspection of the intake tower was not undertaken during the 2010-2011 year. We understand that this was due to difficulties in scheduling the inspections coincident with low reservoir water level to enable adequate dive time and safe access by divers in accordance with current safety regulations.

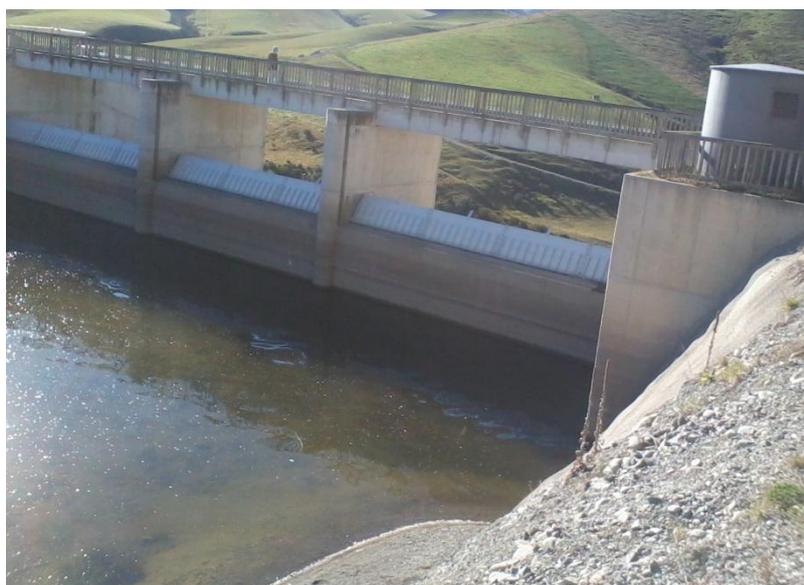
Photo 5.1 Approach to service spillway

As shown in Photo 5.1 below, the approach was clear of significant debris at the time of inspection. The approach to the service spillway was inspected and was in good condition. The repair to the shotcrete coating on the rock on the right hand side of the spillway is in good order.

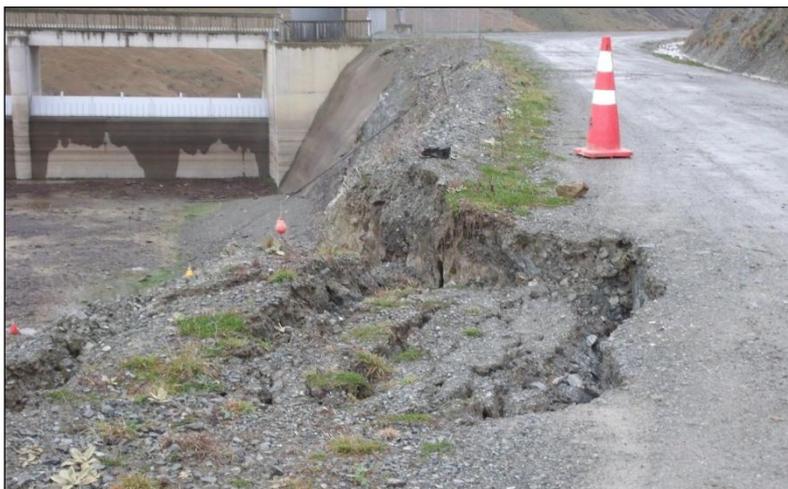
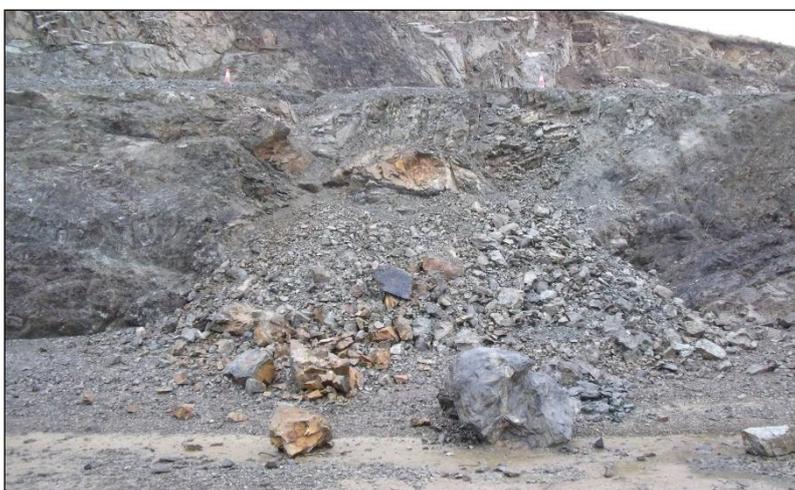
A slip failure of minor significance occurred to the right hand side of the spillway approach channel/road cutting northwest of the service spillway (between the bridge and the boat ramp) during May 2010. Photographs 5.2 and 5.3 taken 28 May 2010 by OWL illustrate the damage). The damage was subsequently repaired soon after and Photo 5.4 illustrates the repair.

Photo 5.2 Road embankment slip (looking south towards service spillway – photo by OWL 28 May 2010)

Photo 5.3 Road embankment slip (looking up from reservoir to road embankment – photo by OWL 28 May 2010)

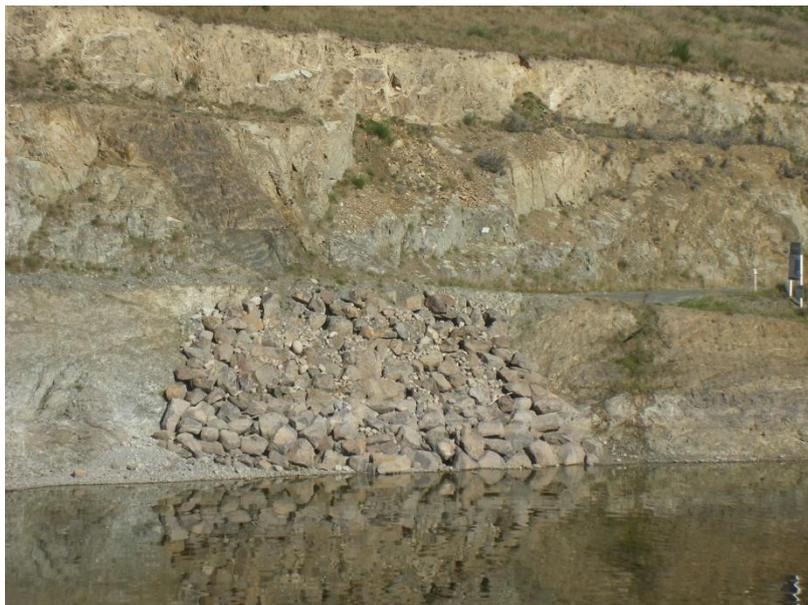
Photo 5.4 Slope protection and stabilisation works on true right of spillway approach

The recent spillway true right approach slip repair (Photo 5.4 below) was inspected and found to be in good condition. However, we note that ponding was observed in the road stormwater drainage upslope from the slip repair. It is desirable that the maintenance works are undertaken to ensure that the road drains correctly function. It is speculated that stormwater ponding at the road side and infiltrating into the slope was a potential contributing factor to the recent slip.

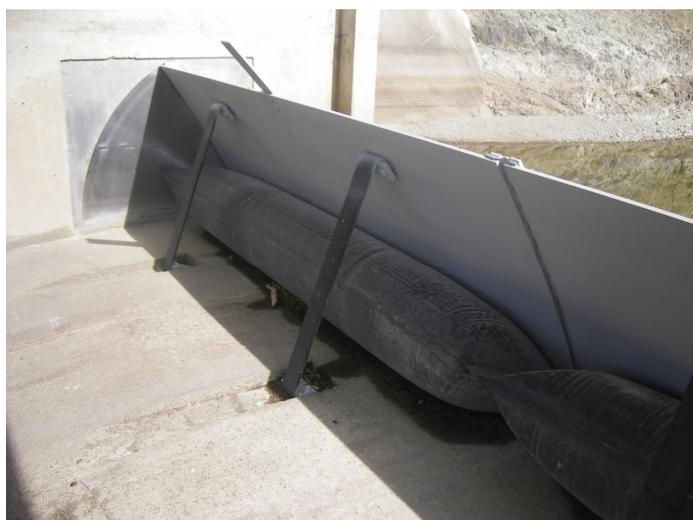
Photo 5.5 Obermeyer gates from service spillway crest

The Obermeyer gates appear to be in sound condition (Photo 5.3 below).

The exact functioning of the Obermeyer gates during the New Year period when the service spillway operated is not well understood. The Operator reports that the gates failed to respond to the instruction originating from Clyde Power Station Control Room for the gates to lower but that the gates subsequently dropped themselves (timing and trigger uncertain). The Operator also advises that the trigger for the gates to rise was unclear and the gates did not rise as anticipated. This issue is being investigated by the Operator and corrective action is necessary to ensure that the operation of the Obermeyer gates is understood and that the gates correctly function in future. In addition to confirming gate functionality, the Operator advises that a camera will be installed to allow real time observation of the spillway from the Clyde Control Room.

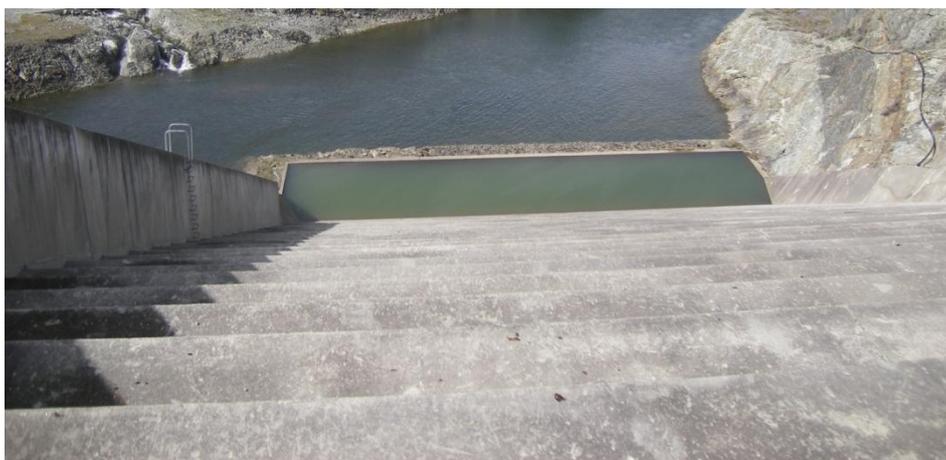
Photo 5.6 Service spillway steps from middle of spillway

The spillway steps appeared to be in satisfactory condition (Photo 5.6 below).

As noted in previous annual inspection reports, large rocks thrown from the spillway bridge have broken off step edges in isolated locations. We understand that the Obermeyer gates are similarly targeted by rocks.

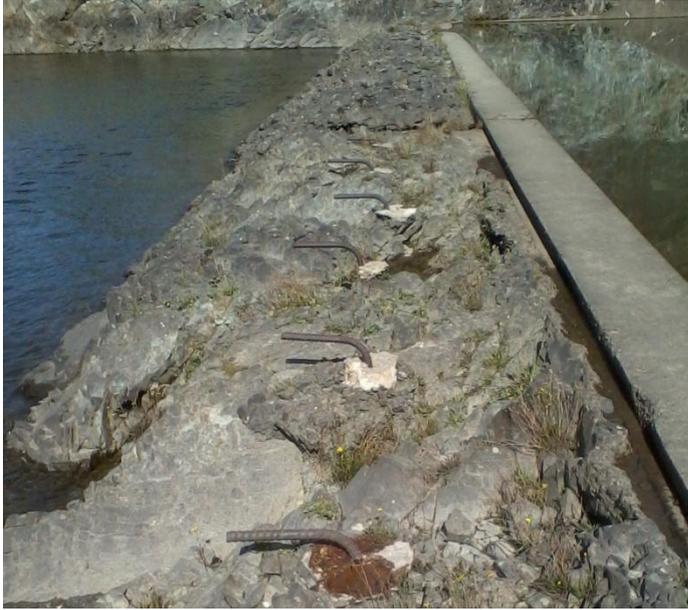
Photo 5.7 Concrete face protection on rock sill

The spillway basin rock sill was exposed during the inspection. There is minor erosion of the rock sill at the downstream edge of the basin (Photo 5.7 below).

The upper rock cover to the dowel bars had been lost prior to the May 2009 flood. This damage is concentrated at both ends of the sill over a length of approximately 2m on the right and 10m on the left side. In some areas the concrete cover is undermined.

Inspection indicates that the small spillway flows during the period did not erode a significant additional quantity of rock from the sill area. Close monitoring of the sill by OWL will continue. Consequently, the Operator has indicated that works associated with 2008 report recommendation RCM2008-28 will be postponed for the time being. The Operator advises that repair works will be implemented as deemed necessary by the ongoing inspection regime. Based on recent performance this approach is considered to be appropriate.

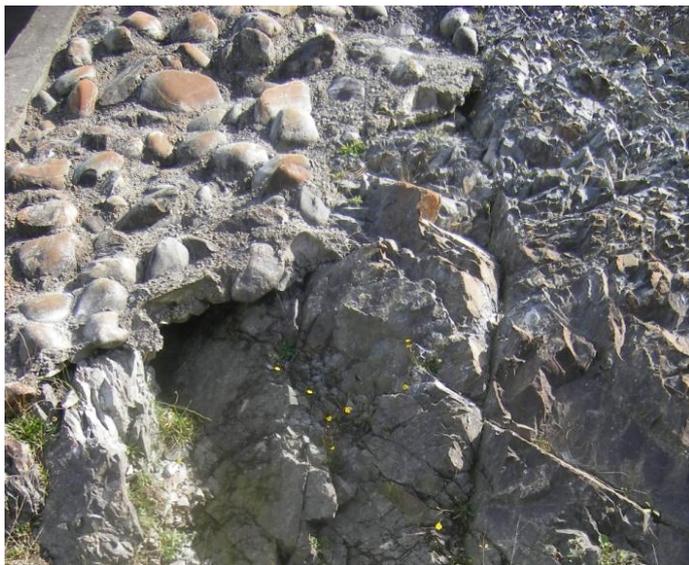
The concrete facing on the outside of the chute true left wingwall was observed to be undermined near the stilling basin in the vicinity of a crush zone in the rock foundation (Photo 5.8 below). While this does not appear to be of immediate concern, ongoing monitoring of this undermining is warranted.

Photo 5.8 Undermining to concrete face at true left wall of chute near stilling basin

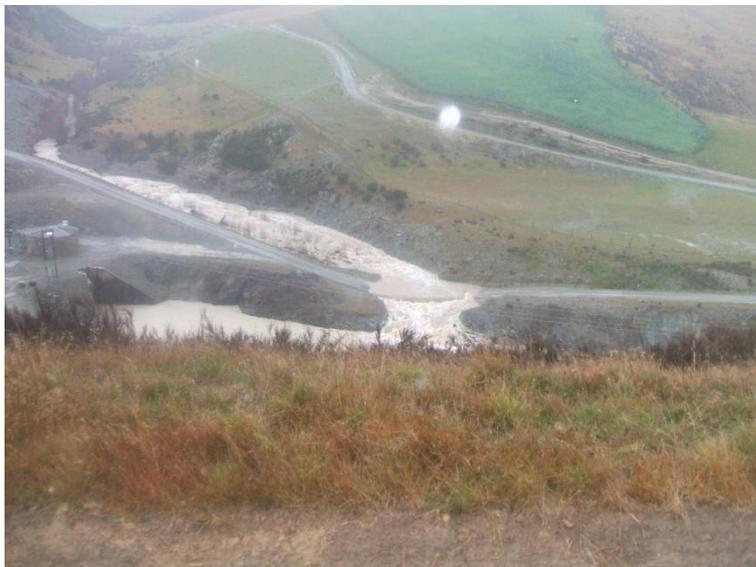
Photo 5.9 May 2010 Gooseberry Stream flood

Significant inflows entered the tailrace/downstream weir pondage via Gooseberry Stream during the 24 to 31 May 2010 storm (Photo 5.9 below). Floating debris swept into the tailrace and the downstream weir area was subsequently flushed from the vicinity of the gate structure over the ogee weir. A modest quantity of coarse sediment has been deposited in the power station tail bay area by Gooseberry Stream flows during the flood (Photo 5.10 below). The Operator advises that this material was excavated from the tailrace and removed by truck.

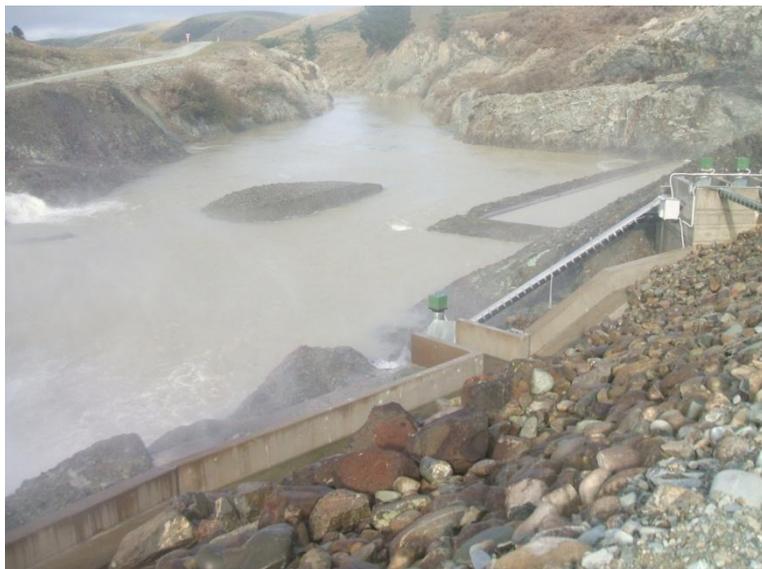
Photo 5.10 Sediment deposition in the tailrace area after the May 2010 flood

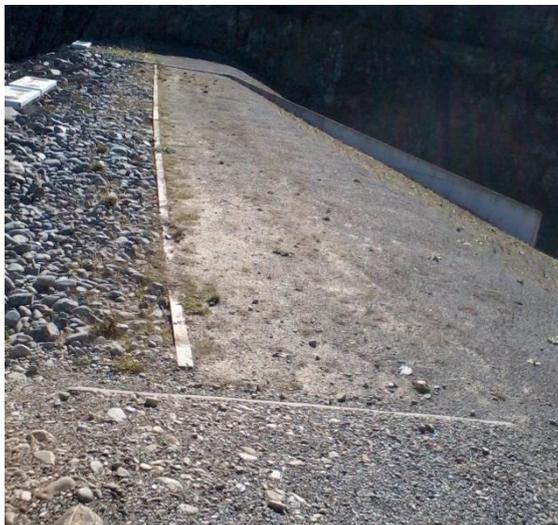
Photo 6.1 Downstream face of auxiliary spillway fuse plug

The auxiliary spillway appeared to be in a satisfactory condition. The riprap and approach are sound.

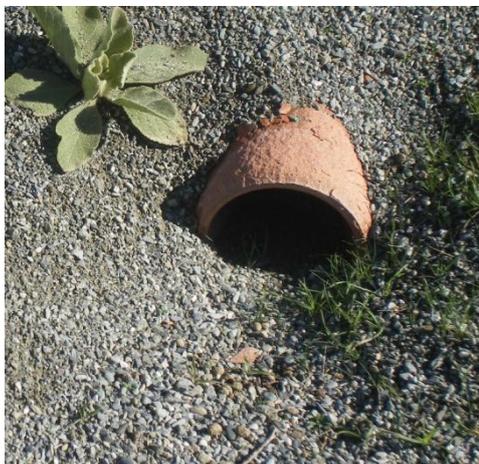
One of the right hand side fuse plug triggering device clay tile pipes is partially blocked (Photo 6.2 below). We suggest that this is cleared and any future blockages removed as they may arise.

Photo 6.2 Partially blocked inlet to clay tile pipe

RCM2011-06: Routine maintenance to ensure that the inlets to the fuse plug triggering device clay pipes are kept clear of debris.

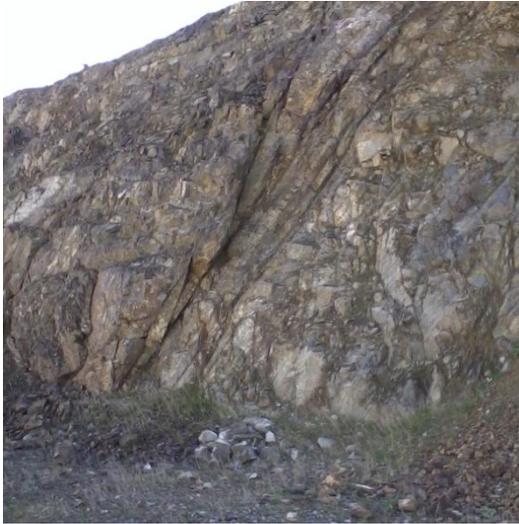
Photo 6.3 Historic wedge failure on true left abutment of auxiliary spillway

The left abutment cut and benches, above the auxiliary spillway, are in good condition. The historical wedge failure downstream of the fuse plug shows no sign of recent movement (Photo 6.3 below). There were no further signs of any significant movement on the slope.

Some minor surficial slipping was observed during this inspection, however this was of a minor nature only. Regular clearing of debris from the cut benches is suggested to avoid prior issues whereby stormwater runoff was concentrating and scouring the fuseplug. No cracking or significant deformation was observed at the top of the cut face.

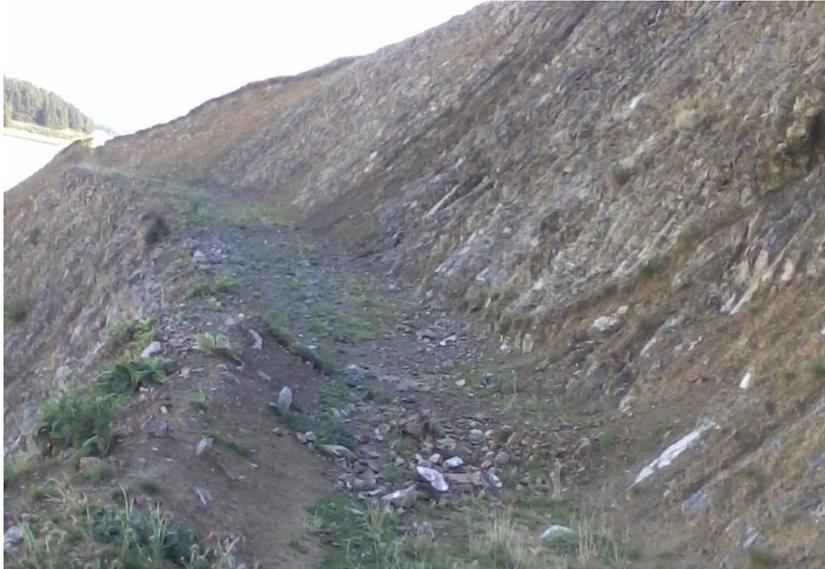
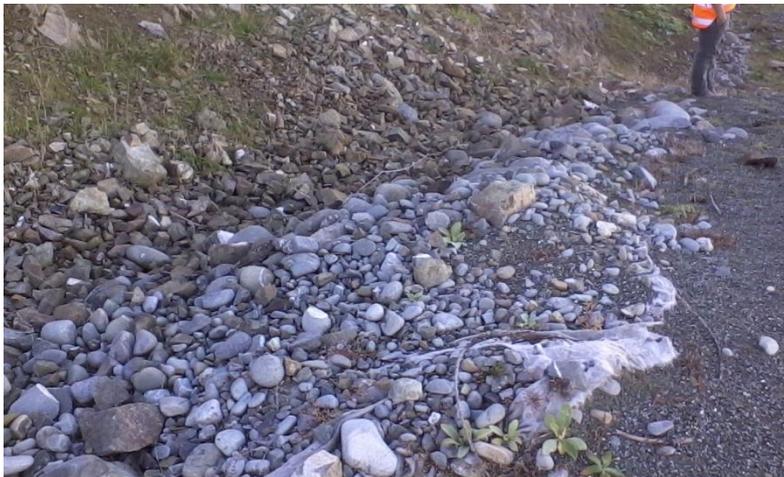
During the previous year works have been undertaken to regrade the cut slope benches (Photo 6.4 below) to divert storm water and prevent concentrated stormwater flows affecting the auxiliary spillway fuse plug (Photo 6.5 below).

Photo 6.4 Regraded cut slope benches

Photo 6.5 Auxiliary fuseplug edge drain

RCM2011-07: Undertake routine maintenance of left abutment cut benches and drains to ensure adequate stormwater control is maintained.

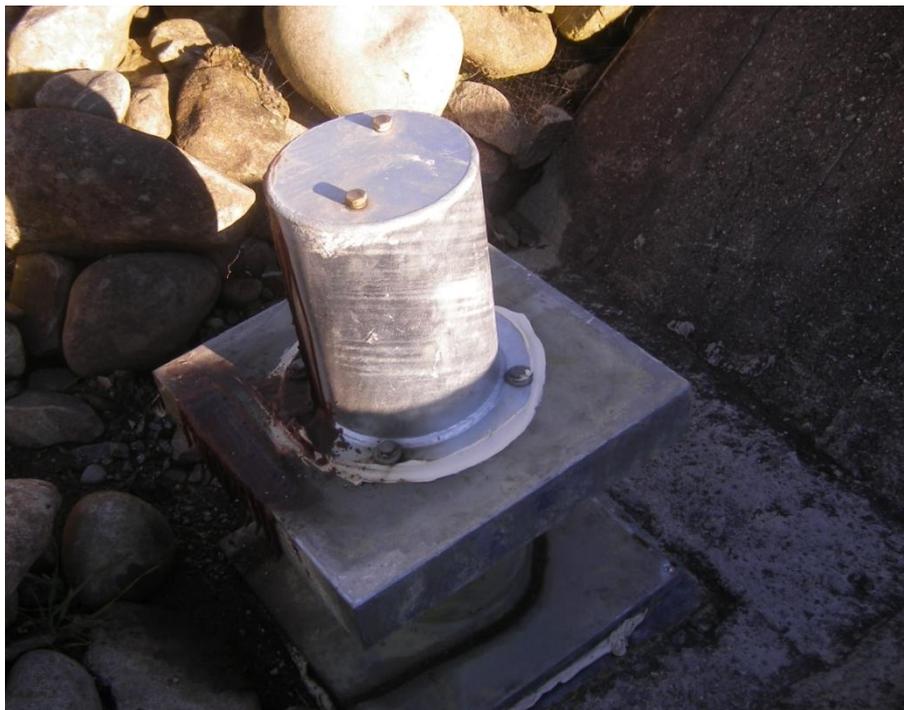
Photo 7.1 Replacement anchor head arrangement

The left hand side conduit anchor block AB2 stressed anchor failed during a proof load test on 24 June 2010. A temporary repair has subsequently been carried out. Preliminary design for a mass concrete overlay has been completed and detailed design of a permanent solution is pending approval by OWL. It is important that this work is completed soon.

We strongly recommend that a permanent AB2 solution is undertaken as soon as possible.

RCM2011-08: Undertake works to install a permanent replacement arrangement for conduit anchor block 2

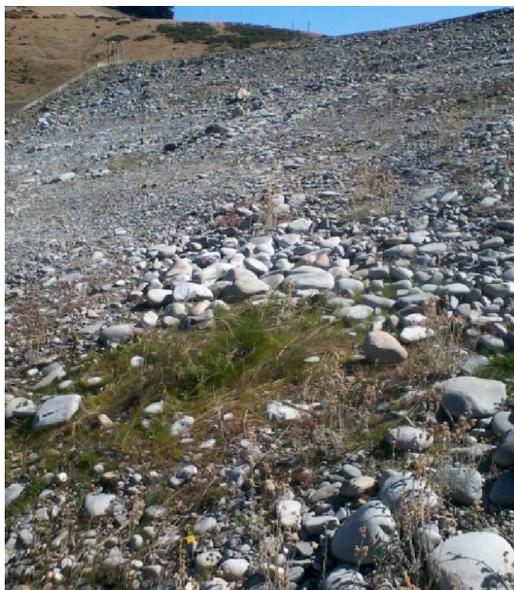
A green wet spot was observed on the DWOE at the time of the inspection (Photo 8.1 below). OWL advised that this patch has been visible throughout summer but has not increased in size. No visible flow was observed at the surface at the time of inspection.

Photo 8.1 Wet patch on downstream face of overflow embankment

Some minor seepage through the structure may be expected based on previous DWOE structures and prior precedent. Based on observations and advice from OWL regarding the stable nature of the wet spot, we do not consider this seepage to require immediate action. However, we suggest that the wet patch is monitored on a regular basis by OWL and T&T be informed if visible flows, discoloured flows or an increase in the wet patch area is observed.

RCM2011-09: Ongoing visual monitoring be undertaken by OWL of wet spot on DSWOE

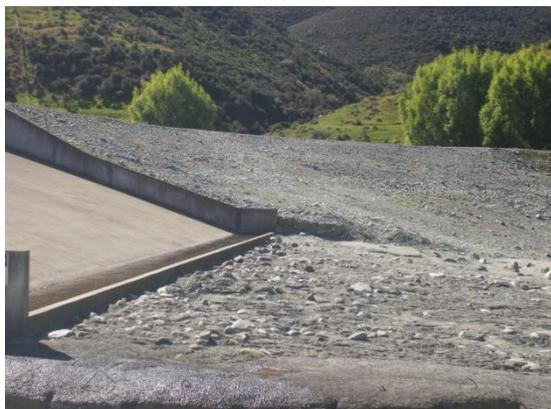
Photo 8.2 Downstream weir overflow embankment

The reinstated fusible section of the left embankment was otherwise in good condition at the time of the inspection (Photo 8.2 below).

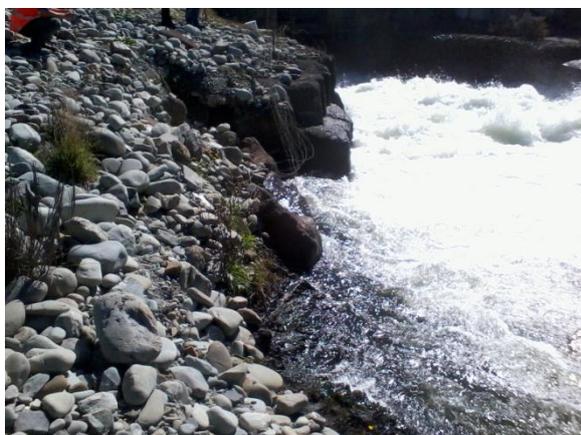
Some minor erosion has occurred to the armour material on the true right training wall downstream of the radial gate (Photo 8.3 below). The damaged area was previously reinstated in 2009 and erosion in this vicinity appears to be an ongoing issue. While this currently does not pose an immediate concern to the stability of the structure, we recommend that armour material in this area be reinstated as soon as practical to reduce the likelihood of further scour.

Photo 8.3 Observed erosion to TR bank downstream of radial gate

RCM2011-10: Repair scour damage to true right training wall for downstream weir radial gate.

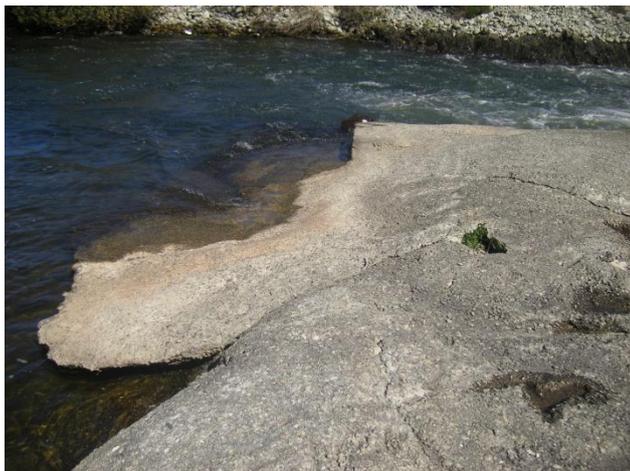
It was previously noted that the mass concrete beyond the end of the chute right hand training wall (beyond the toe of the ogee weir) is at least partially undermined (Photo 8.4 below). Ongoing monitoring of this area by OWL is warranted.

Photo 8.4 Partial undermining of mass concrete and end of left training wall

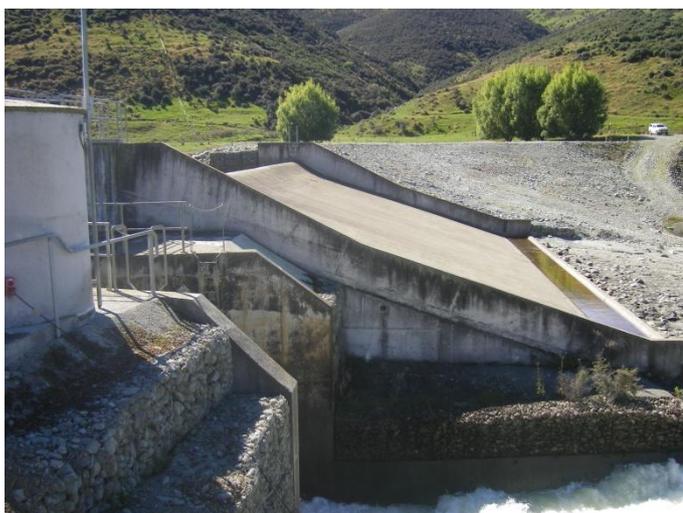
Photo 8.5 Downstream weir and gate structure (downstream face)

The structure was generally in good condition. Photo 8.5 below illustrates the area in the vicinity of the weir and gate structure.

Some accumulation of debris (tree trunk and branches) was noted upstream of the gate structure. This debris requires removal to ensure the radial gate structure is kept clear. OWL advise that the removal of this debris is imminent. We recommend that removal of this debris occurs as soon as practical. We understand that periodic debris removal is undertaken and this should continue. This matter was covered by a previous recommendation in 2008 (RCM2008-37).
