## **Opuha Dam**

### **Annual Safety Inspection 2015**

**Opuha Water Ltd**

**May 2015**

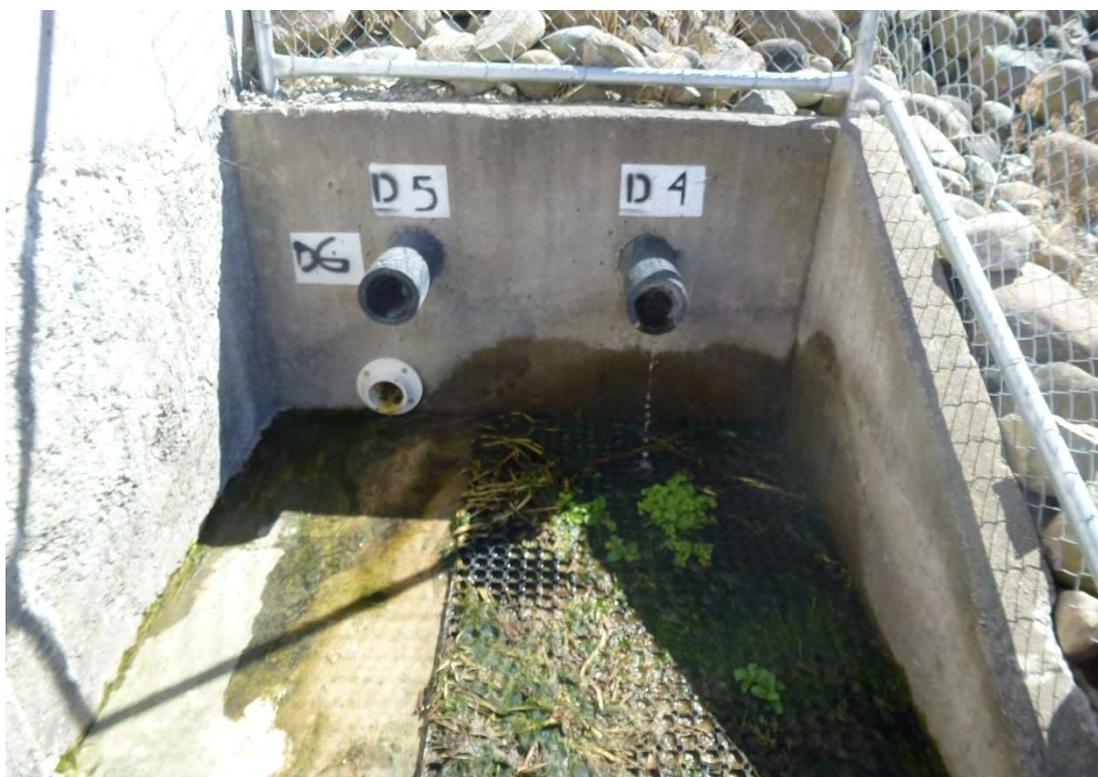
In 2013, OWL redirected the flow from D4, D5 and D6 to the sump adjacent to the switch yard. This is order to keep the site tidy and limit effects that this water may have on potential ground movement in the area. Some minor weed and moss growth was noted in the sump and the safety non slip mat (refer Photo 2-1 below), but otherwise this area appeared in good condition and is easily accessible.

Photo 2-1 D4, D5 & D6 drain outlets

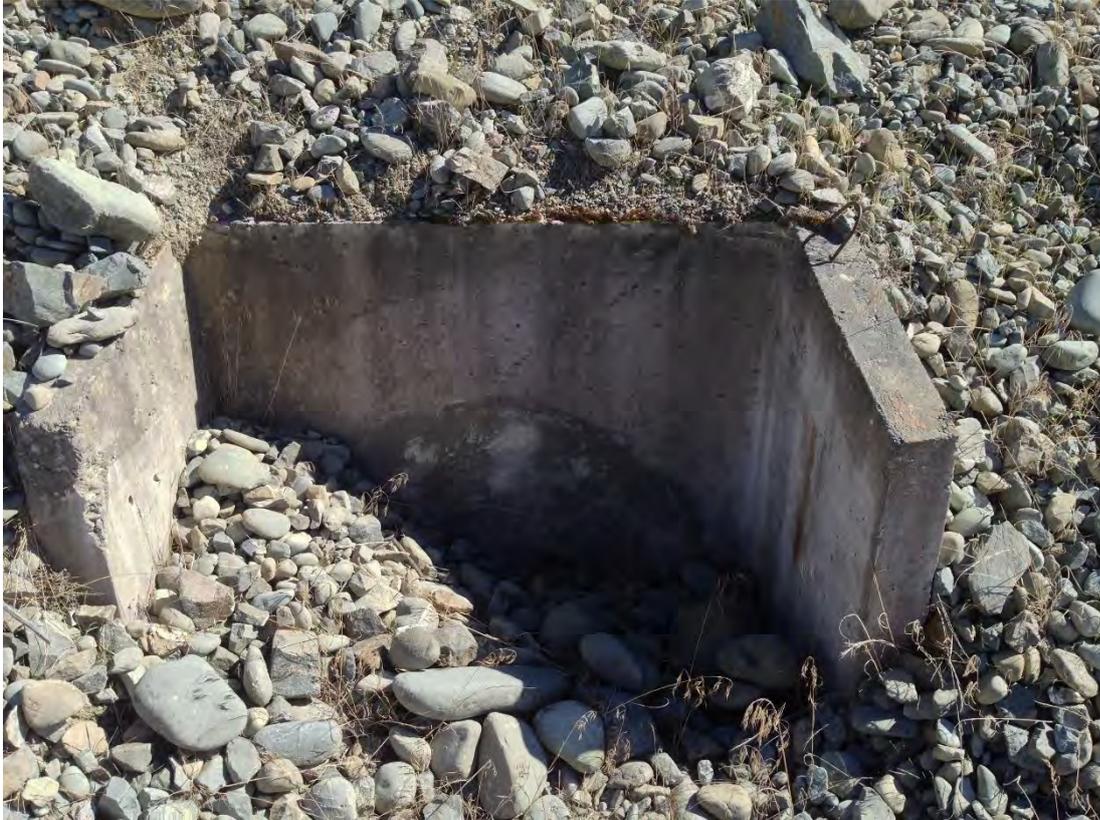
Debris was observed to be blocking the drain D16 outlet (refer Photo 2-2 below) (located beside the access road). It is recommended that this debris be cleared to enable monitoring from this drain (usually dry), and ongoing routine maintenance to all drains continue to ensure drains are kept clear.

*Photo 2-2      Blocked D16 outlet*

*RCM2015-01    Clear blocked drain D16 outlet*

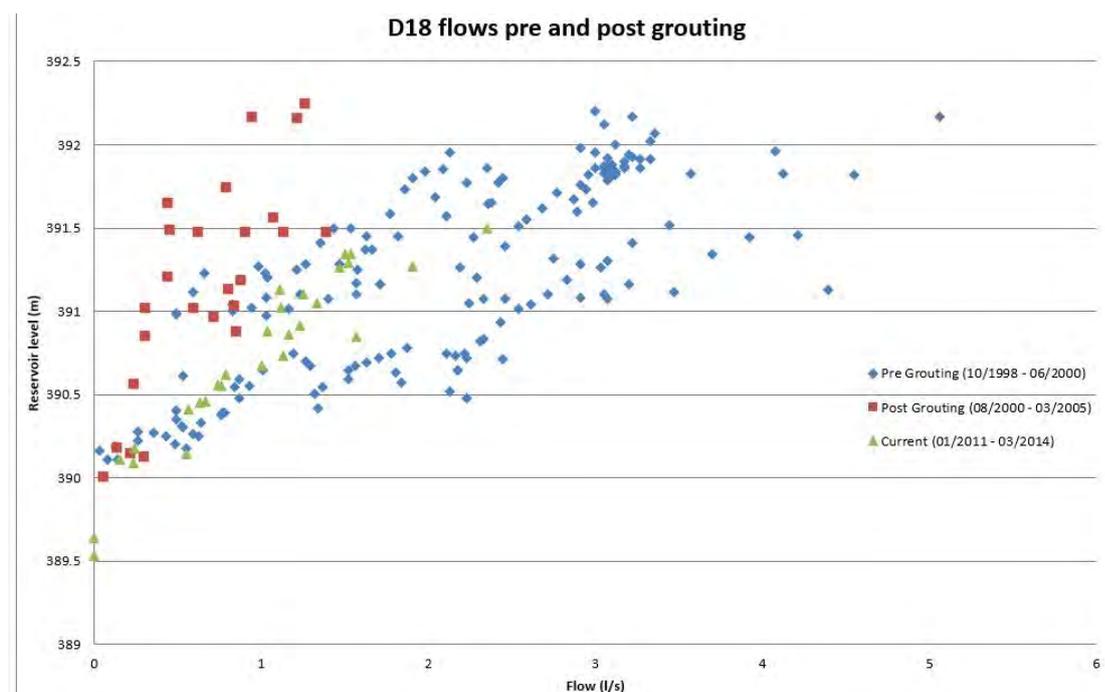
There is a long term trend of increasing flow from this drain since grouting was carried out on the upstream three metres of D18 in July 2000. The results of this can be seen in Figure 2.2 below which shows the flows produced pre-grouting, post-grouting and current flows from the drain.

It is important that close attention is given this area in order to better understand long term trend associated with seepage in the vicinity of D18.

Figure 2.2 Drain D18 flows, pre and post grouting (as per 2014 annual report)

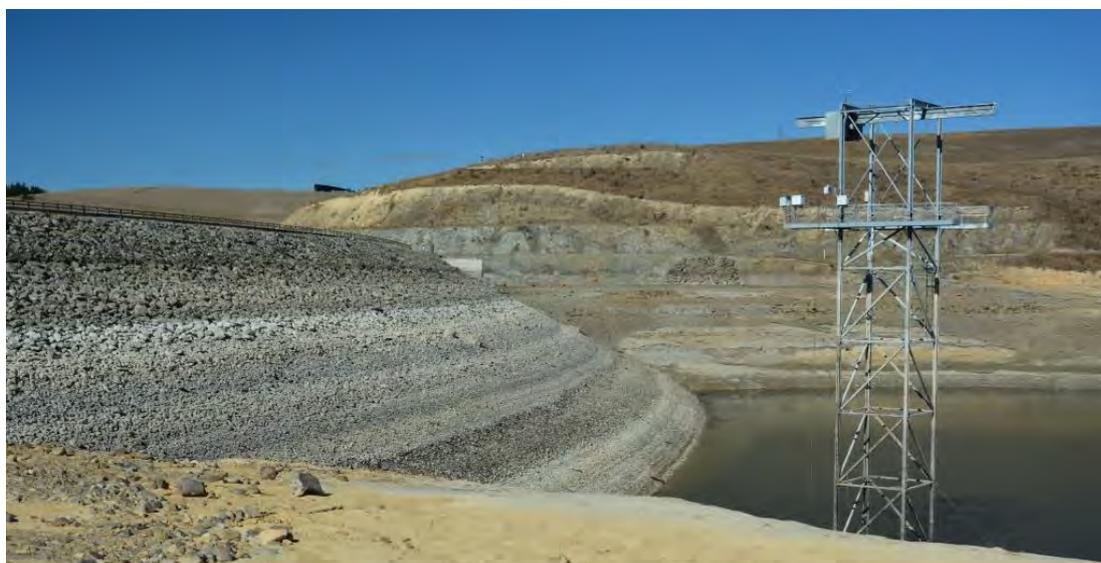
The upstream slope and riprap appeared to be in satisfactory condition to the extent visible above the 371.0 m RL reservoir water level.

*Photo 3-1 Upstream face at 27 Feb 2015 (from true left abutment)*

Substantial accumulation of debris (i.e. tree branches and timber) was visible on the face. Periodic debris removal is undertaken and this should continue.

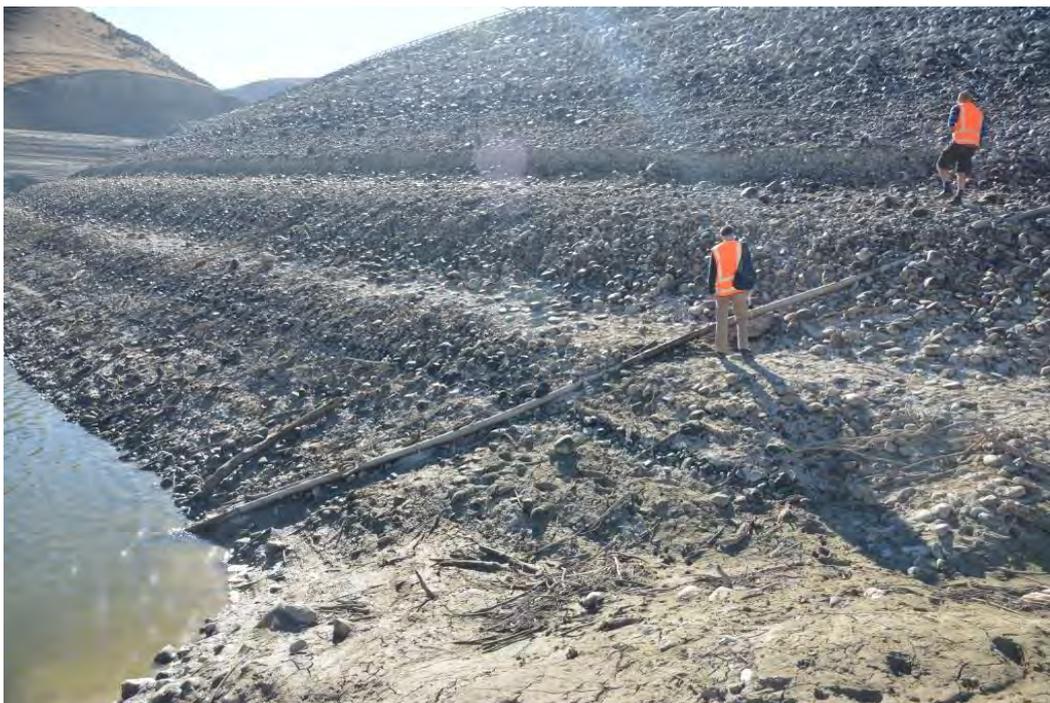
The very low water level exposed a well defined bench on the upstream face at around 374 m RL. This level correlates well with the observed deformation marker M3 just above the bench level. The other upstream face deformation markers (M1 & M2) were not visible during the inspection.

*Photo 3-2 Upstream face at elver pass outlet showing established benches*

It is recommended that the elevation of this bench be confirmed, in addition to survey of the upstream survey deformation markers, as part of the scheduled 2015 deformation survey.

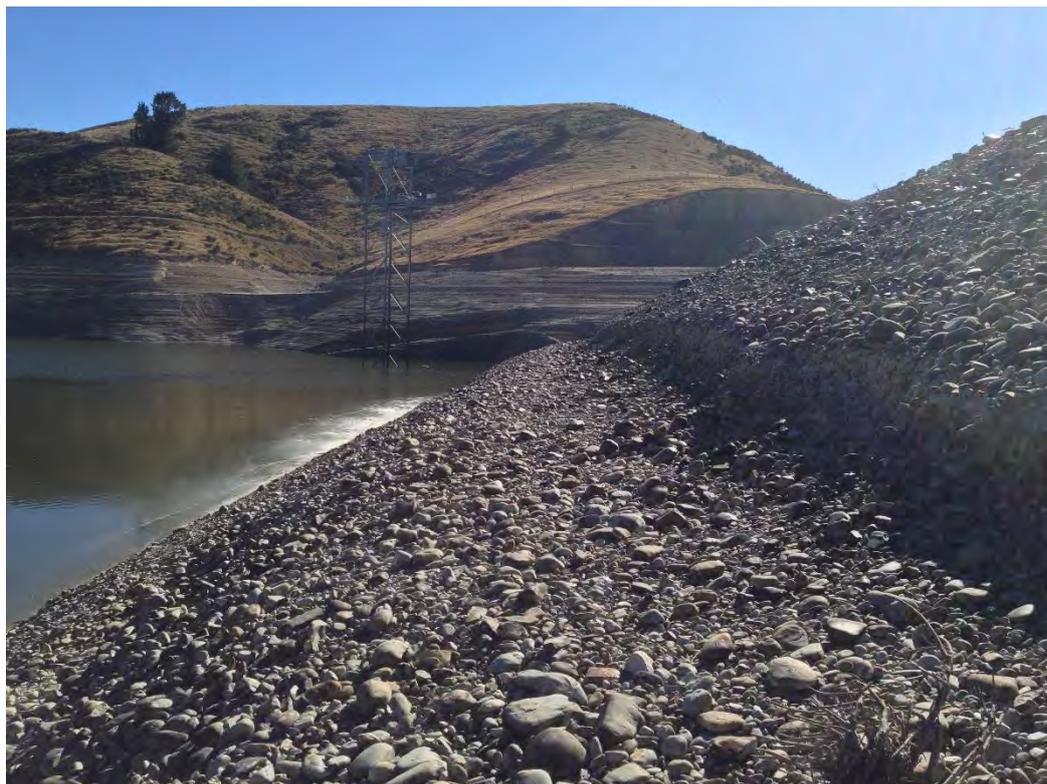
*Photo 3-3 Bench on upstream face around 374 m RL.*

Some erosion and benching of this material was anticipated in the design and a suitably thick layer was construction to accommodate this. The risk presented by significant wave erosion at this location was considered during the design phase to be mitigated, given that the normal operating range of the reservoir is above this zone and the coincident probability of sustained high design winds with a water level in this zone is low.

*RCM2015-04 OWL to monitor exposed upstream bench at around 374 m RL and exposed upstream face when the reservoir level is around 375 m RL and report to Dam Safety Consultant if ongoing erosion to the armour layer is observed.*

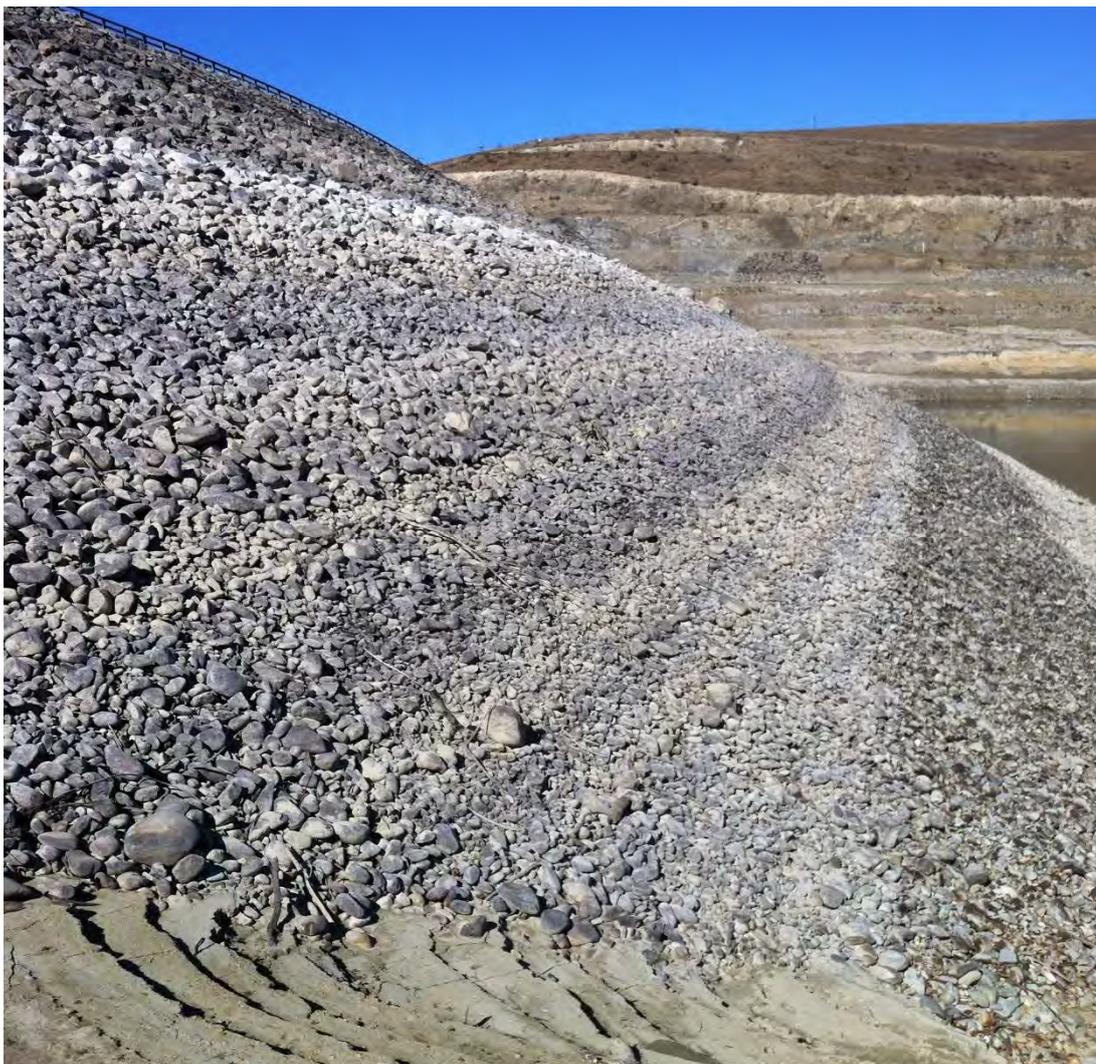
Another area of interest was noted in previous annual inspection reports on the embankment upstream face near the intake tower, where the riprap surface appeared to be slightly concave (area located in the vicinity of steel reinforcing protruding from reinforced concrete demolition material reused as riprap). However there is no other evidence of any significant movement, and this area appears stable based on observations to date (refer Photo 3-4 below).

*Photo 3-4 Upstream face opposite the tower where riprap surface was previously reported as appearing concave.*

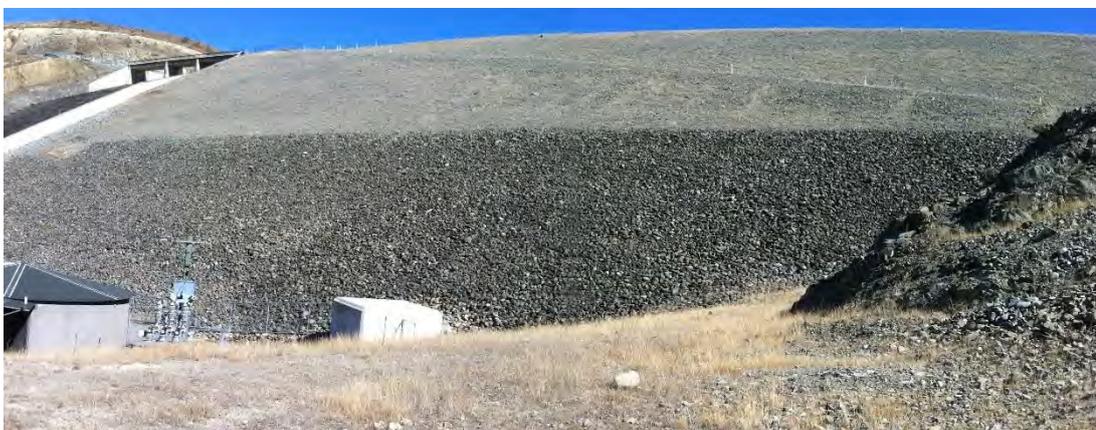
The downstream face appears to be in good condition (refer Photo 3-5 below). Periodic spraying should continue to control weeds.

*Photo 3-5 Downstream face (from true left abutment)*

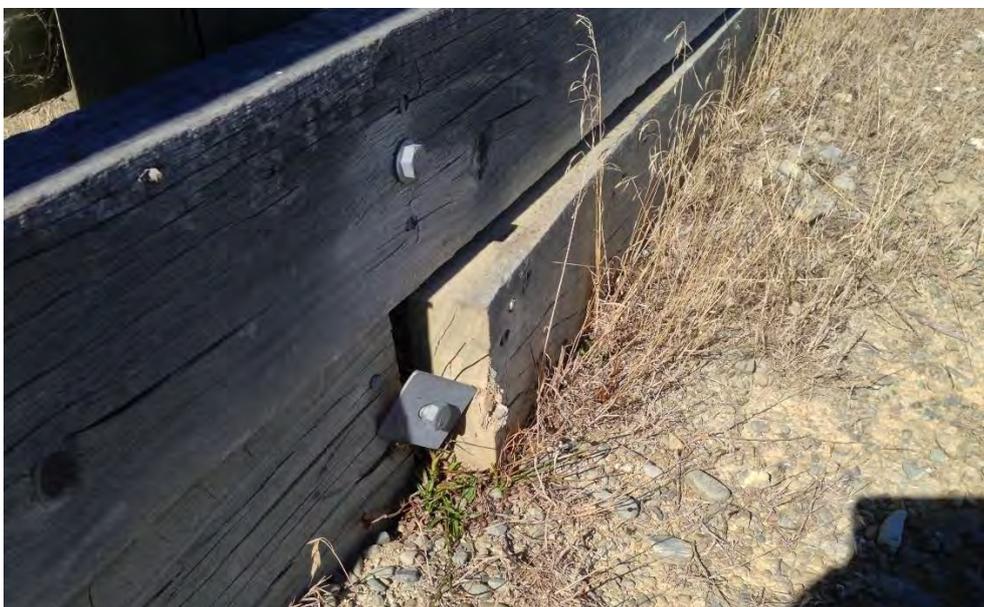
*Photo 3-7 Observed minor deterioration of wave splash barrier*

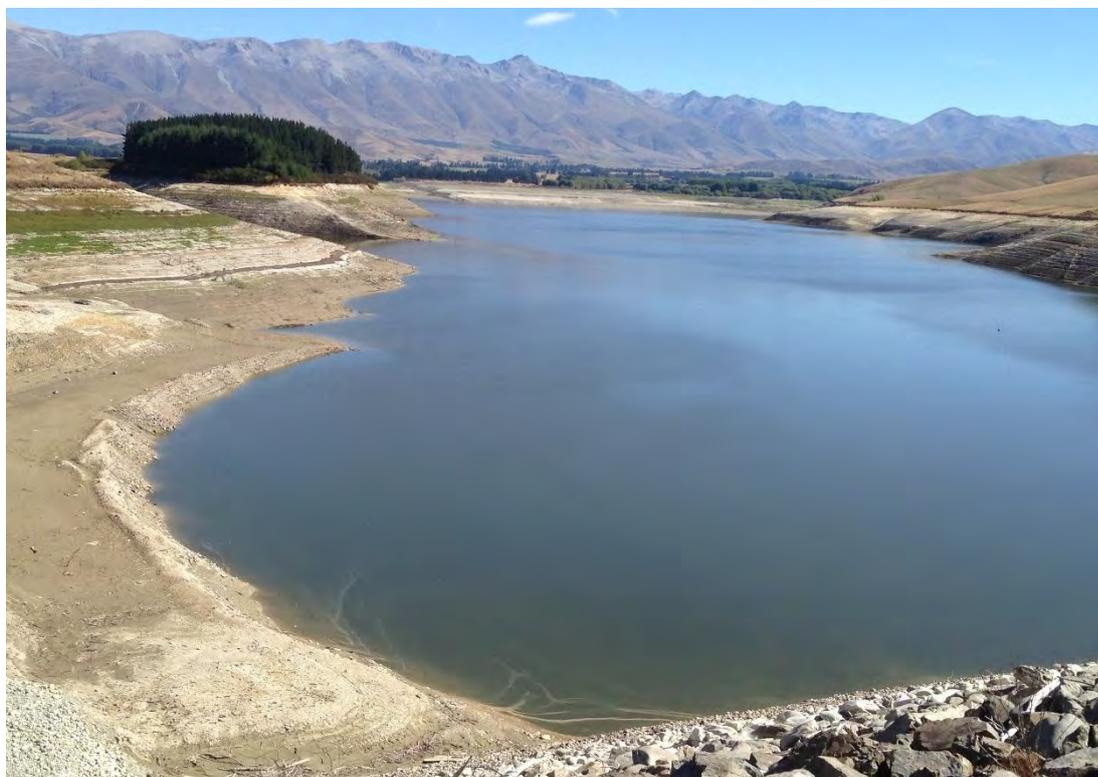
As noted above, the reservoir level was very low at around 371 m RL at the time of the inspection, and as such a significant height of the reservoir margins was visible (refer Photo 4-1 below).

*Photo 4-1 Observed reservoir margins from the dam crest.*

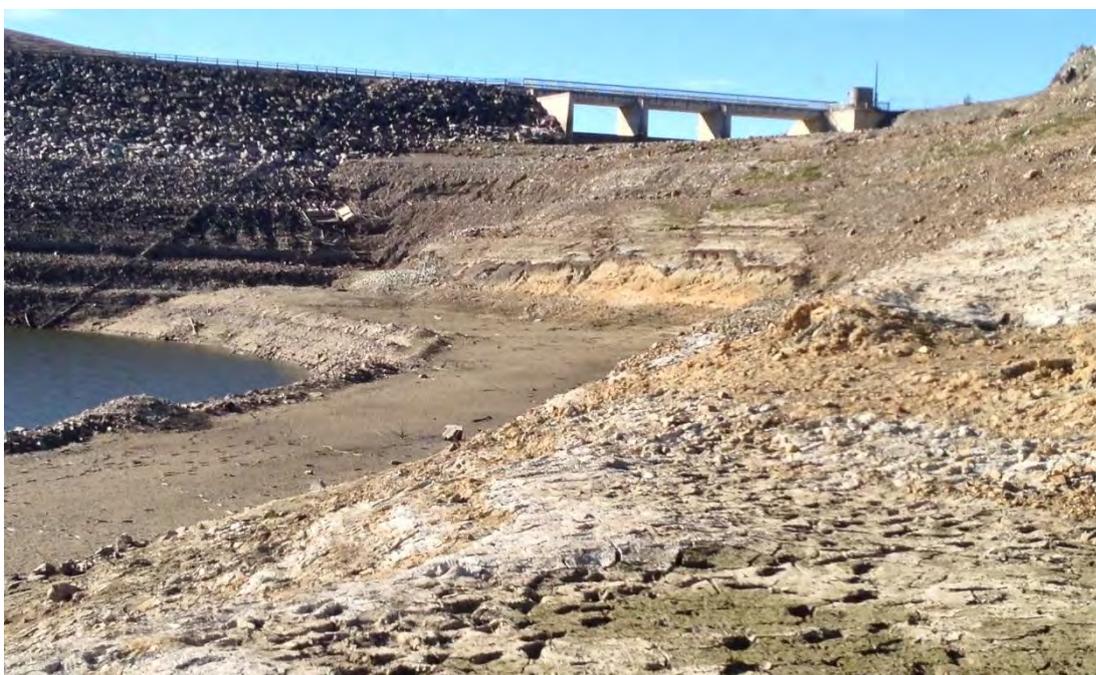
The approach to the service spillway was visible at the time of the inspection due to the very low reservoir level. The approach had moderate debris present, primarily drift wood. The approach was observed to be in good condition (refer to Photos 5-1 & 2 below).

*Photo 5-1 Exposed approach service spillway*

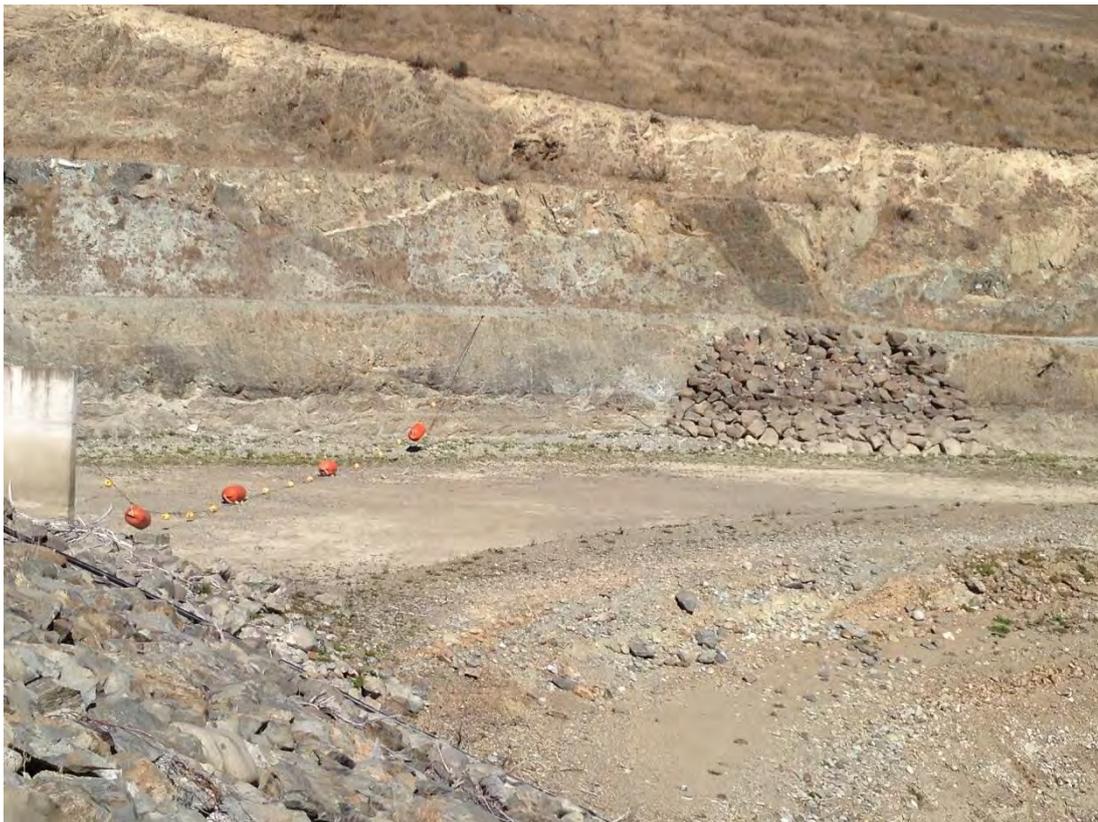
The repair to the slip failure that occurred to the right hand side of the approach channel/road cutting northwest of the service spillway (between the bridge and the boat ramp) remains effective and in good condition (refer Photo 5-2 below).

*Photo 5-2 True right bank of approach channel to service spillway*

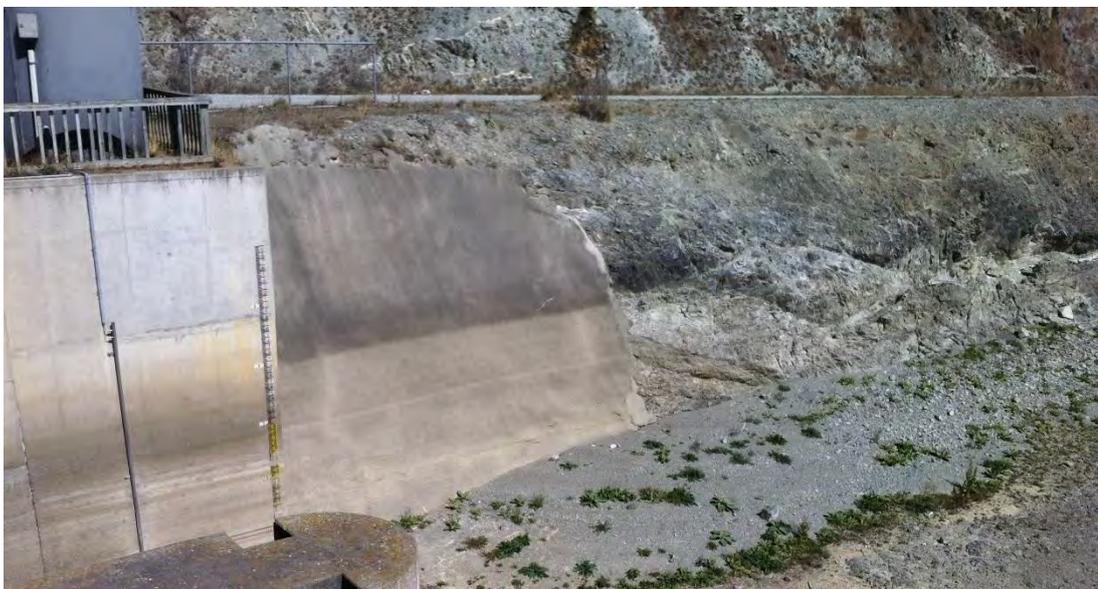
No sign of failure of the shotcrete coating repair over the rock on the right hand side of the spillway inlet approach was observed during the inspection.

*Photo 5-3 Shotcrete repair area (TR bank of inlet)*

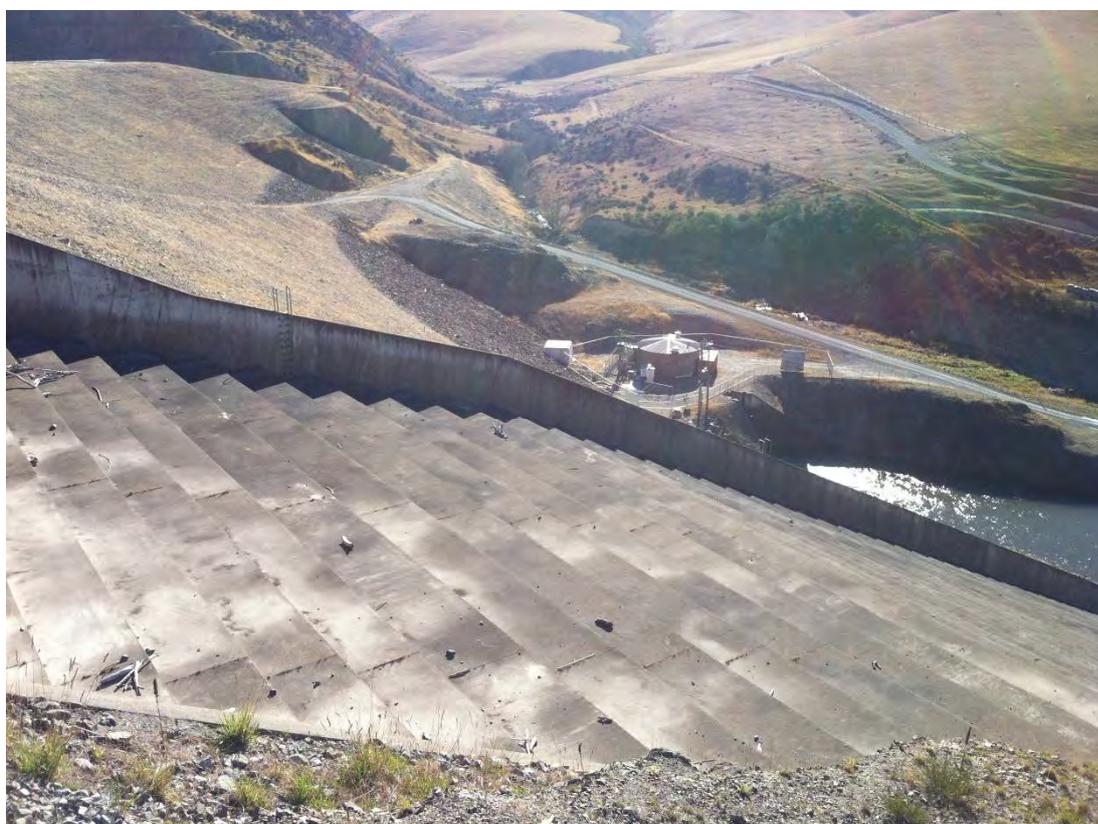
The spillway steps appeared to be in satisfactory condition. A few medium sized rocks were noted on the spillway, but there was no visible damage of major significance at this time to the step edges (refer Photo 5-4 below).

Photo 5-4 Service spillway

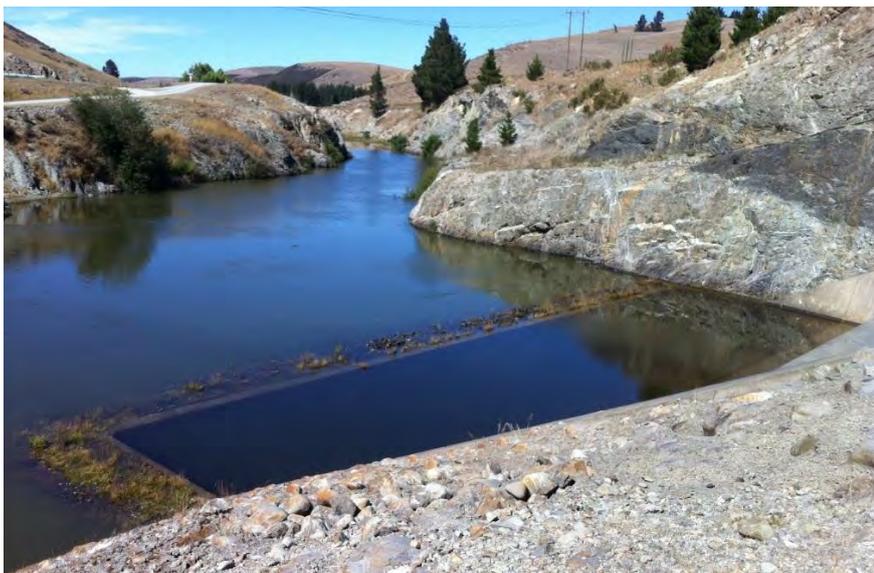
*Photo 5-5 Tailrace and spillway stilling basin*

Previous Annual Reports have recommended monitoring of this area and it is important that this continue. At some point, it will be necessary to drain the stilling basin to inspect the structure and remove accumulated rock.

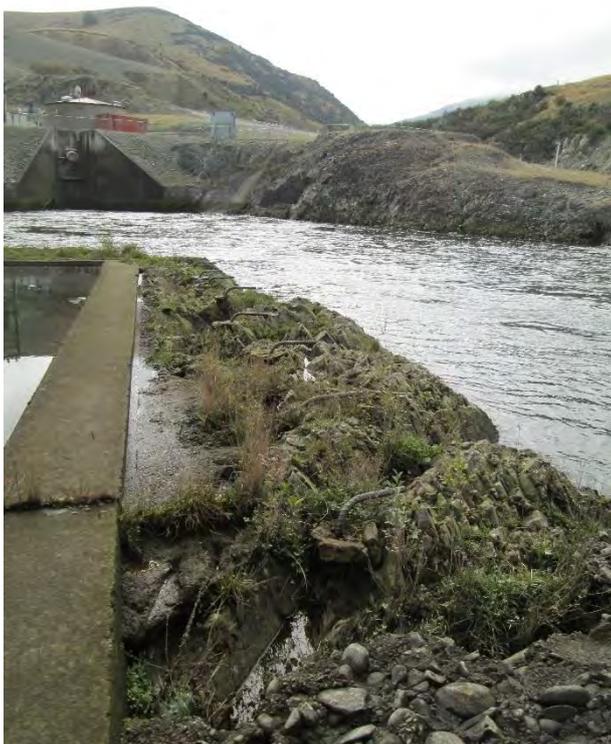
*Photo 5-6 Damaged Sill of Stilling Basin (taken in 2014 as underwater at time of 2015 inspection)*

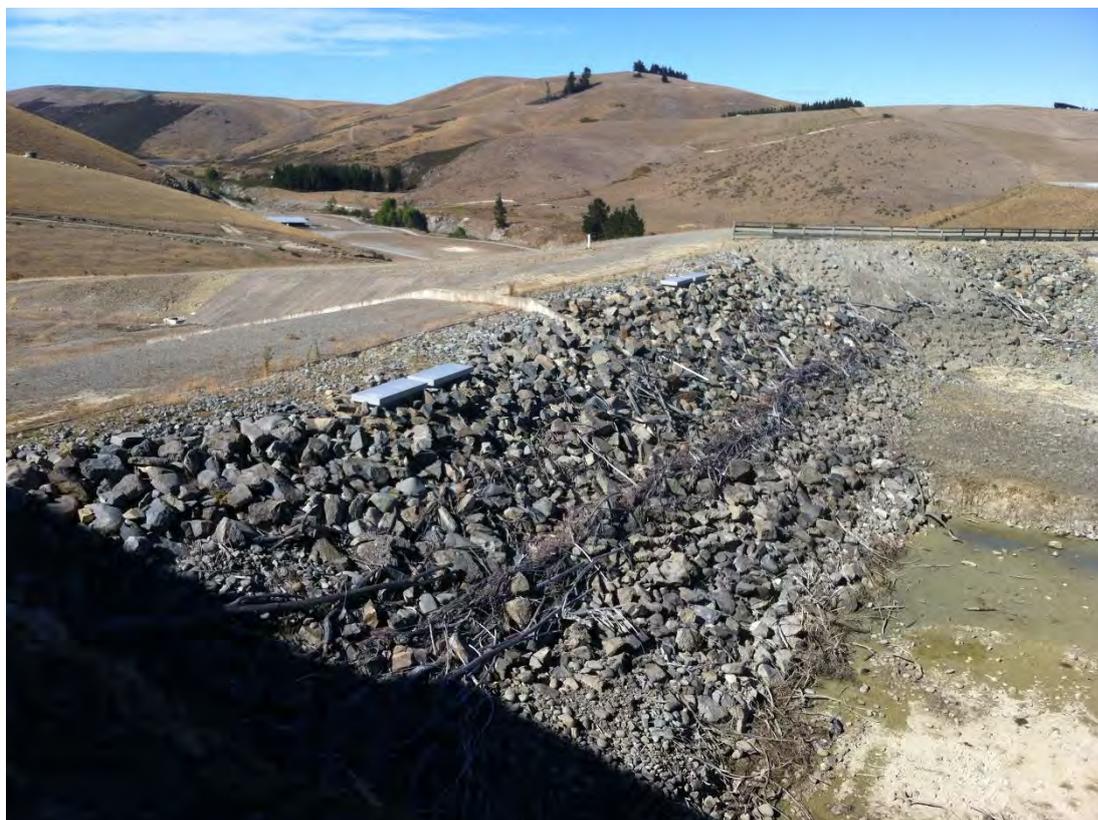
The auxiliary spillway appeared to be in good condition. The riprap on the upstream face and approach channel were in good condition (refer Photo 6-1 below). Routine spraying should continue in order to prevent establishment of vegetation on the fuse plug fill, particularly in the vicinity of the triggering device outlets.

*Photo 6-1 Auxiliary spillway upstream face (from true left abutment)*

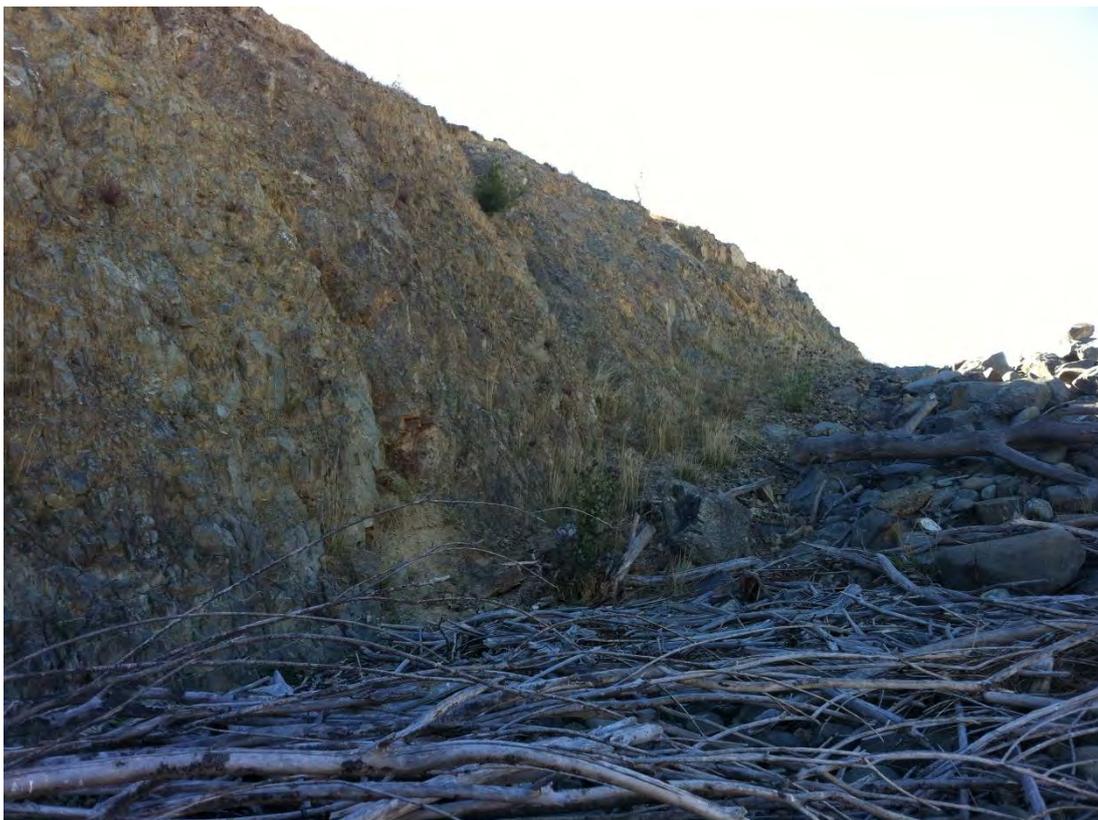
The left abutment cut benches, above the auxiliary spillway, are in satisfactory condition. The historical wedge failure downstream of the fuse plug shows no sign of recent movement. There were no further signs of significant movement on the slope or of fuse plug erosion from concentrated stormwater runoff down the cutting.

*Photo 6-2 Left abutment cut slope*

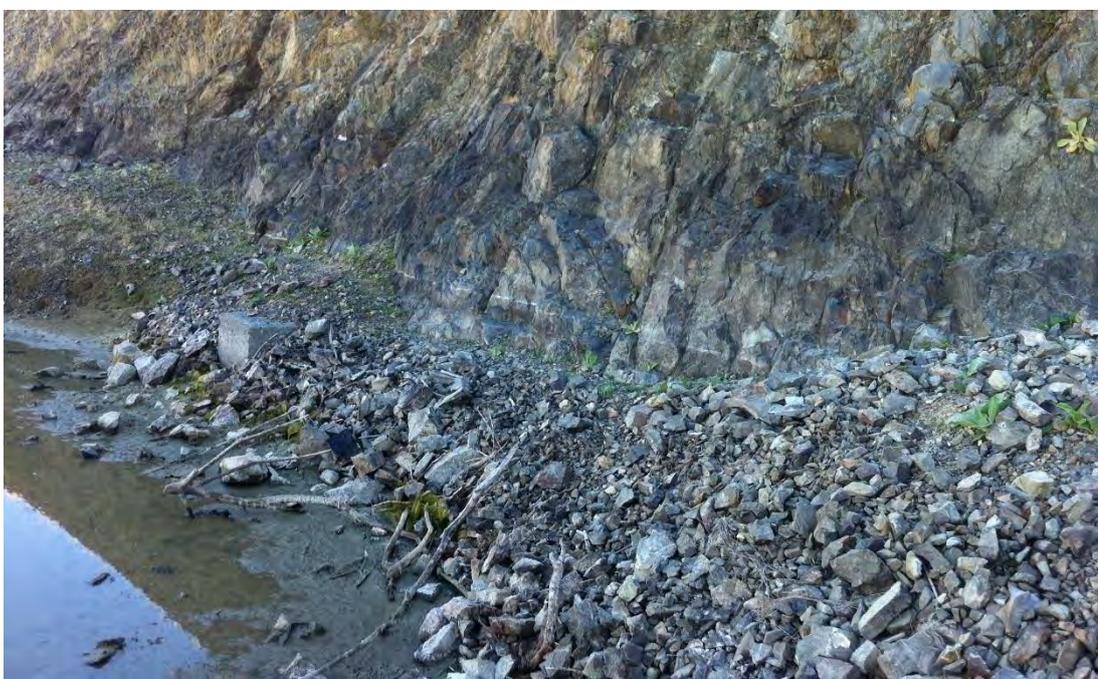
A survey benchmark was exposed at the toe of the true left abutment by the auxiliary spillway cut (refer Photo 6-3 below), due the very low reservoir level.

*Photo 6-3 Left abutment survey marker*

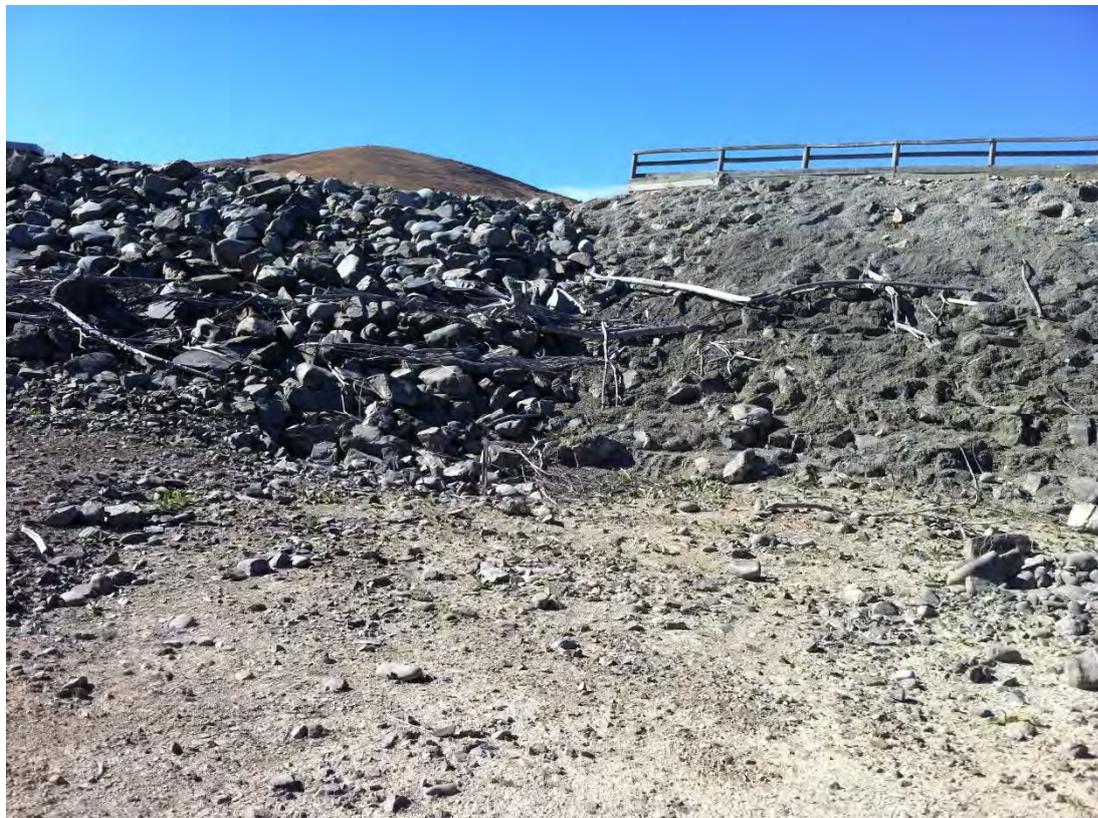
*Photo 6-4*

Observations over the current review period and measurements of D18 drain flows are consistent with historic observations, noting that D18 was dry from November 2014 onwards due to the low reservoir levels.

*Area of interest on the upstream face of the auxiliary spillway*

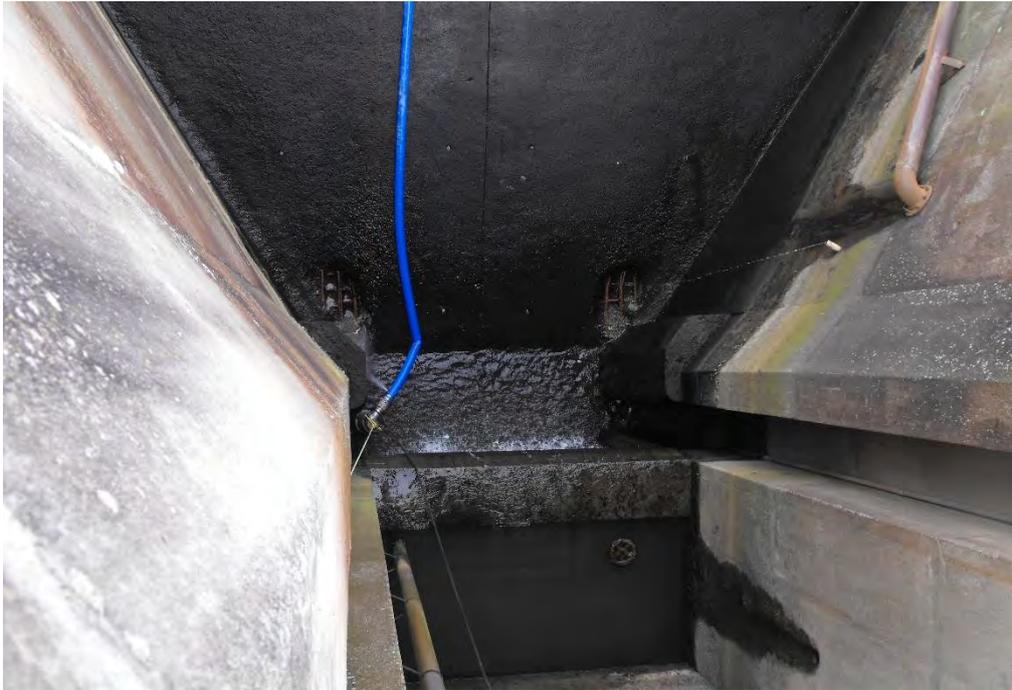
Photo 7-1 Tailbay dewatering and condition assessment (looking down) showing exposed rebar on invert at transition (Provided by Trustpower).

RCM2015-06 Investigate options and undertake repair to damaged draft tube outlet concrete.

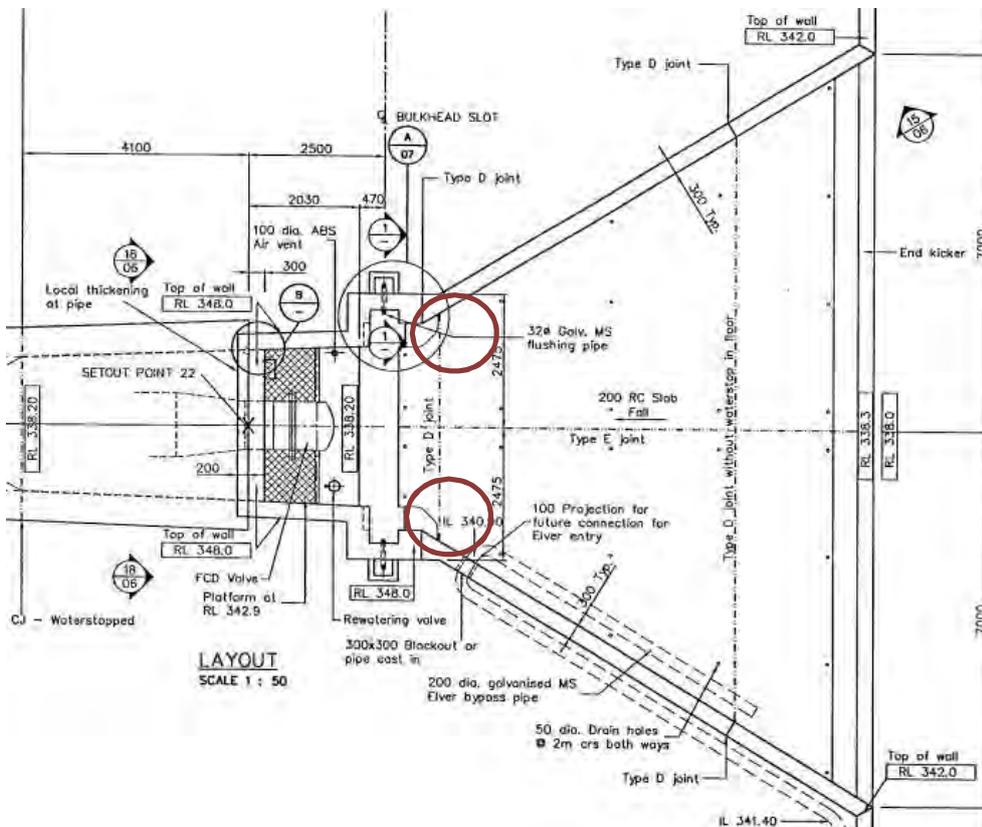
Figure 7-1 Excerpt from As-built Drawing 13897-5-S05 showing draft tube outlet and tailbay areas of observed damage (circled in red)

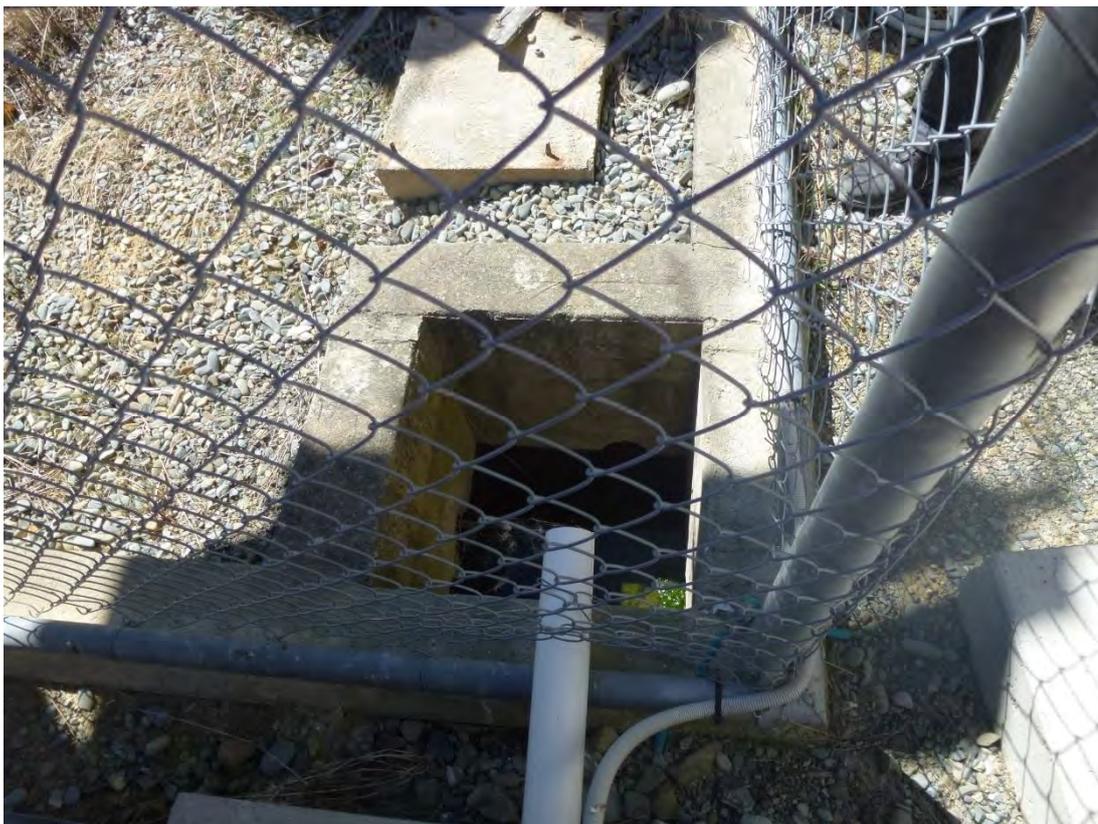
The conduit outlet drain pipe is now feeding into a sump that also serves the subsoil drainage system in the switchyard (refer Photo 7-2 below). This additional water is creating a surcharge on the subsoil drainage system which should be monitored to ensure it does not affect the performance of the subsoil drainage system and stability of loess fill in this vicinity.

*Photo 7-2 Conduit outlet drain discharge*

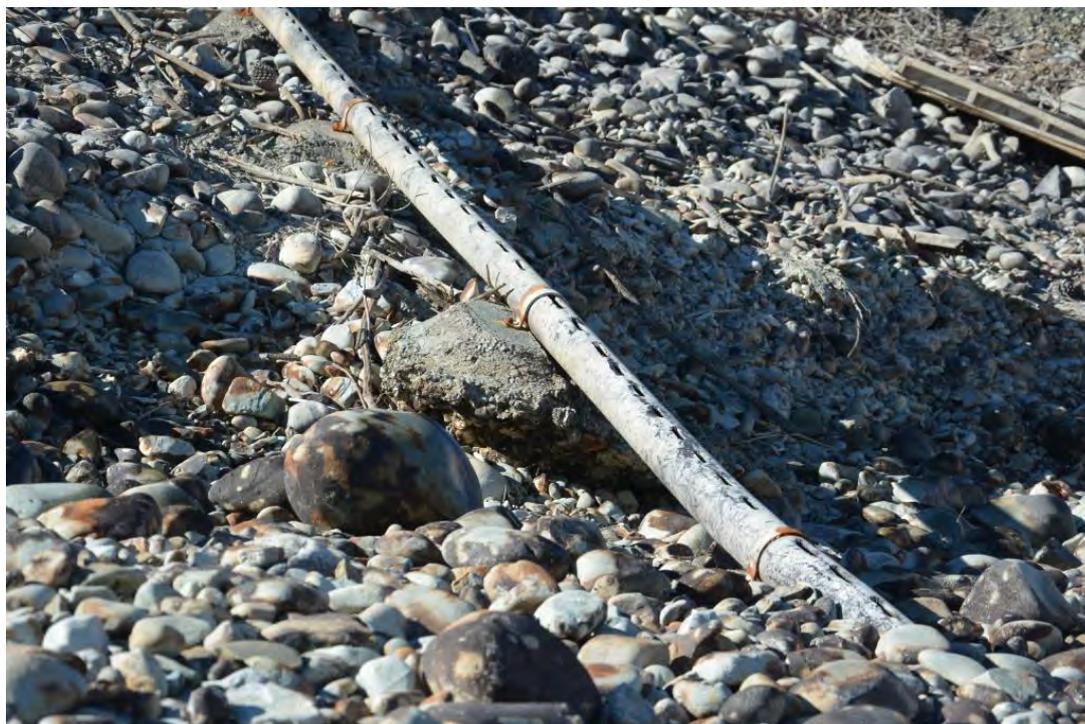
The elver pass outlet pipe line was exposed on the upstream face of the dam (refer Photo 7-3 below). Some minor blockage was noted and cleaned by OWL during the inspection but otherwise the pipeline appeared to be in operable condition.

*Photo 7-3 Exposed elver pass outlet pipe on upstream face of dam*

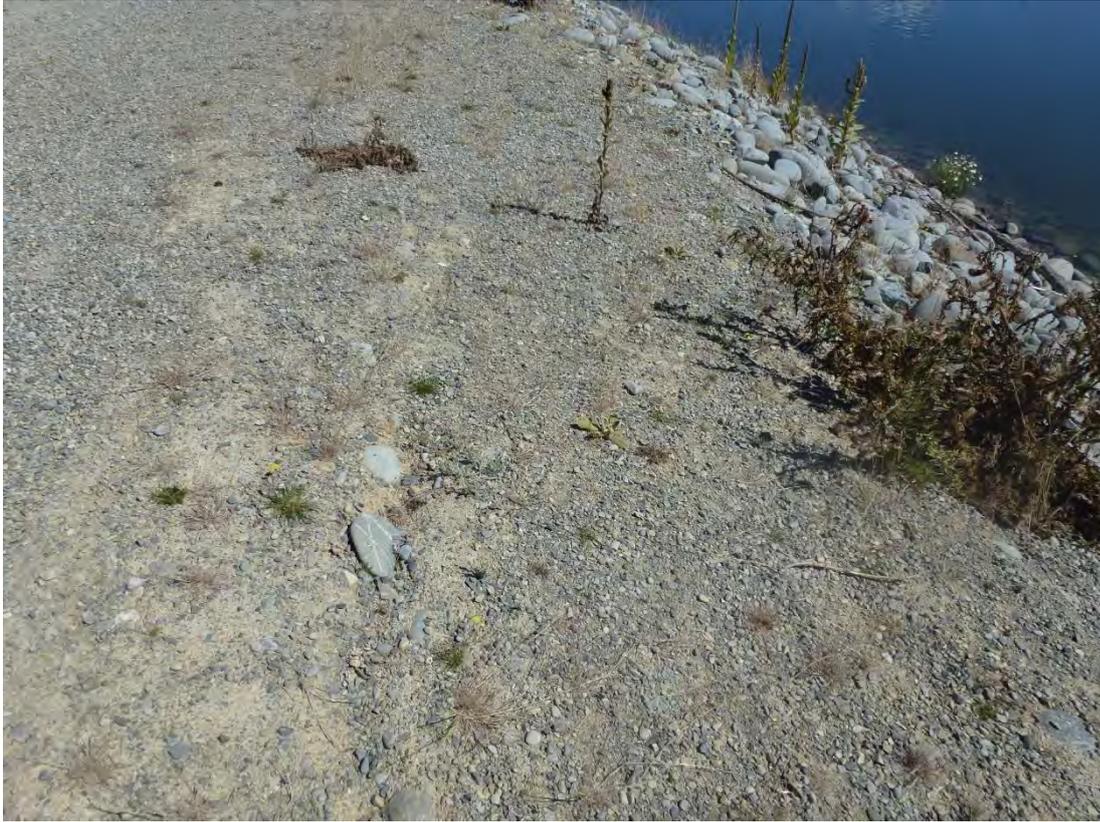
Photo 8-3

*Crack in crest close to recent embankment repair (2015)*

It is anticipated that the life of the overflow embankment will now increase (due to proposed downstream weir enhancement works) and thus it is suggested that OWL review the strategy to manage the overflow embankment. Options range from visual surveillance and regular monitoring and review whilst accepting some minor leakage to a major rebuild featuring filters between the upstream liner and gravel bulk fill.

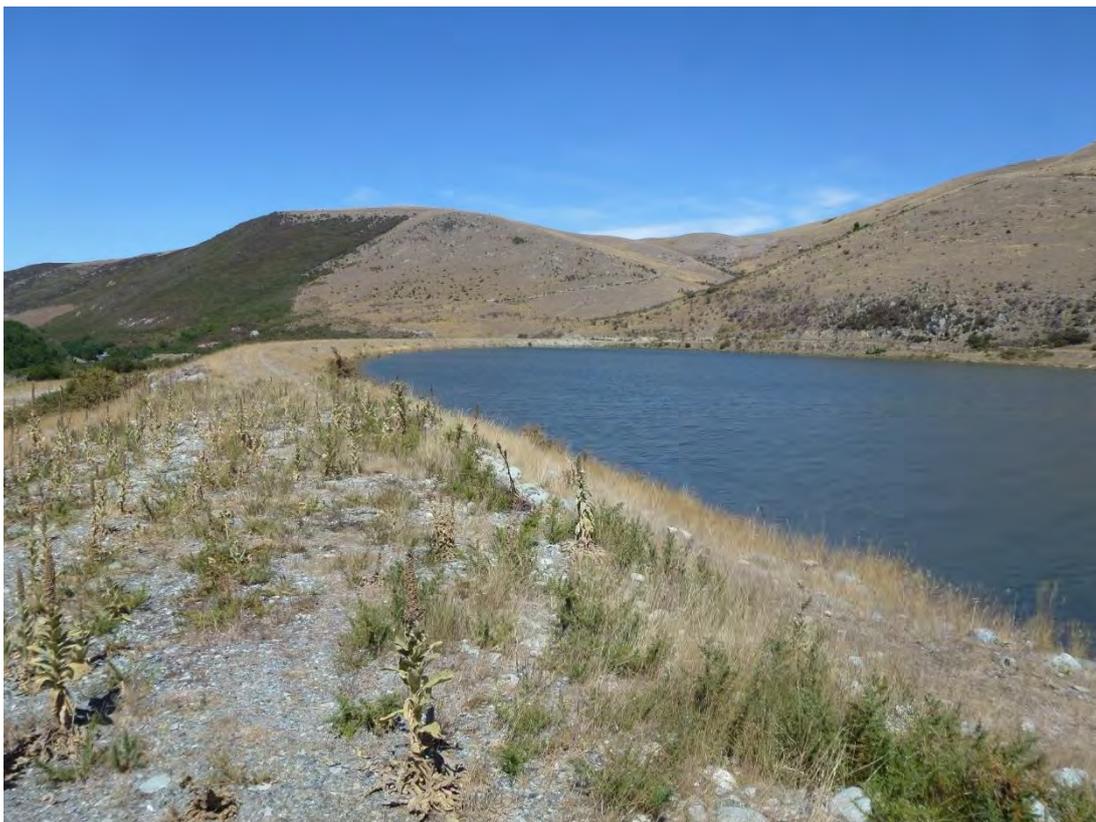
The enclosure embankment appears to be generally in good condition with the exception of presence of weeds in the area immediately adjacent the radial gate structure (see Photo 8-4 below). Weed growth in this area was advised to be likely due to the new fill added in this location to top up the embankment crest level following the recent survey. Spraying of these weeds is recommended (as per ongoing maintenance requirements).

*Photo 8-4 Area of weed growth on downstream weir enclosure embankment for spraying*

*RCM2015-07 Spray weeds on downstream weir embankment.*
