## **Opuha Dam**

### **Annual Safety Inspection 2015**

**Opuha Water Ltd**

**May 2015**

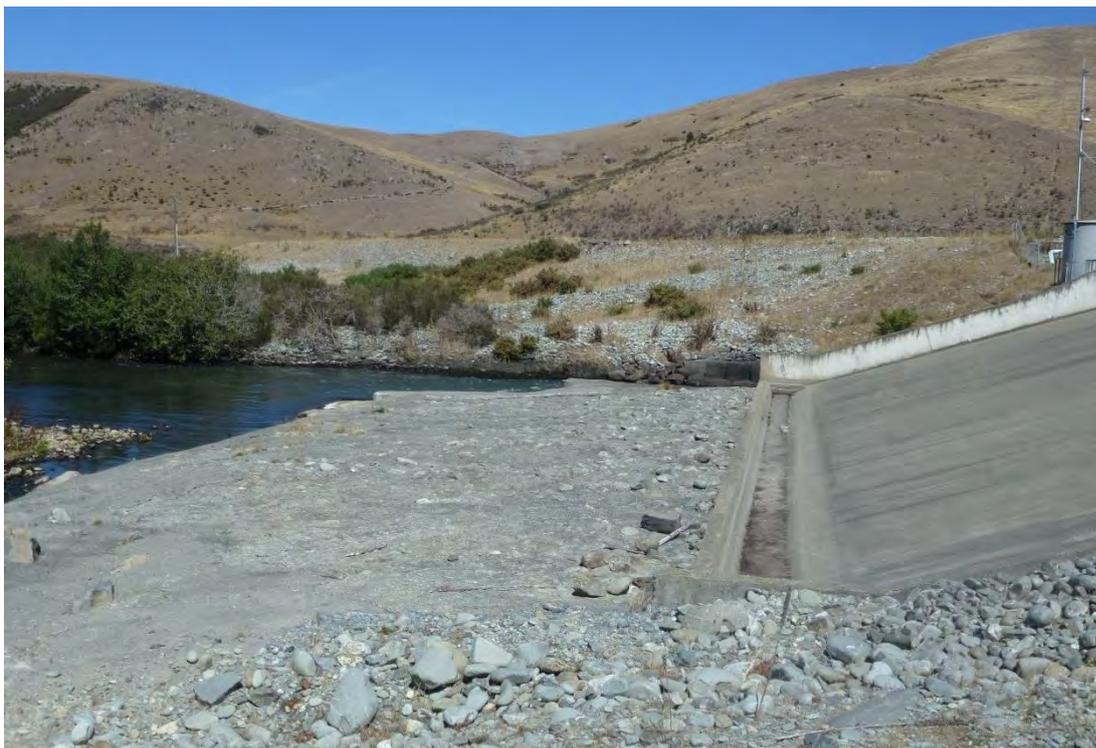
The concrete weir spillway is in a satisfactory condition (refer Photo 8-5 below). Small horizontal cracks and superficial spalls noted in previous inspection reports do not appear to have significantly changed in the last year.

*Photo 8-5 Service spillway*

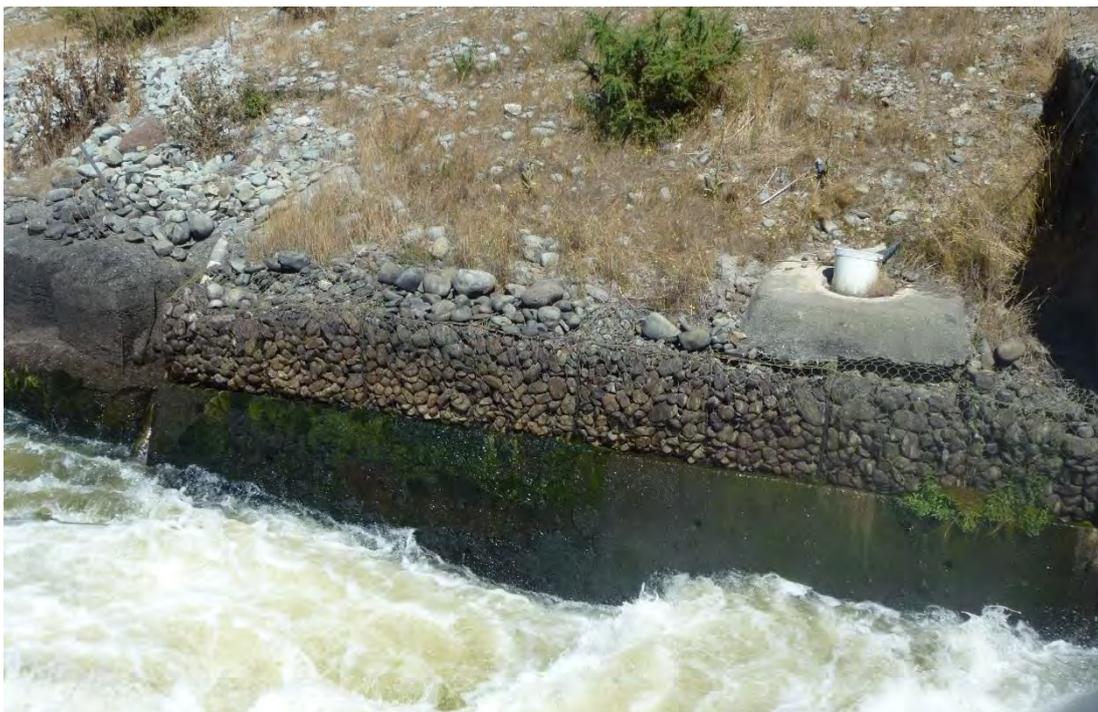
The concrete and stone armouring on both banks is generally in satisfactory condition (refer Photo 8-6 below). It has been previously noted that the mass concrete beyond the end of the chute right hand training wall (beyond the toe of the ogee weir) is at least partially undermined. This has not changed significantly since 2010 but ongoing monitoring of this area by OWL is warranted.

*Photo 8-6 True right bank of radial gate channel*

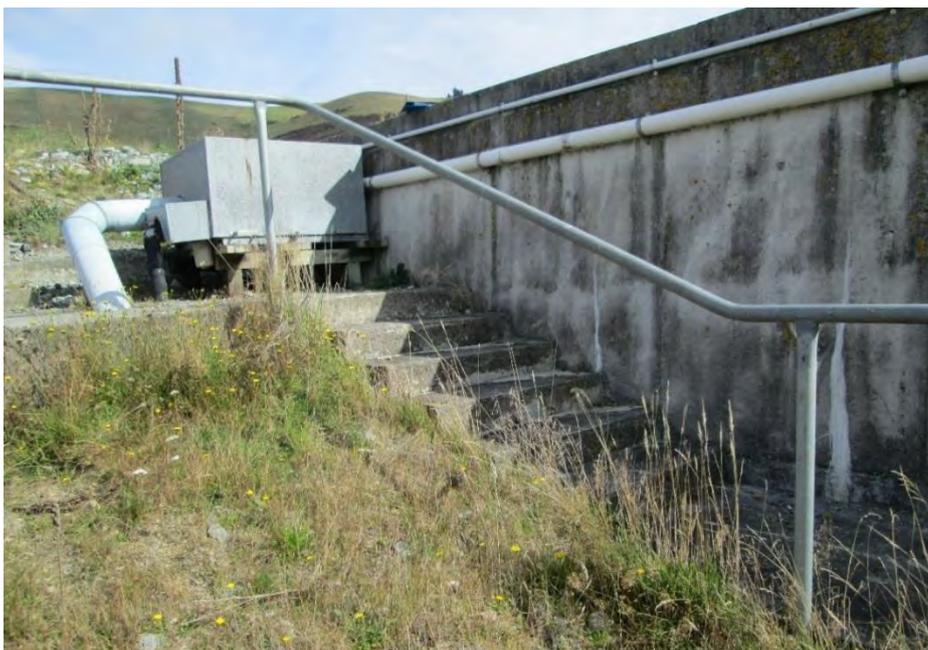
Some of the handrails around the control structure (refer Photo 8-7 below) may not comply with current requirements according to Building Code Clause F/4 which requires that, in areas used exclusively for maintenance where someone can fall more than 1 m, vertical gaps between longitudinal bars must not exceed 460mm. We suggest investigating whether these handrails require upgrading.

*Photo 8-7 Current handrail configuration*
