Quarterly Water Quality Report

January 2023 to March 2023

Introduction to Opuha Water's Quarterly Water Quality Report

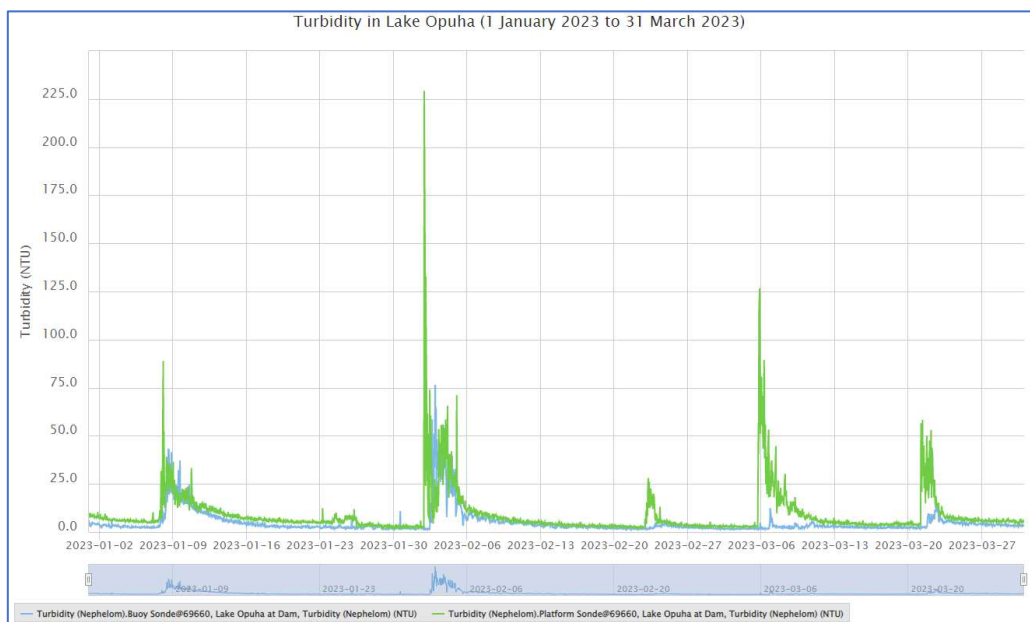
Turbidity increases in the lake at the surface (—) and at depth (—) during rain events. The greatest increase in turbidity (decrease in water clarity) occurs at depth, most likely due to inflows travelling along the bottom of the lake and not mixing with the water at the top of the lake. The increased turbidity in the lake has implications for the supply of water to the Kakahu Irrigation Scheme as high turbidity water (low water clarity) flows from the lake into the Opuha River.

Figure 1: Turbidity in Lake Opuha at surface (—) and depth (—) from 1 January 2023 to 31 March 2023.

OWL is currently working with NIWA, research scientists from the University of Canterbury and environmental consultants to develop a workplan to better understand the source of sediment coming into Lake Opuha, and also what happens to the sediment once it enters the lake (*i.e.*, Where does it deposit? How long does it take for sediment to settle? Is sediment remobilised within the lake during increased inflows?). It is anticipated that this work will give OWL a better understanding of sediment dynamics within the lake and what factors can be controlled to improve water clarity.

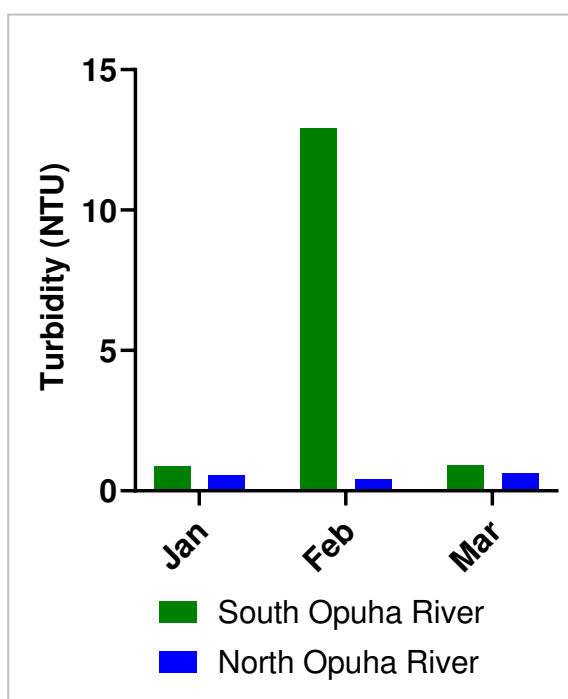
Figure 3 shows the turbidity in the South and North Opuha Rivers measured during January, February and March 2023. Sampling is done one day per month, so the results illustrate what occurred on that particular day. All turbidity values were reasonably low during the January – March period, except for the South Opuha River, which recorded a turbidity of 12.9 NTU in February. A turbidity sample collected approximately 6.5 km upstream of the South Opuha River sampling site returned a value of only 1.1 NTU, indicating that an activity is occurring between these two sampling points that is increasing turbidity within the river (this might either be a land-use input or maintenance works within the river).

Figure 3: Turbidity in the South Opuha River and North Opuha River for January, February, and March 2023.

Due to the increase in turbidity in the tributaries of Lake Opuha during rain events, and outside of rain events, OWL is considering installing turbidity sensors in the South and North Opuha Rivers, and Ribbonwood and, Station Creeks; and flow sensors in Ribbonwood and Station Creeks. This would allow estimates of the sediment load

flowing into Lake Opuha and identification of where in the catchment the largest loads of sediment are coming from.

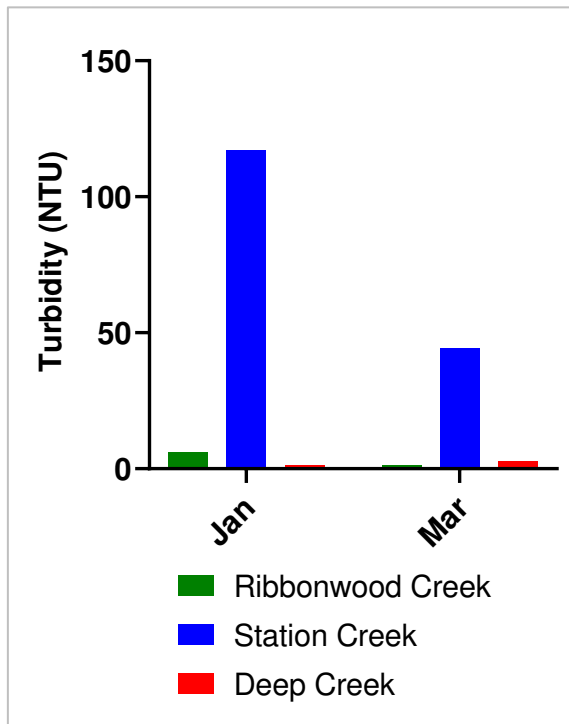
Figure 4 shows the turbidity in Ribbonwood, Station and Deep Creeks measured for January and March 2023. No sampling was done in February. All turbidity values were reasonably low except for Station Creek, which recorded turbidity values of 117 NTU and 44 NTU for January and March respectively. Station Creek has also looked considerably dirtier than other creeks in the area at various times during the past three months. OWL was notified by ECan that there had been a slip in the Station Creek catchment. Work was done by ECan to clear the slip, however it is likely that increased sediment concentrations within the creek will continue for some time. OWL will continue to monitor the tributaries of Lake Opuha and will discuss turbidity levels within these tributaries in the next quarterly report.

Figure 4: Turbidity in Ribbonwood, Station, and Deep Creeks for January and March 2023.
