## Quarterly Water Quality Report

July 2023 to September 2023

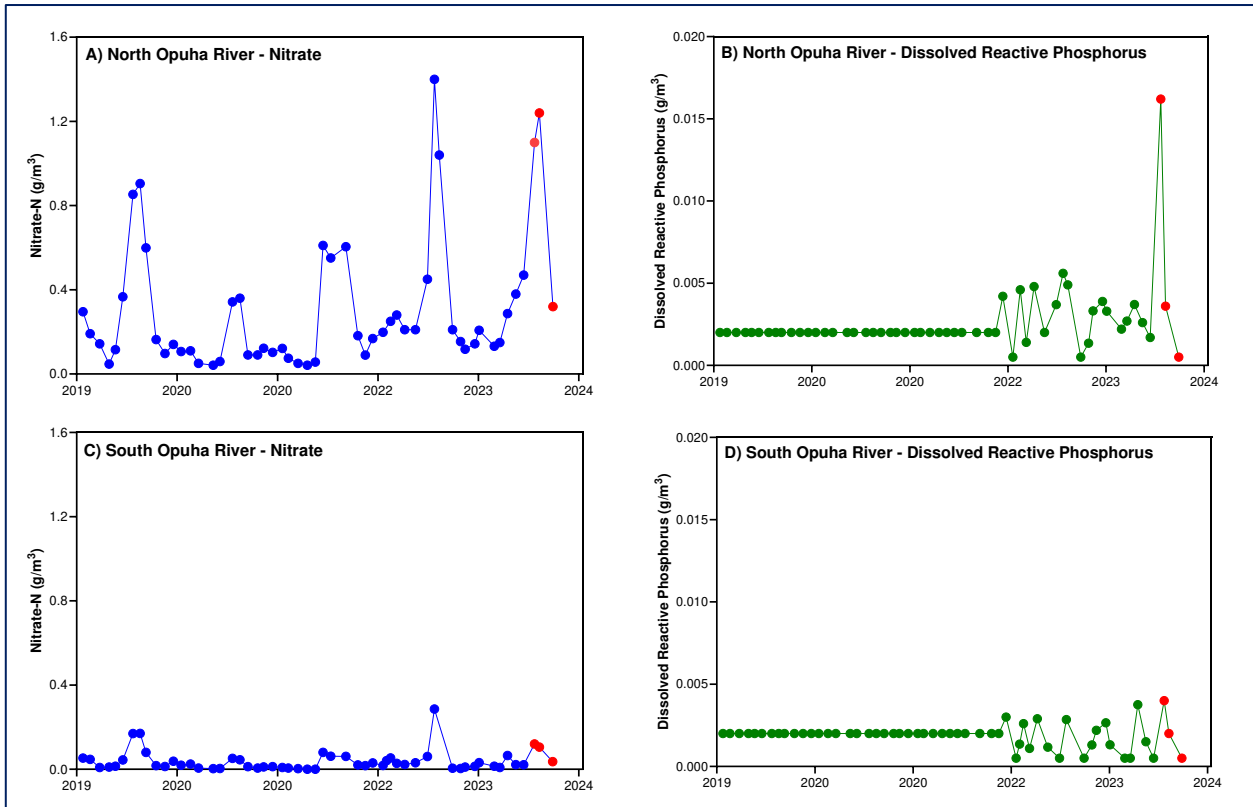
**Figure 4: Nitrate-N concentration at A) North Opuha River and D) South Opuha River; and dissolved reactive phosphorus concentration at B) North Opuha River and D) South Opuha River. Red data points are those from sampling in July, August and September 2023.**

in **suspended solids** (decrease in **water clarity**) in the tributaries (Figure 3) as well as increases in **nitrate-N** and **dissolved reactive phosphorus (DRP)**, as illustrated in Figure 4 for the North and South Opuha Rivers. Sampling in September 2023 showed that levels of nitrate-N and DRP returned to normal.

Although nitrate-N and DRP were elevated in both the North and South Opuha Rivers, the concentration of both parameters was significantly higher in the North Opuha River relative to the South Opuha River (Figure 4).

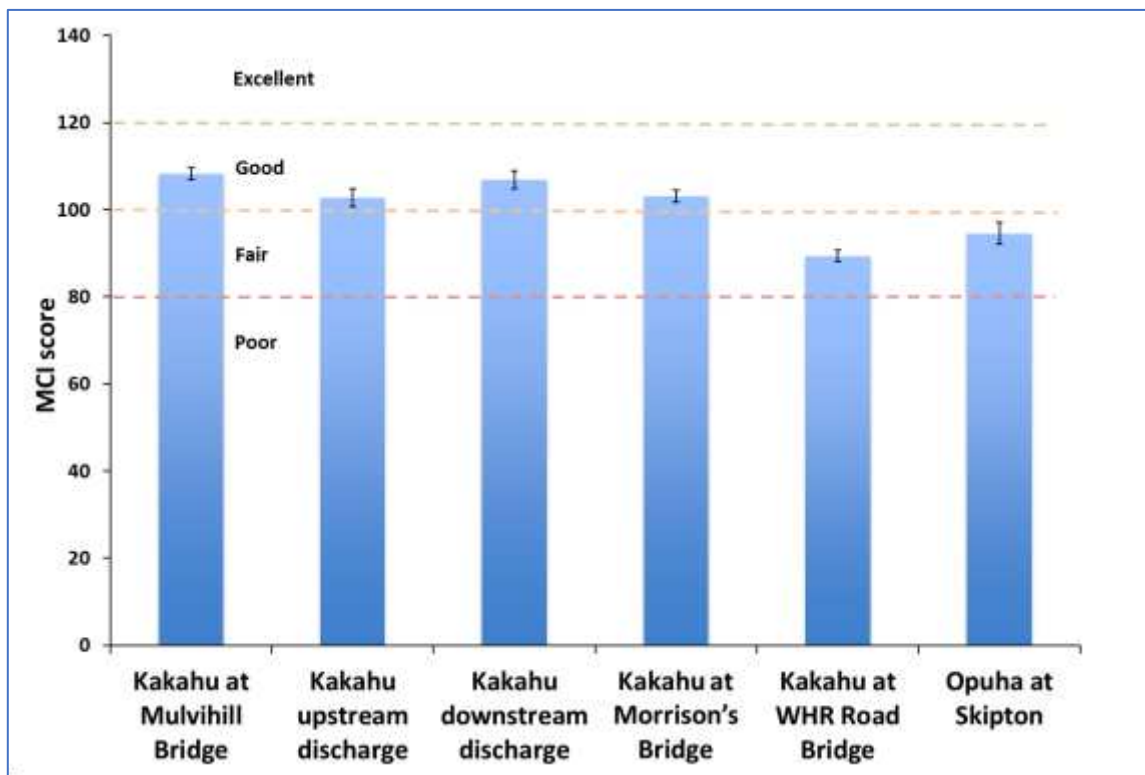
Figure 7: Average MCI scores at Kakahu and Opuha river sites, August 2023 (mean +/- one standard error).

The **MCI** data from the 2023 ecological survey shows that the MCI score was similar upstream and downstream of the discharge point, except for Winchester Hanging Rock Road Bridge (Kakahu at WHR Road Bridge) which is the furthest downstream site studied (Figure 7) and often has poorer water quality than other sites in the Kakahu River—scores ranged from *Fair* to *Good* with sites immediately upstream and downstream of discharge point rated *Good*.

The August 2023 survey (like previous surveys) showed that Winchester Hanging Rock Road Bridge (WHR) had lower MCI and QMCI scores than the other sites; this is more a reflection of the sampling site rather than the discharge as WHR tends to have higher nitrogen, phosphorus and *E.coli* than other sampling sites, indicating other inputs from the catchment affecting WHR.

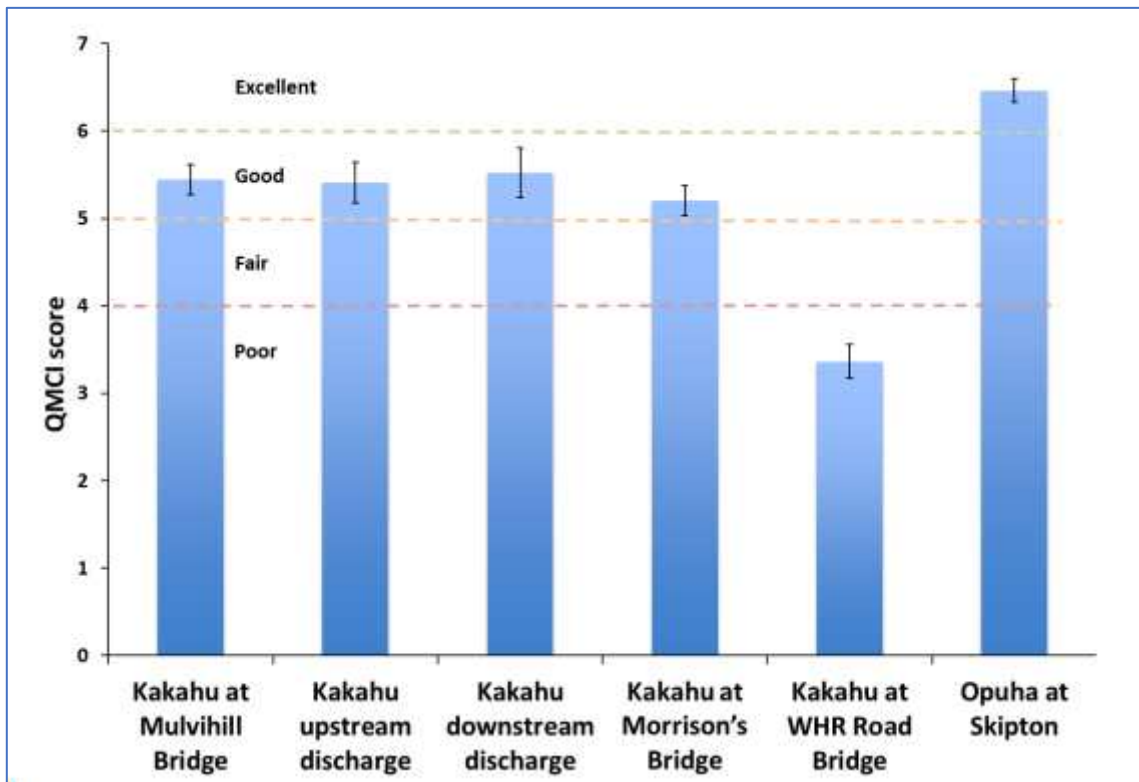
**Figure 8: Average QMCI scores at Kakahu and Opuha river sites, August 2023 (mean +/- one standard error).**

The **QMCI** data from the August 2023 ecological survey shows that the QMCI score was similar upstream and downstream of the discharge point, except for Winchester Hanging Rock Road Bridge (Kakahu at WHR Road Bridge) which is the furthest downstream site studied (Figure 8) – scores ranged from *Poor* to *Good* with sites immediately upstream and downstream of discharge point rated *Good*.
