Opuha Water Ltd

Opuha Dam
Annual Dam Safety Inspection 2013

Report prepared by:
Tonkin & Taylor Ltd

April 2013

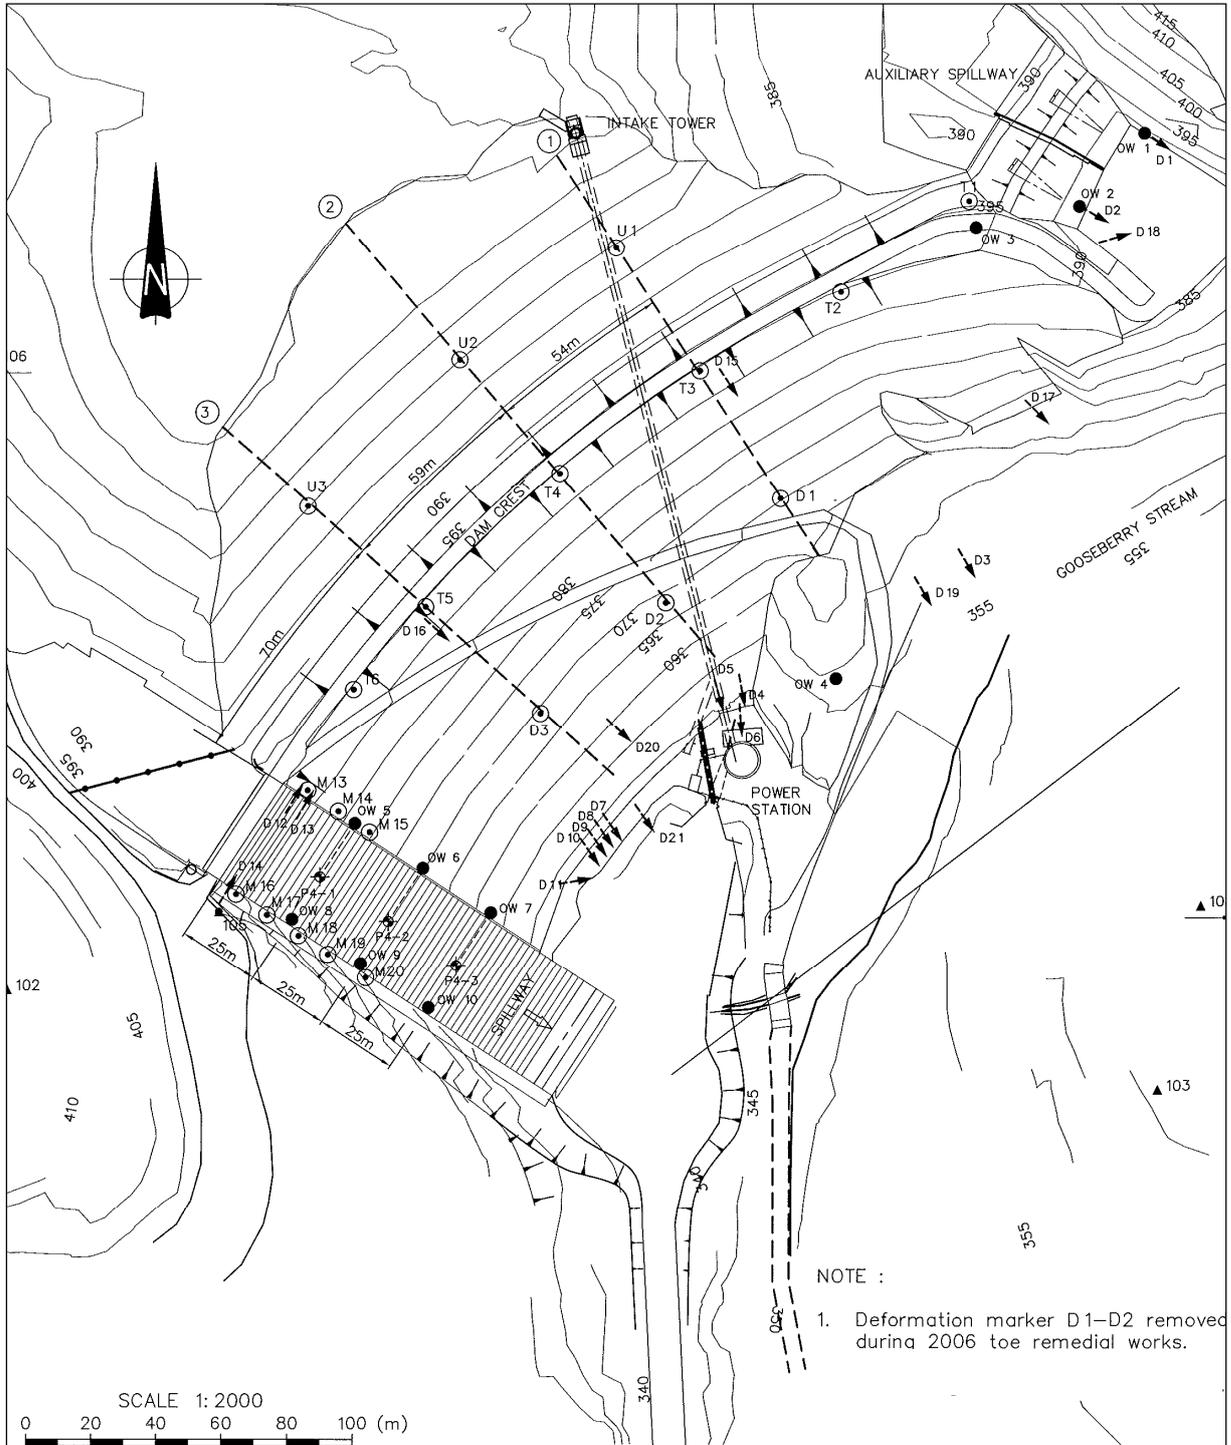
Figure 1 Instrument Layout

This section reviews the data for the dam instrumentation for the period 1 April 2012 to 31 March 2013. The layout of the dam instrumentation is presented in Figure 1 below. In general, the dam and spillway instrumentation continues to operate satisfactorily.

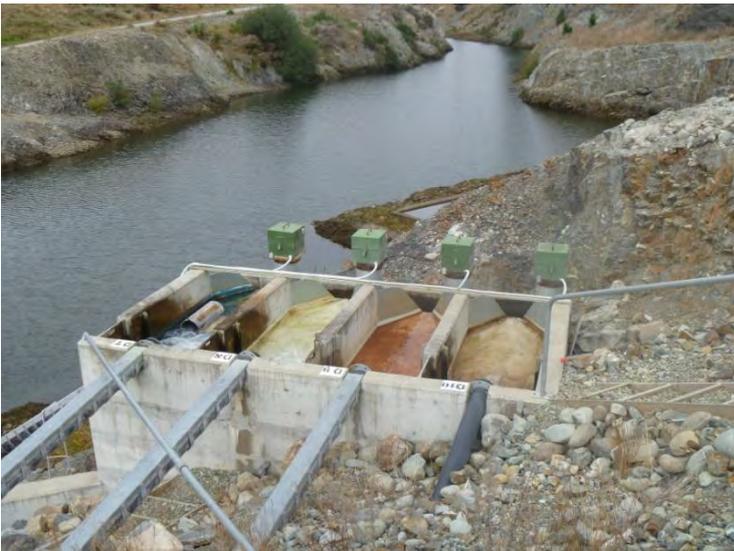
Figure 3 Chimney drains D8-10, and D7

Flow through the chimney drain is collected by D8, D9 and D10, with water being conveyed from the left chimney sump, central chimney sump and right chimney sump via the respective drains. The outlet for these flows is located at the base of the dam, adjacent to the spillway stilling basin. The outlet for flows conveyed from the base drain, D7, is also at this location.

The surveillance regime carried out by OWL over the period has allowed for observation of the levels of solids within the drains. OWL advise that the observed sediment in D10 drain flow had increased in terms of the volume of sediment that is settling in the H flume. Though recorded flow rates were within the acceptable bounds, sediment levels within the flow have apparently increased.

The source of the sediment is unknown, with potential for it to have originated from the chimney drain material. The location of the D10 flume also may allow for accumulation of windblown dust and grit. OWL advise that a sample of the drain flow will be collected for material analysis. Drain D10 should be included in the sediment flux measurement trial recommended in Section 3.2.2.

Monitoring of the turbidity of the chimney drain flow has yet to be successfully achieved. Past attempts have shown the difficulty of installing a meter in the drain where the three chimney drain flows meet, due to turbulence issues. ECS have recommended that a small stilling well be installed and a turbidity meter hung to obtain the reading. An automatic turbidity monitoring system should be installed on the chimney drain flow outlet and incorporated into the monitoring system.

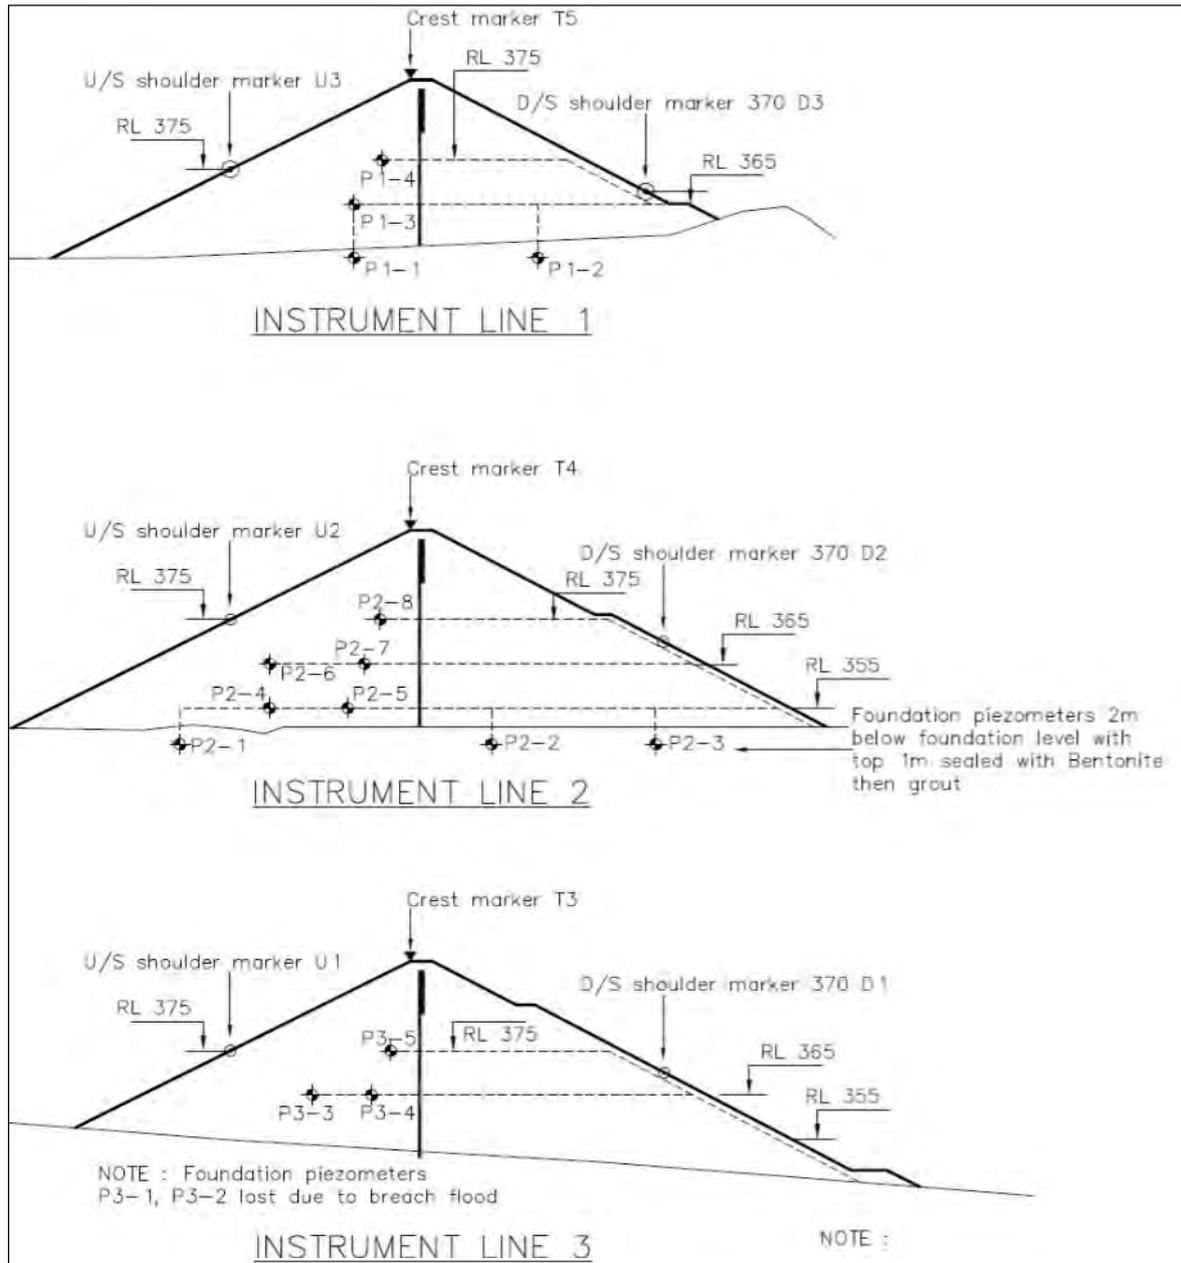
Figure 8 Piezometer positions

Graphs of the data since May 2007 are provided in Appendix A2. The locations of the three lines of piezometers are shown in Figure 1 (above picture) and the positions of each piezometer in Figure 8.

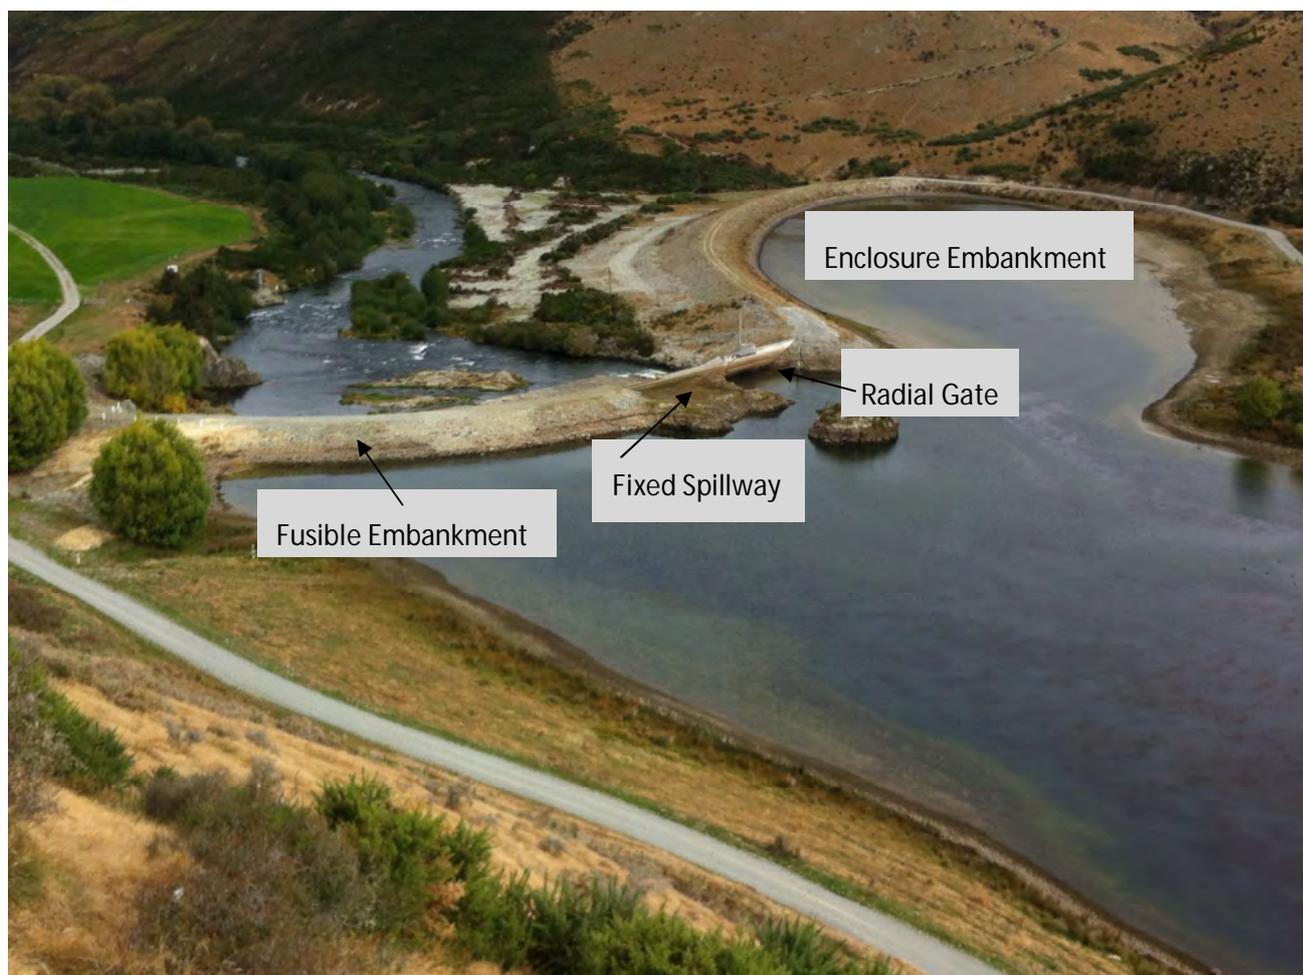
Figure 28 ODDW

The Opuha Dam Downstream Weir (ODDW) is approximately 1.4 km downstream of the Opuha Dam and is physically separated from the main dam. The ODDW attenuates the flow released from the main dam and regulates the flow discharged to the Opuha River downstream. The key components consist of a radial gate, fixed spillway, fusible embankment and enclosure embankment. These are shown in Figure 28 below.

The crest, part of the upstream face and downstream face of the right hand closure embankment were inspected. Monitoring instrumentation on the downstream weir and appurtenant structures include:
