Opuha Water Ltd

Opuha Dam
Annual Safety Inspection 2014

Tonkin & Taylor Ltd

April 2014

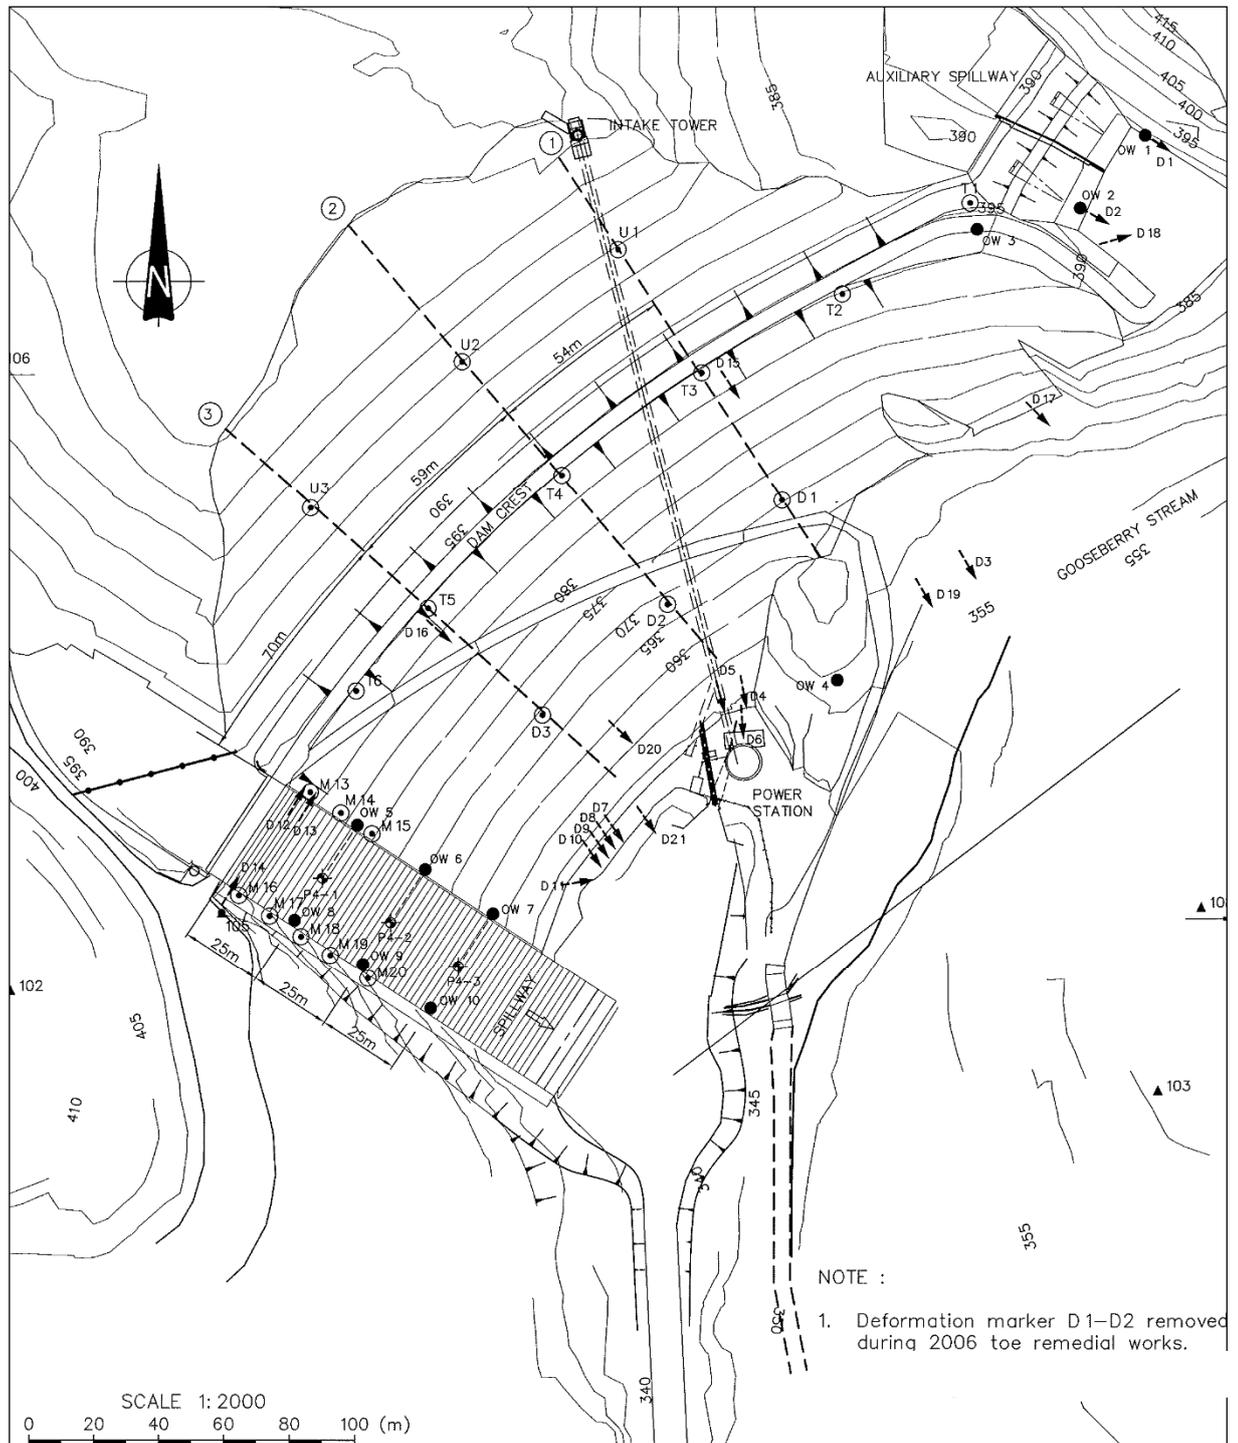
Figure 1 Instrument Layout

This section reviews the data for the dam instrumentation for the period 1 April 2013 to 31 March 2014. The layout of the dam instrumentation is presented in Figure 1 below. The locations of the hydraulic piezometers located within the embankment on the instruments lines 1, 2 and 3 shown in the figure below can be found in Section 3.3.1. In general, the dam and spillway instrumentation continues to operate satisfactorily.

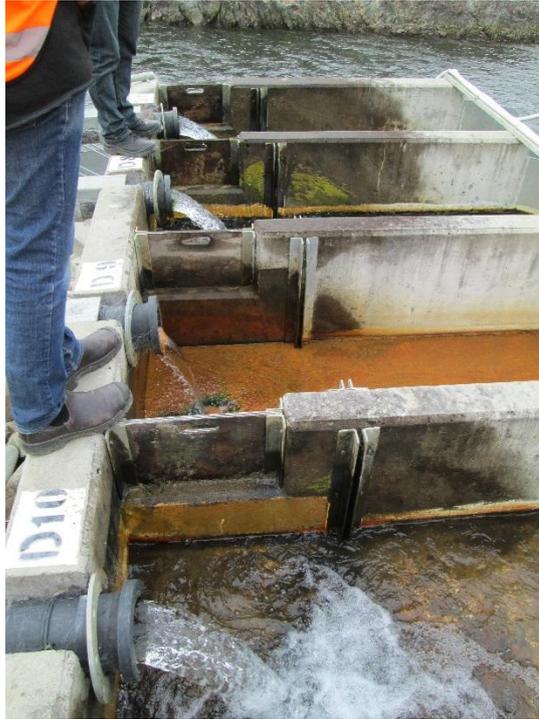
Figure 2 Chimney drains D8-10, and D7

BCM2013-03 (Installation of an automated turbidity monitoring system) is yet to be actioned. This recommendation should be reviewed in light of the data recorded by the automated D7 (base drain outlet) turbidity data. That is, the D7 turbidity meter gives

variable results (refer steps in recorded data) and it is yet to be established if such steps would result in unnecessary alerts/a meaningful automatic alarm system.

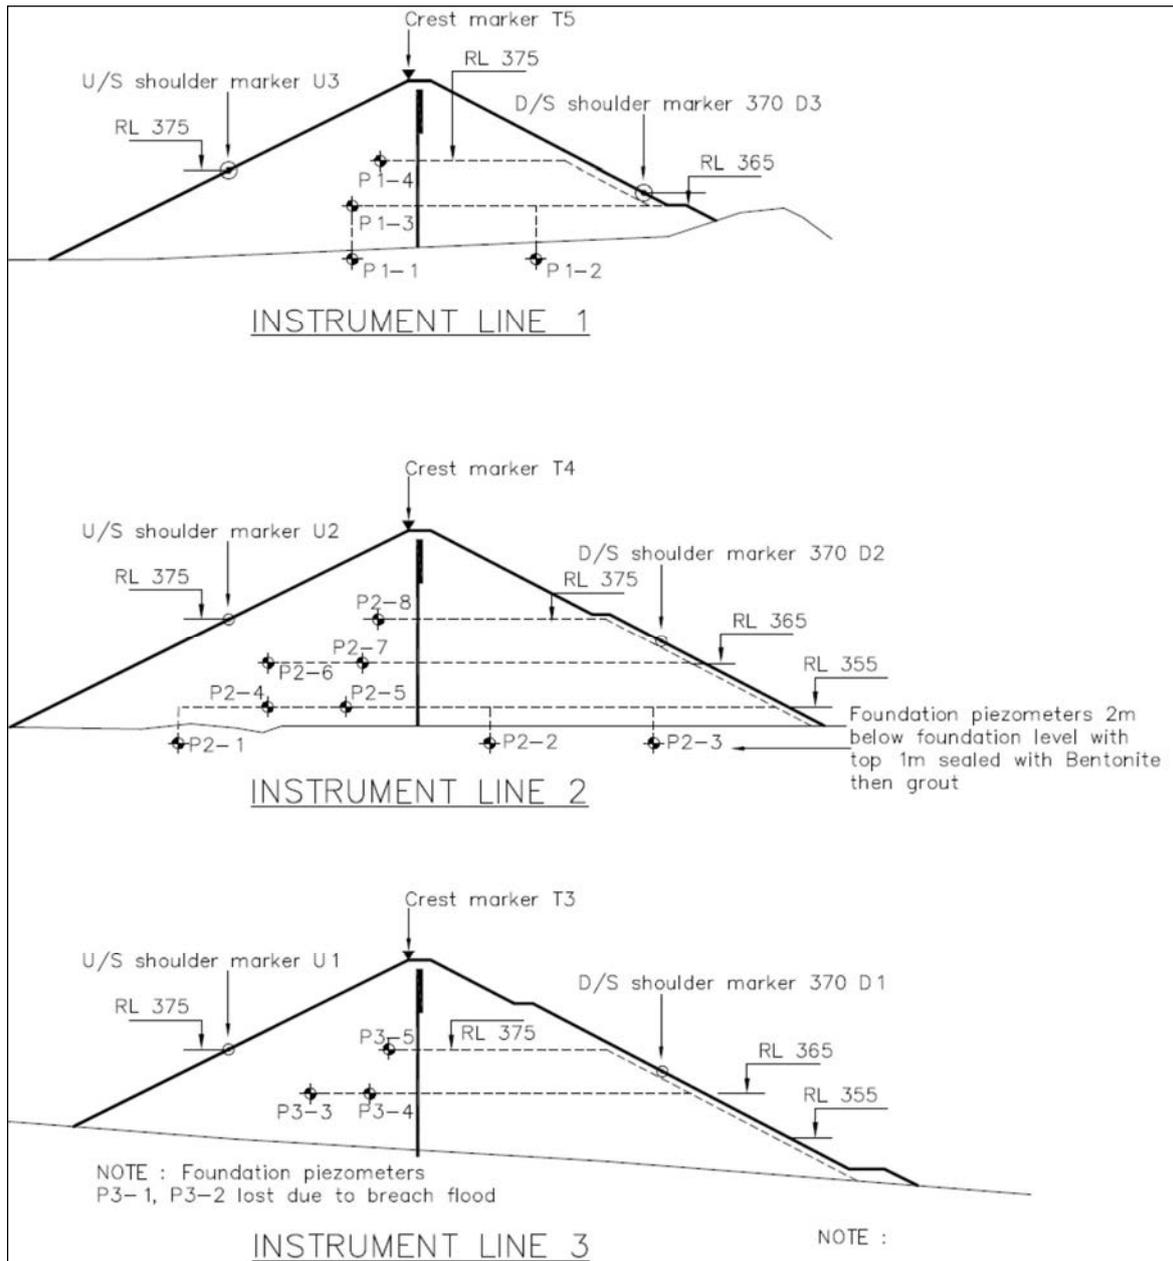
Figure 5 Piezometer positions

Graphs of the data since May 2007 are provided in Appendix A. The locations of the three lines of piezometers are shown in Figure 1 and the positions of each piezometer in Figure 5.

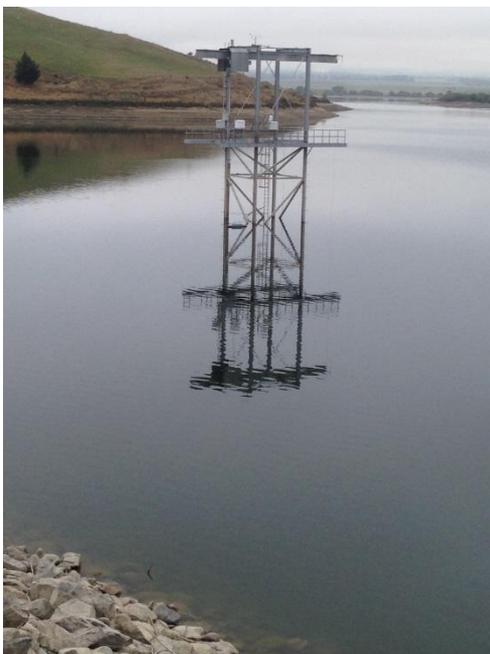
Figure 12

Intake tower

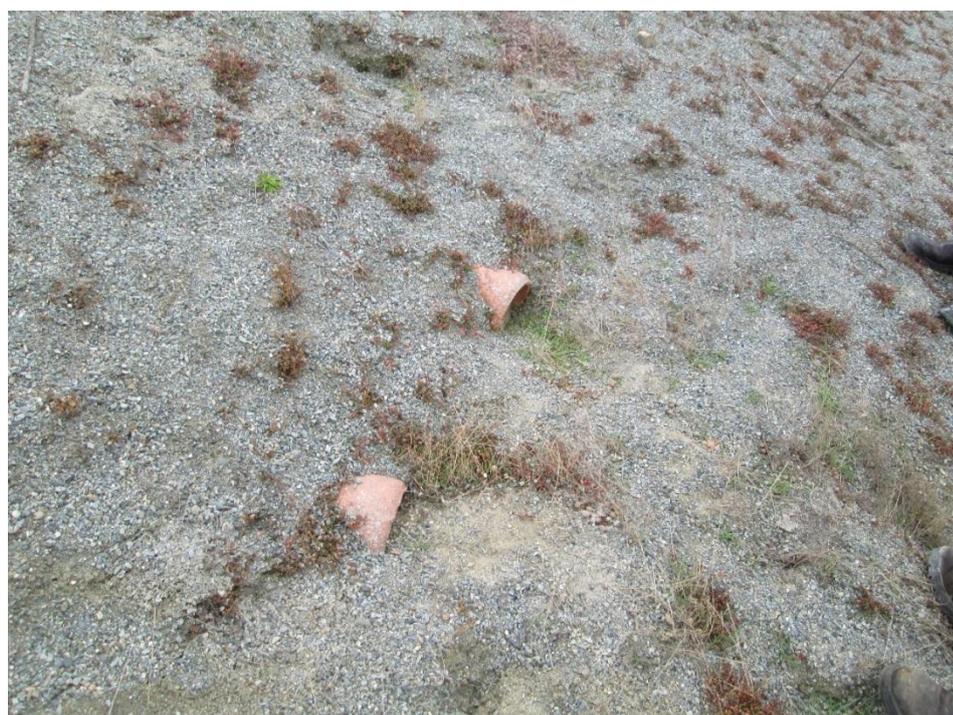
Figure 18

Right hand side fuse plug triggering device clay tile pipes

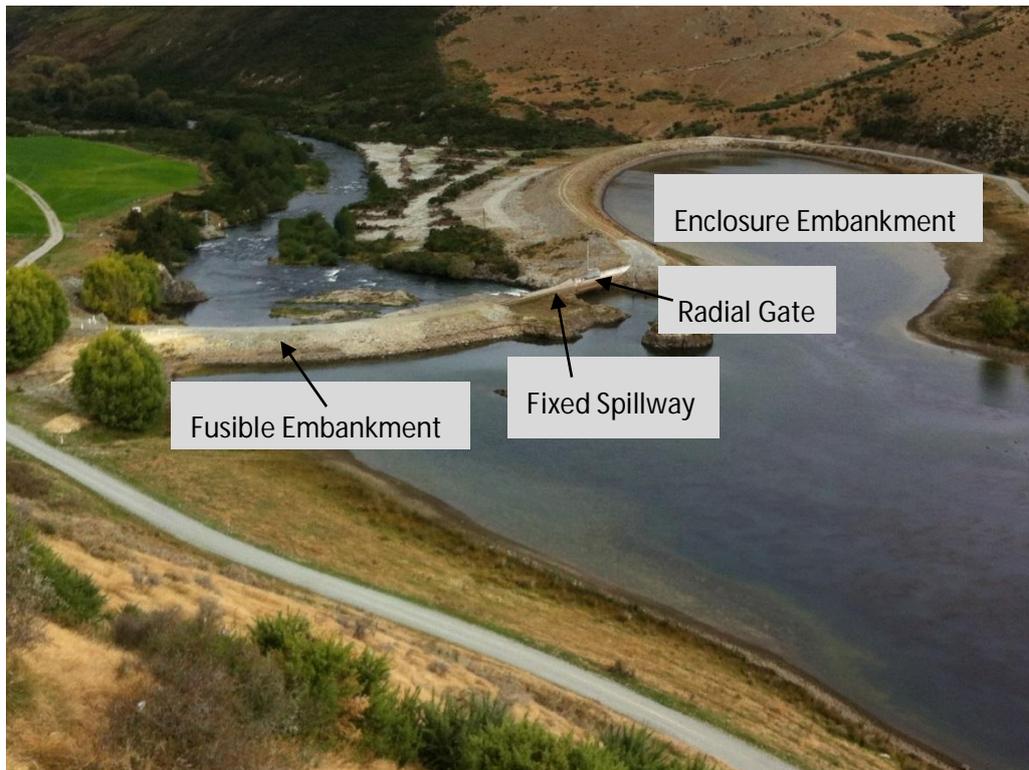
Figure 23 ODDW

The Opuha Dam Downstream Weir (ODDW) is approximately 1.4 km downstream of the Opuha Dam and is physically separated from the main dam. The ODDW attenuates the flow released from the main dam and regulates the flow discharged to the Opuha River downstream. The key components consist of a radial gate, fixed spillway, fusible embankment and enclosure embankment. These are shown in Figure 23 below.

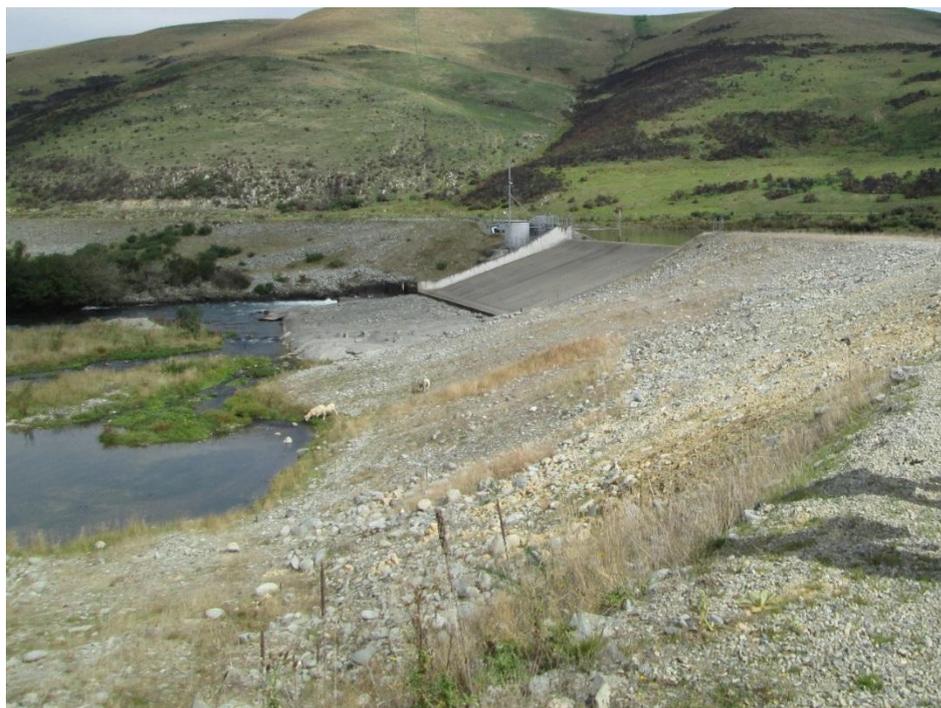
Figure 24 Downstream face of overflow embankment and spillway

The Downstream Weir Overflow Embankment (DWOE) is designed to fuse during a five year or greater Average Recurrence Interval (ARI) flood. The estimated five year ARI routed dam

outflow is approximately 100 m³/s. The present DWOE was constructed in 2009 after it operated during high flows in May 2009.

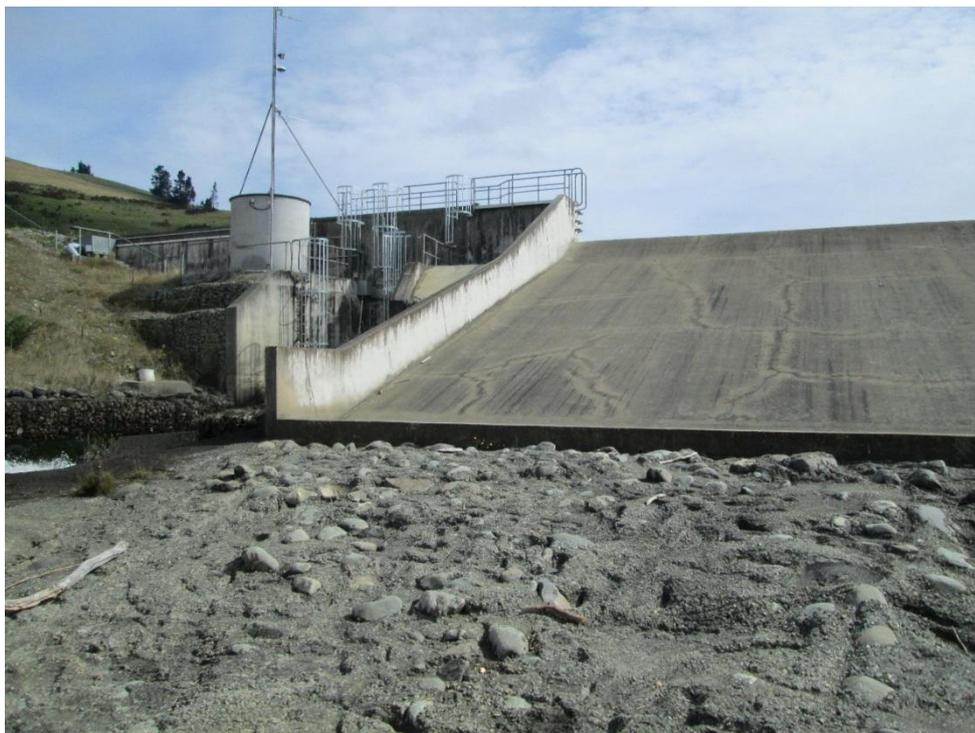
*Figure 26**Service spillway*

The concrete and stone armouring on both banks is generally in satisfactory condition. It has been previously noted that the mass concrete beyond the end of the chute right hand training wall (beyond the toe of the ogee weir) is at least partially undermined. This has not changed significantly since 2010 but ongoing monitoring of this area by OWL is warranted.
