OPUHA WATER LTD

**Opuha Dam
Annual Dam Safety Inspection 2010**

Tonkin & Taylor Ltd

May 2010

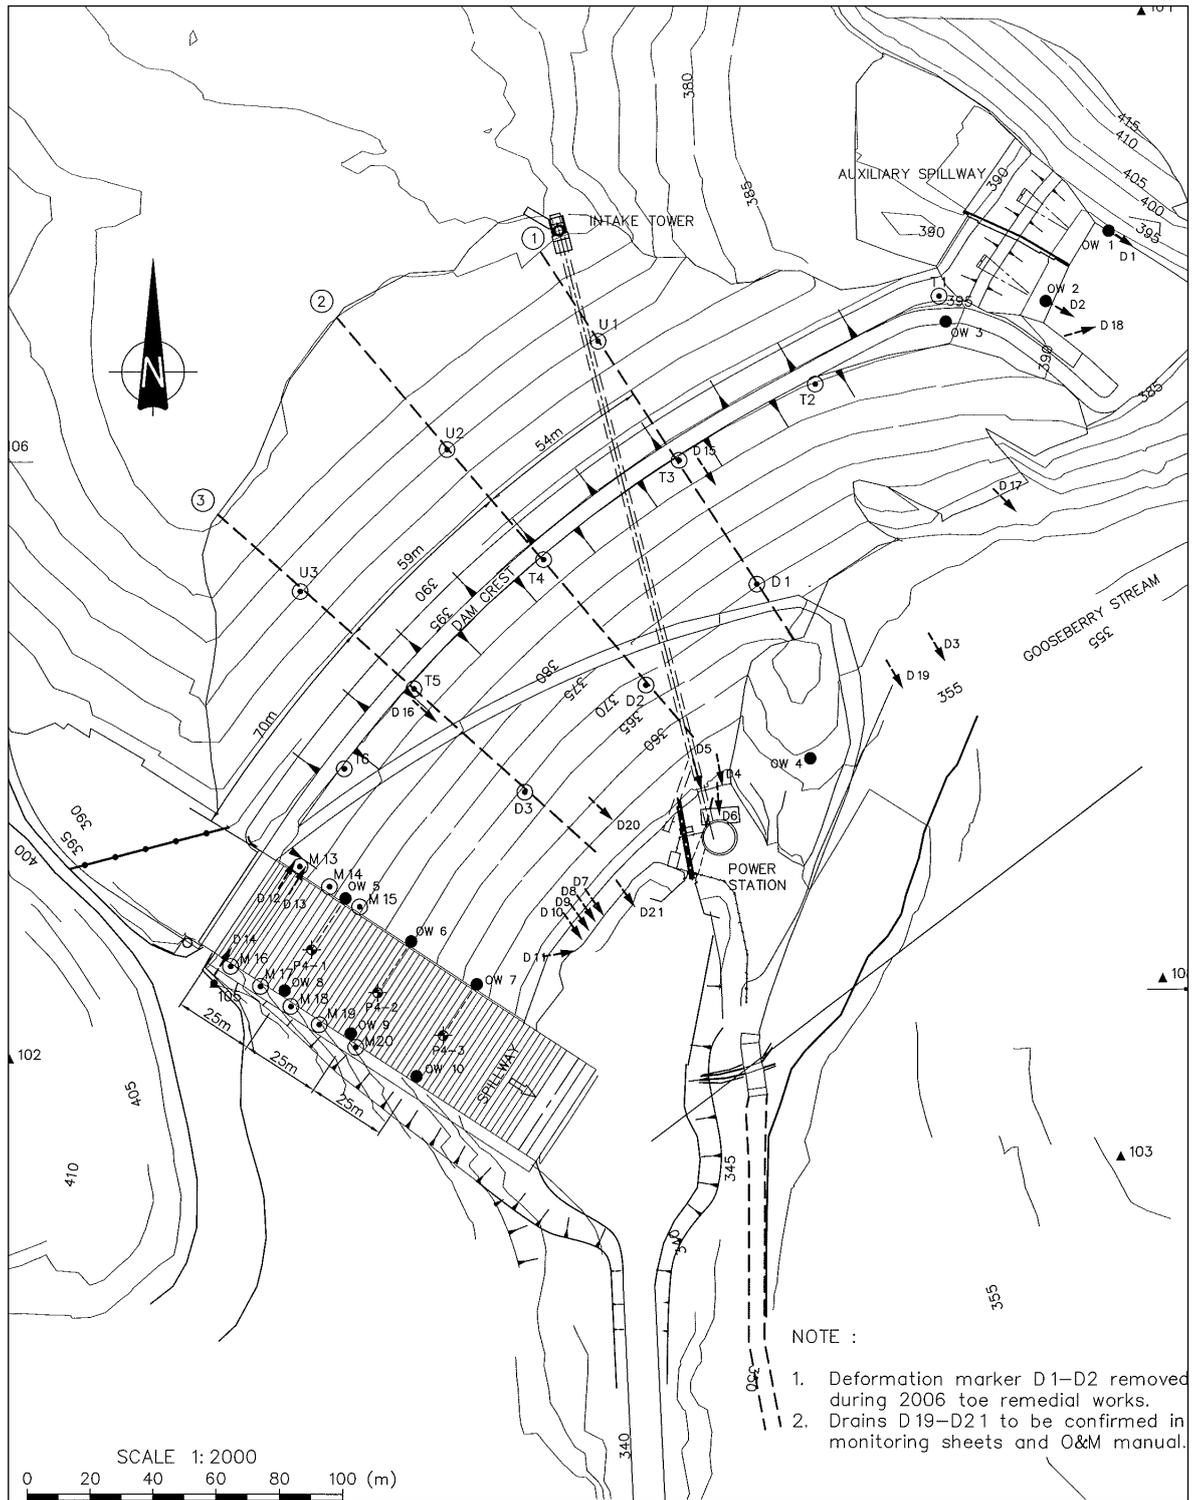
Figure 3.1 Instrumentation layout

This section reviews the data for the dam instrumentation for the period 1st April 2009 to 31st March 2010. The layout of the dam instrumentation is presented in Figure 3.1. In general, the dam and spillway instrumentation continues to operate satisfactorily.

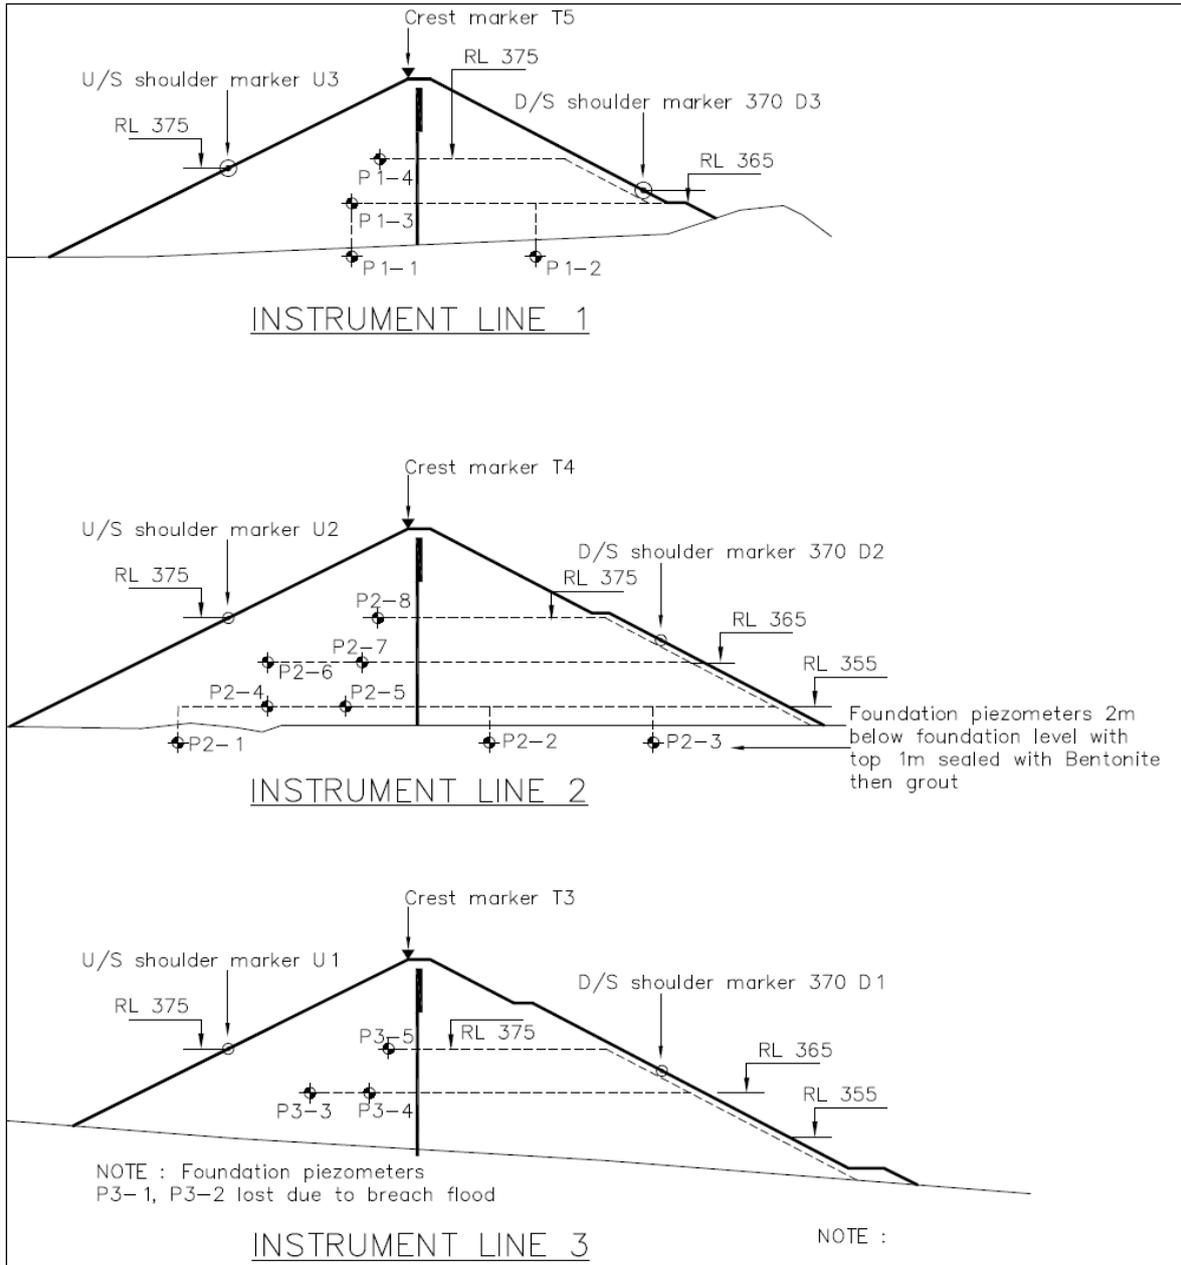
Figure 3.4 Piezometer positions (note P2-5, P3-3 & P3-5 are decommissioned)

- Piezometers P2-5, P3-3 and P3-5 have been decommissioned because they are unresponsive. The readings are still recorded on site but are not reported.
- The gauges for piezometers P1-2, P1-3, P2-6, P2-7, P3-4, P1-4 and P2-8 were being repaired or replaced during early 2007 and readings were restarted on 8th August 2007.
- The remaining piezometers P1-1, P2-1, P2-4, P2-2 and P2-3 recommenced readings on 5th March 2007.

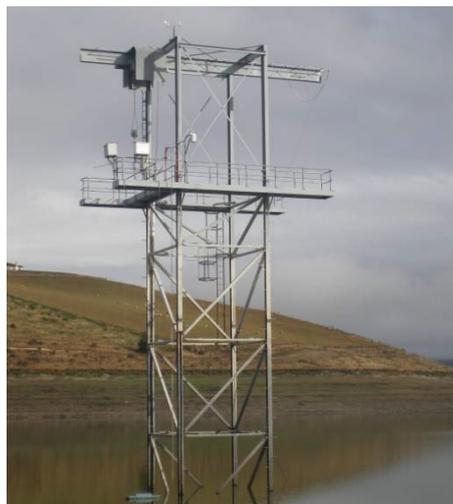
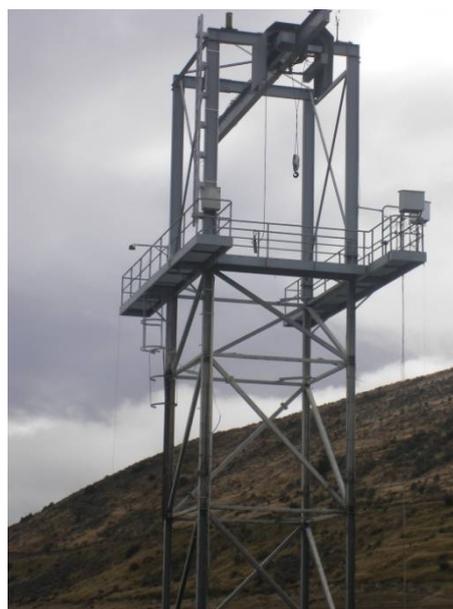
Figure 4.1 Intake tower

Figures 4.1 and 4.2 illustrate the Intake Tower to the extent that the structure was visible from the dam upstream face of the dam.

A dive inspection of the intake tower was not undertaken during the 2009-2010 year. Diver inspections are scheduled every two years and the next diver inspection is scheduled for May 2010. The imminent dive inspection will provide an opportunity to undertake a more thorough inspection of the intake tower structure. A section of access ladder hoop is loose (Figure 4.2). As-built drawings indicate that the ladder hoops are hinged to allow access to the ladder at varying reservoir levels and that the hinged sections are restrained by chains. It is presumed that the loose hoops are due to the lashing chain coming loose. This matter will be investigated at the time of the upcoming dive inspection.

- RCM2008-18 – Clarification of the labelling of the guide ropes from the South West tower leg.
- RCM2008-19 - The Operator reports that it is believed that the bulkhead valve handle is located in the powerhouse. This is to be confirmed at the time of the next divers' inspection

- RCM2008-20 - The loose steel bar/plate at the NE tower leg splice should be investigated during the 2009-2010 diver inspection.

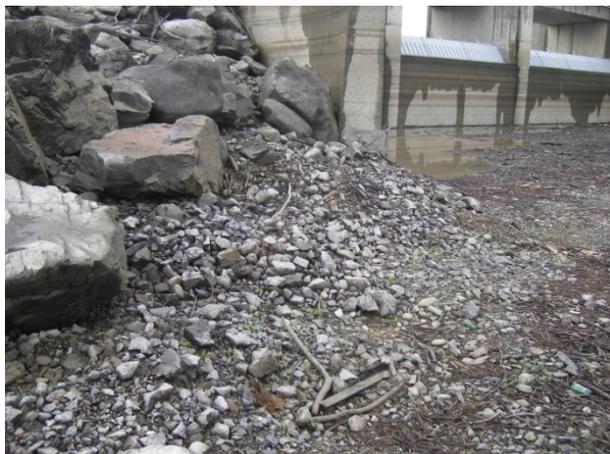
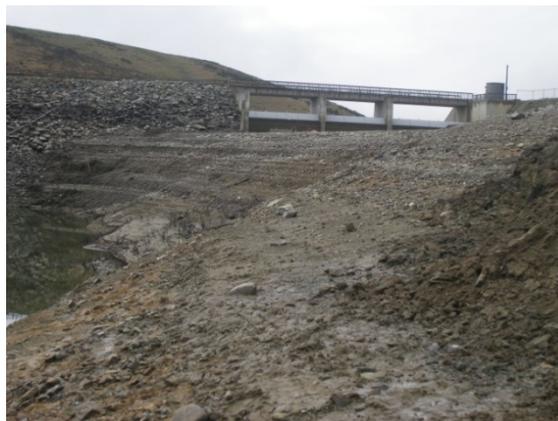
Figure 5.1 Service spillway approach

The Obermeyer gates appear to be in sound condition.

The Operator advises that the procedures for operation of the Obermeyer gates during flood events have recently been reviewed and clarified. Also, the Operator advises that the compressor that operates the Obermeyer gates has been replaced in the last few months. It is understood that the old compressor will be serviced and retained as a standby unit.

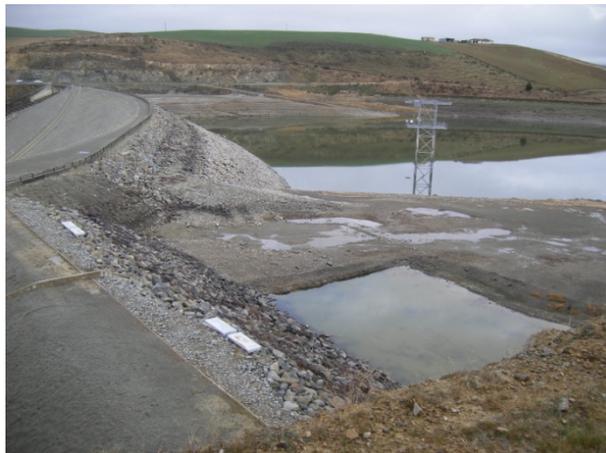
Figure 6.1 Auxiliary fuse plug and approach channel viewed from left hand side cut slope.

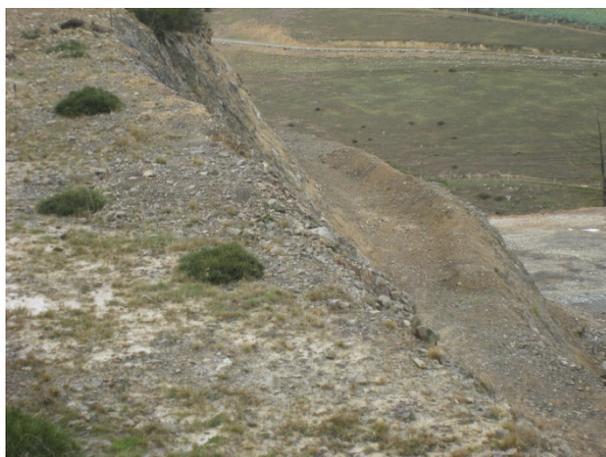
The left abutment cut, above the auxiliary spillway, is in good condition. The historical wedge failure downstream of the fuse plug shows no sign of recent movement. Apart from this, there are no signs of any significant movement on the slope. No cracking or

Figure 6.3 Left abutment cut slope drainage

significant deformation was observed at the top of the cut face.
