Opuha Water Ltd

Opuha Dam
Annual Dam Safety Inspection 2011

Report prepared by:
Tonkin & Taylor Ltd

April 2011

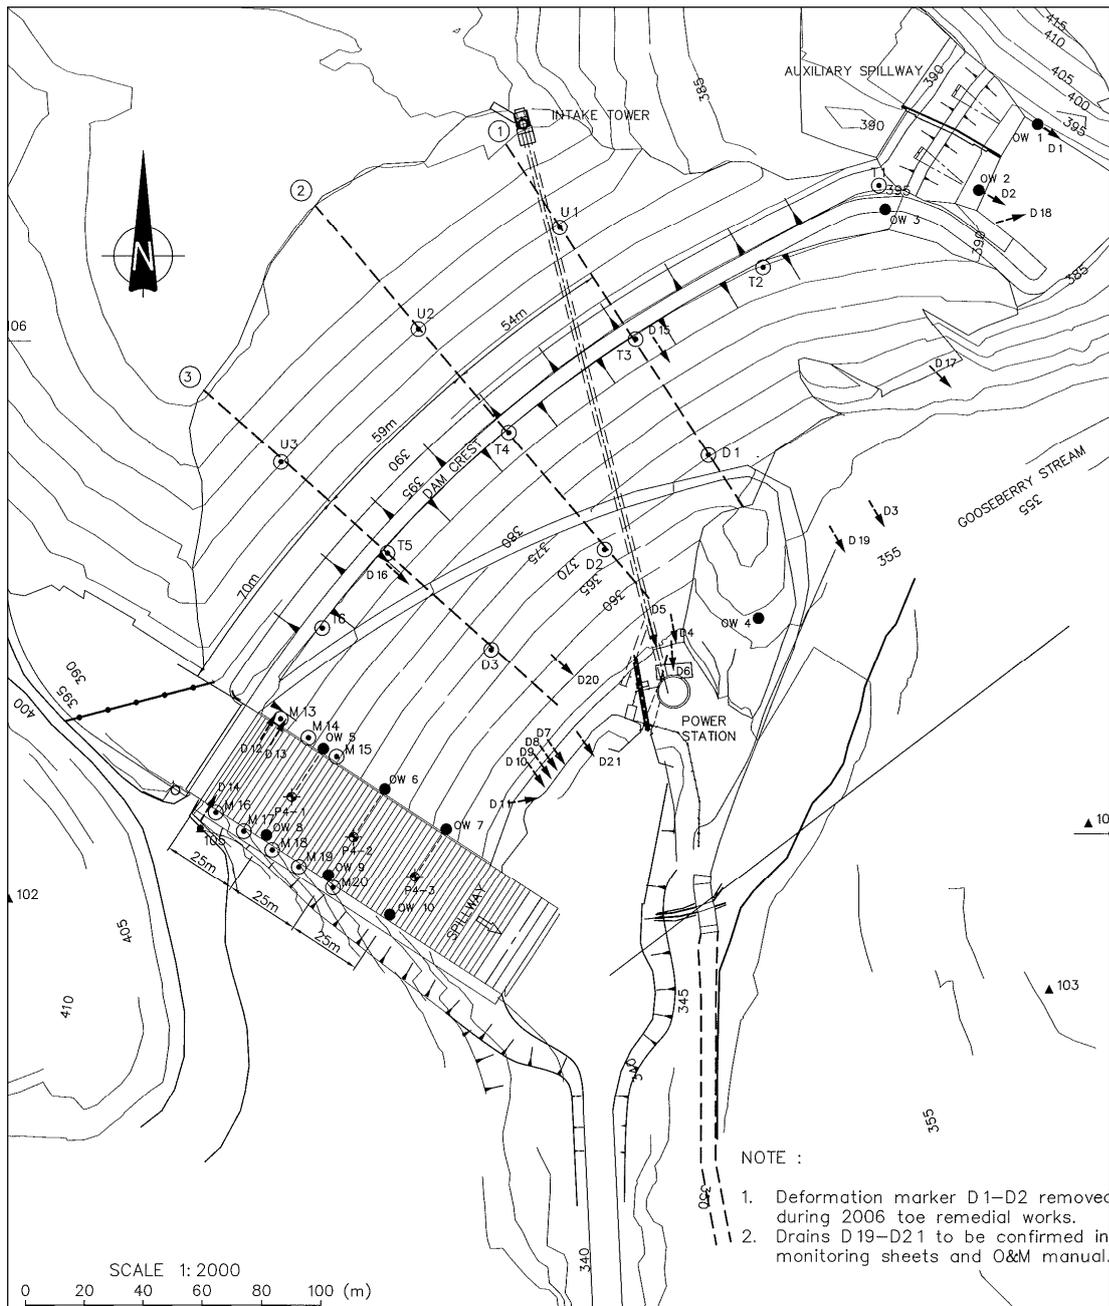
Figure 2.1 Instrumentation layout

This section reviews the data for the dam instrumentation for the period 1 April 2010 to 31 March 2011. The layout of the dam instrumentation is presented in Figure 2.1 below. In general, the dam and spillway instrumentation continues to operate satisfactorily.

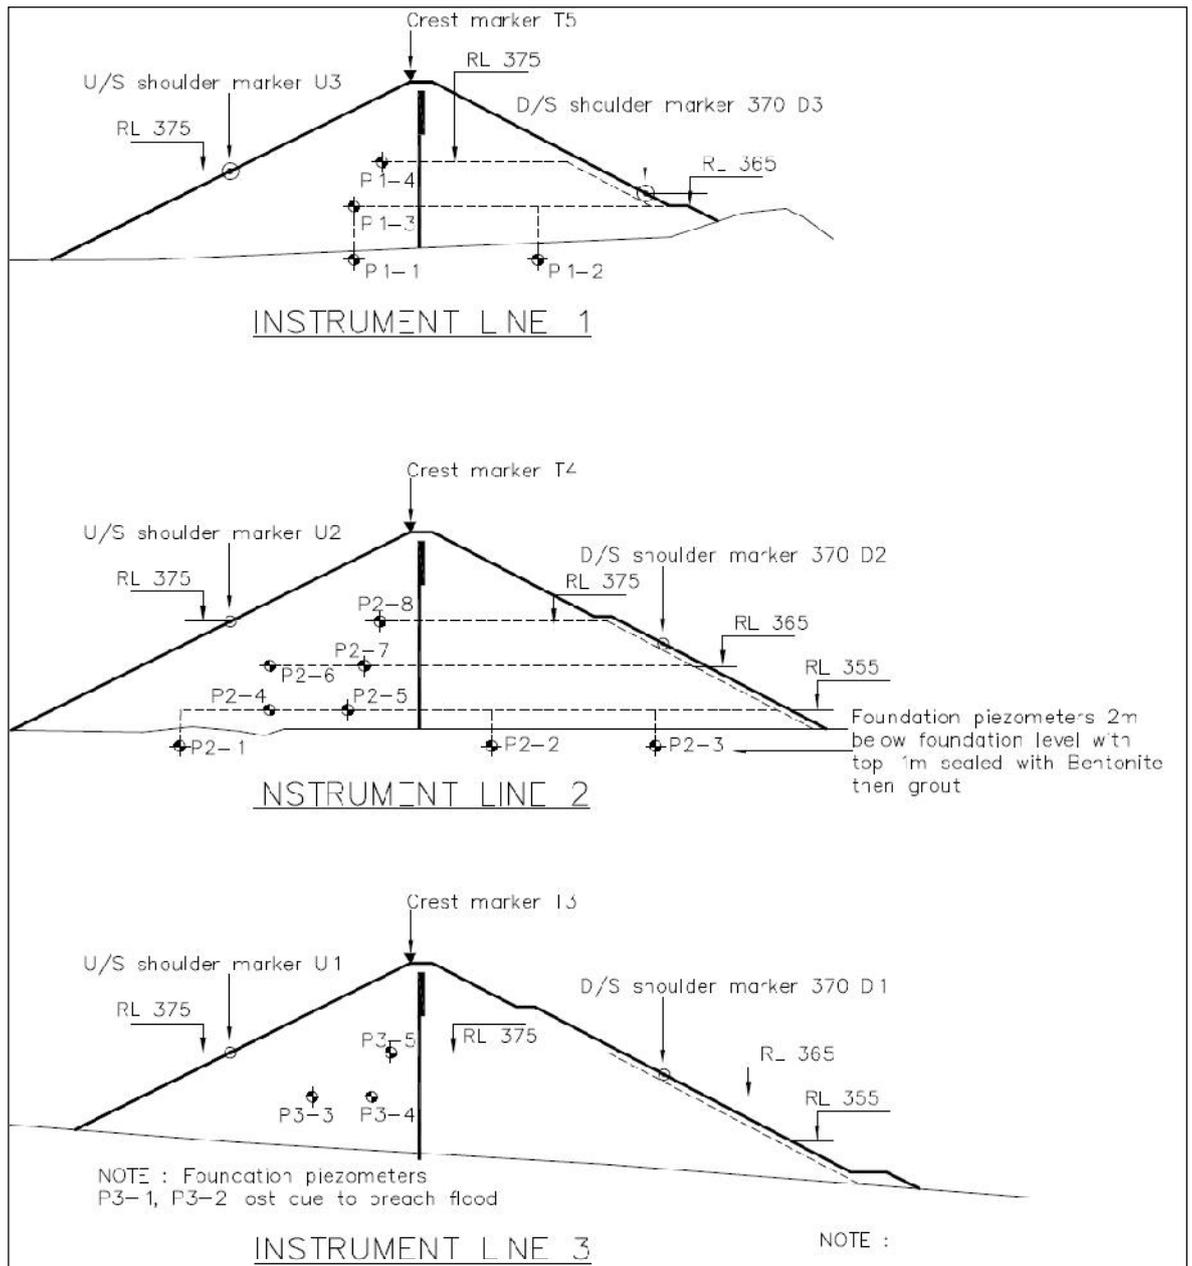
Figure 2.2 Piezometer positions (note P2-5, P3-3 & P3-5 are decommissioned)

Graphs of the data since May 2004 are provided in Appendix A2 on 3 sheets. The locations of the three lines of piezometers are shown in Figure 2.1 and the positions of each piezometer in Figure 2.2.

The pneumatic piezometers under the service spillway are to be read following spillway operation. The service spillway operated during the New Year holiday period and the pneumatic piezometers were not read because of the timing of the spillway discharge.

RCM2011-01: Hydraulic piezometer gauge calibration factors to be checked and gauge maintenance works to be undertaken. Pneumatic piezometer leads to be repaired and rehoused.
