## **Opuha Dam**

### **Annual Safety Inspection 2015**

**Opuha Water Ltd**

**May 2015**

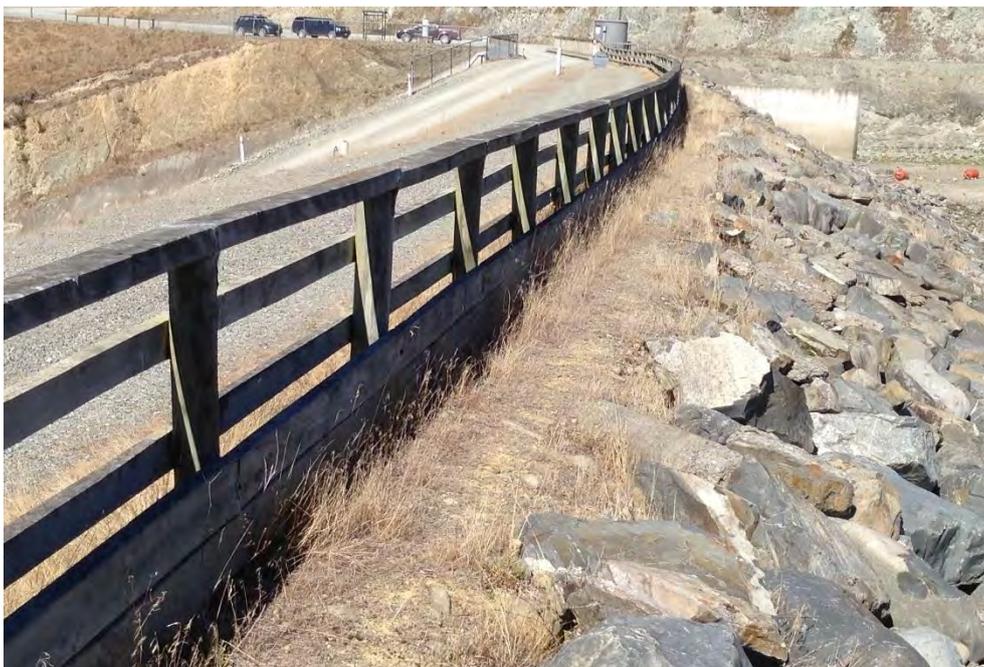
The crest roadway and fence were generally in good condition (refer Photos 3-6 & 7 below). However, as noted in the 2014 annual safety inspection, there were some instances of slight deterioration to the wave barrier and there was a small gap between the bottom board and the ground in some places. Further to RCM2014-03, we recommend that the damage to the wave barrier is repaired and any gaps between the timber and embankment surface filled. This item is being considered in more detail as part of the CSR review responses.

*Photo 3-6 Upstream face of wave splash barrier*

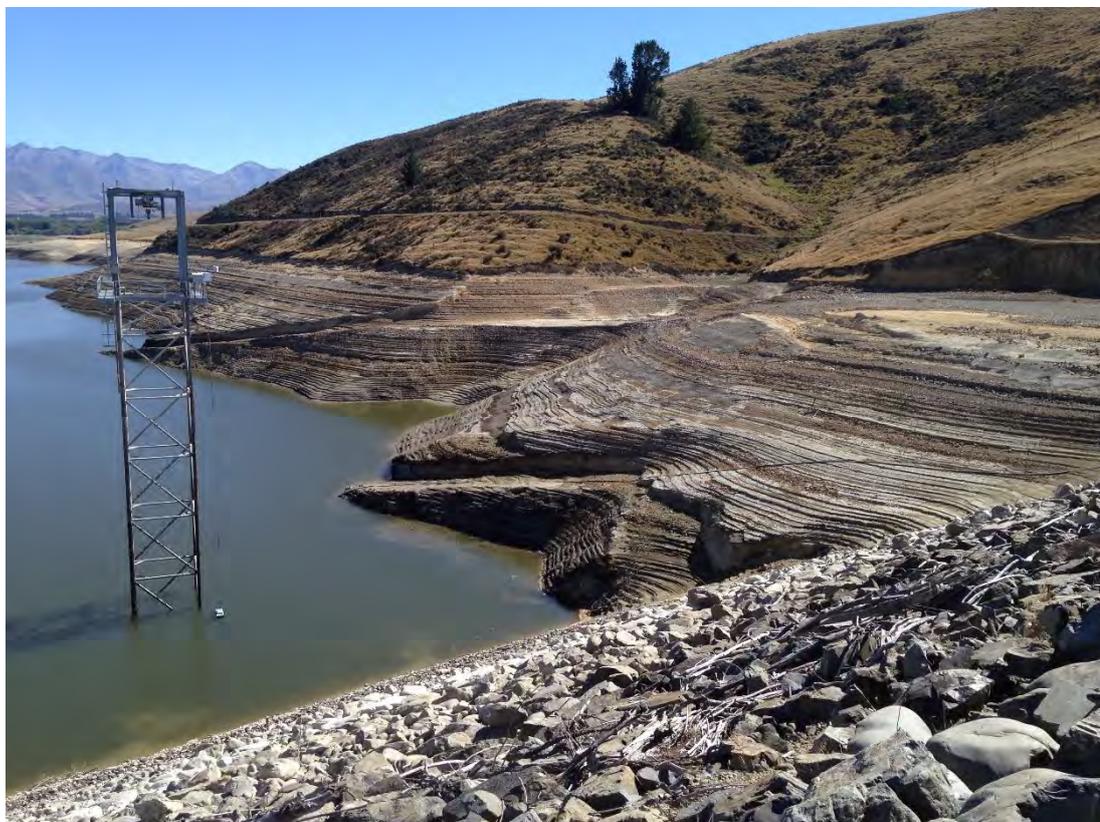
The intake tower was mostly above water level (10 m submerged only) at the time of inspection and appeared to be in acceptable condition (refer Photo 4-2 below).

It was however observed that the gantry crane power cable was not fully attached to the monorail beam and hanging loose for a section. Reattachment of the loose section of power cable is recommended. We understand that the crane certification is current.

*Photo 4-2 Intake tower from crest of the dam*

*RCM2015-05 Refasten hanging section of gantry crane power cable to monorail beam*

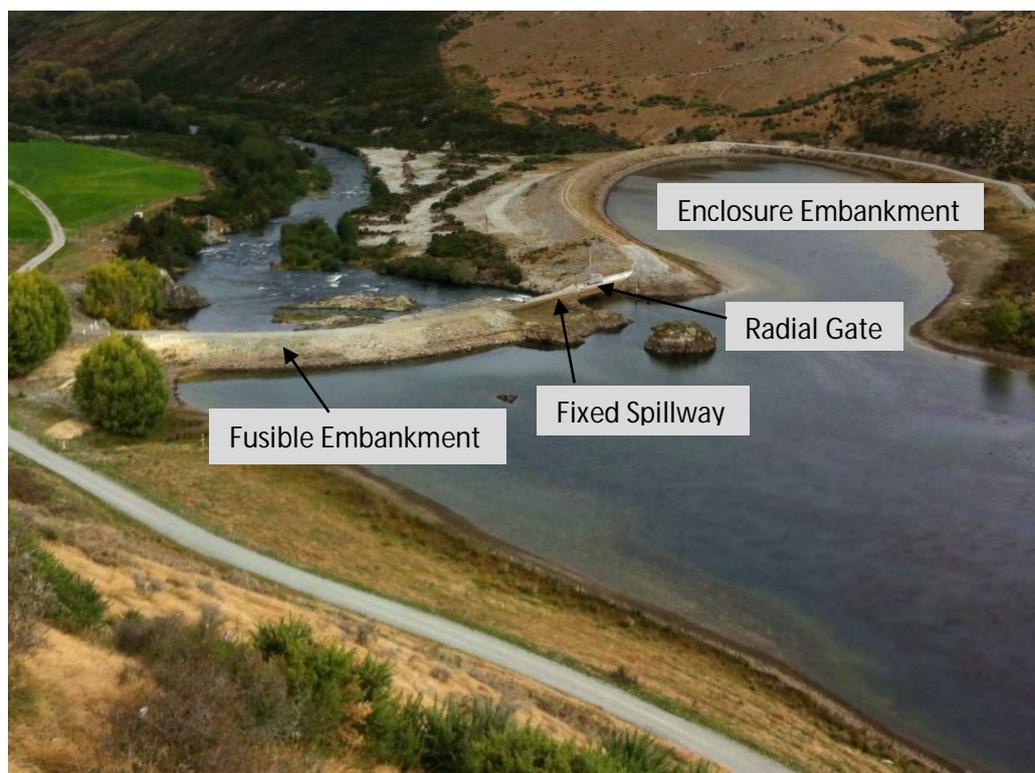
The Opuha Dam Downstream Weir (DSW) is approximately 1.4 km downstream of the Opuha Dam and is physically separated from the main dam. The DSW attenuates the flow released from the main dam and regulates the flow discharged to the Opuha River downstream. The key components consist of a radial gate, fixed spillway, fusible embankment and enclosure embankment. These are shown in Photo 8.1 below.

Photo 8-1 Opuha Dam Downstream Weir

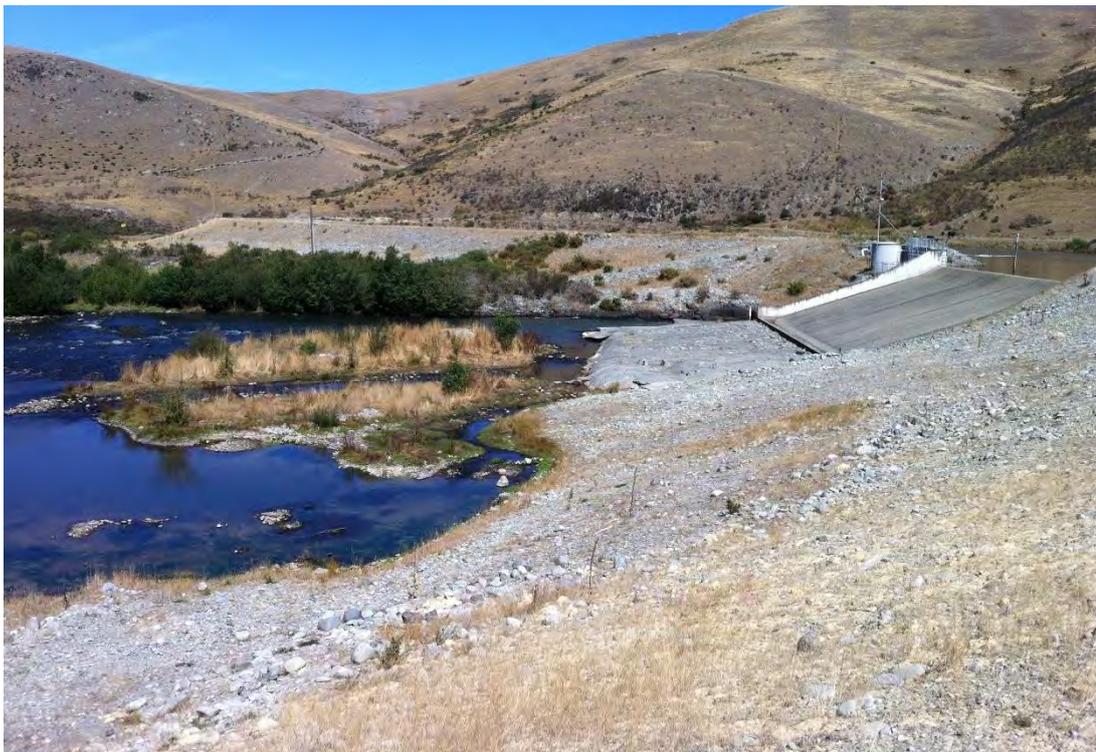
The Downstream Weir Overflow Embankment (DWOE) is designed to fuse during a five year or greater Average Recurrence Interval (ARI) flood. The estimated five year ARI routed dam

outflow is approximately 100 m<sup>3</sup>/s. The present DWOE was reconstructed in 2009 after it operated during high flows in May 2009.

*Photo 8-2 Downstream face of overflow embankment and spillway*
